Client: Undersøkelseskommissjonen etter Utvik Seniors Forlis, Norway
Job reference: T30642 **UTVIK SENIOR**

Figure 1 (4/00A): General view of engine from forward port side.

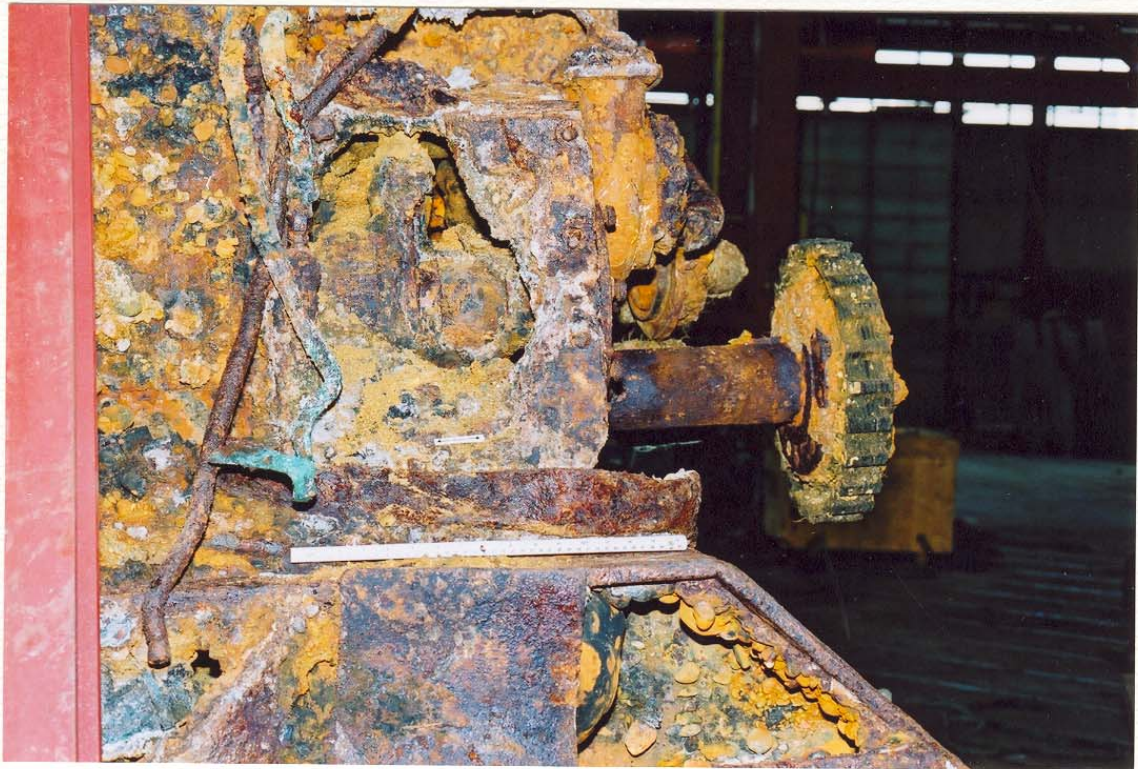
Figure 2 (5/5): Engine forward starboard side, showing fracture of PTO housing mounting and engine casing mounting face, and upward bending of top cover plate.

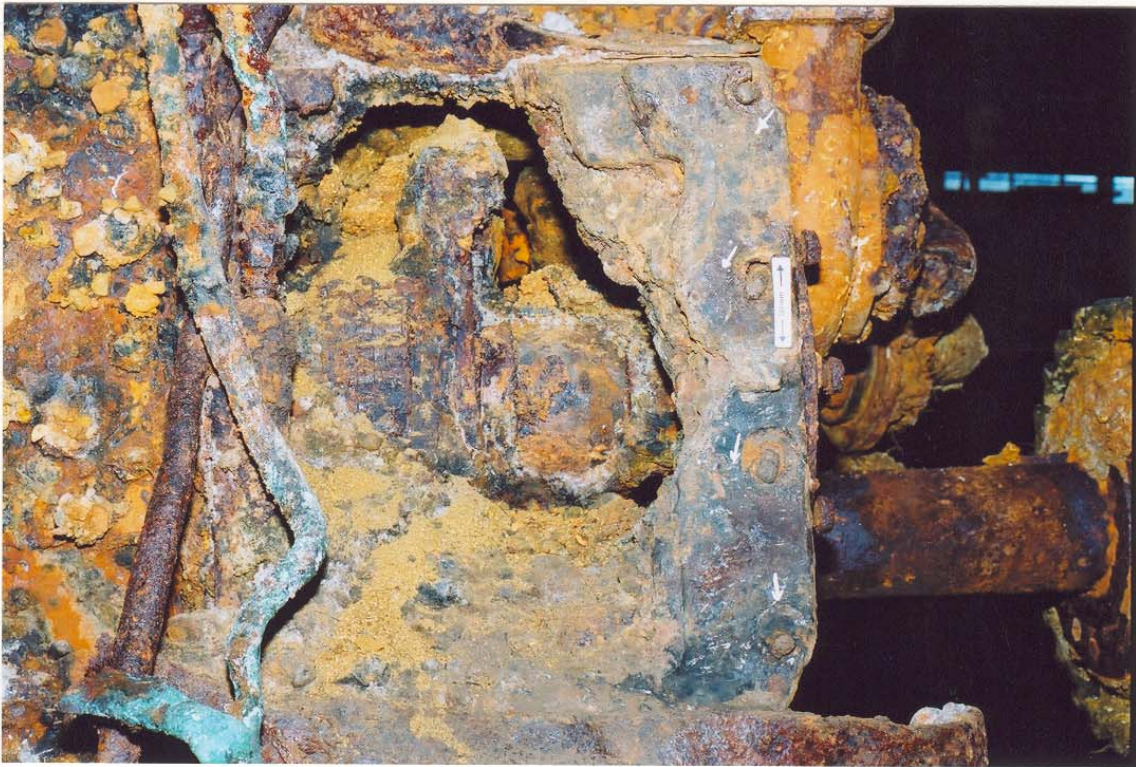
Figure 3 (5/11): Detail of figure 2, showing general direction of stud bending (arrowed).

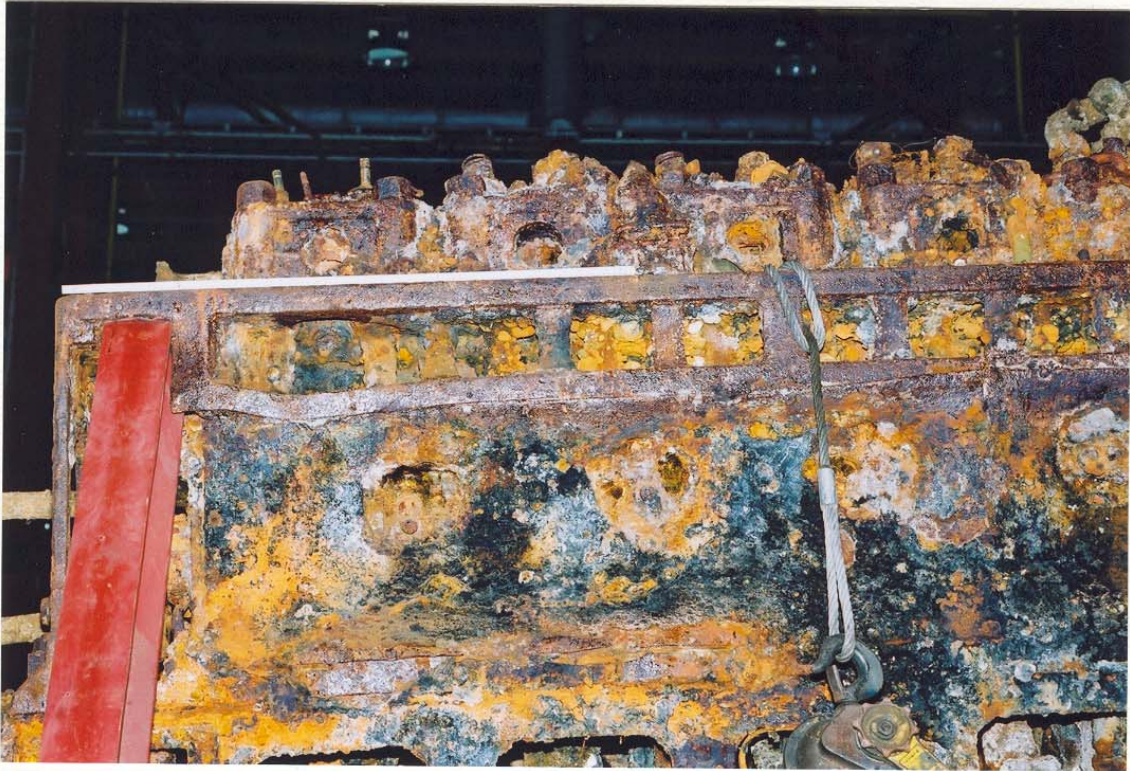
Figure 9 (8/00A): Aft starboard side of engine block showing damage to charge air distributor.

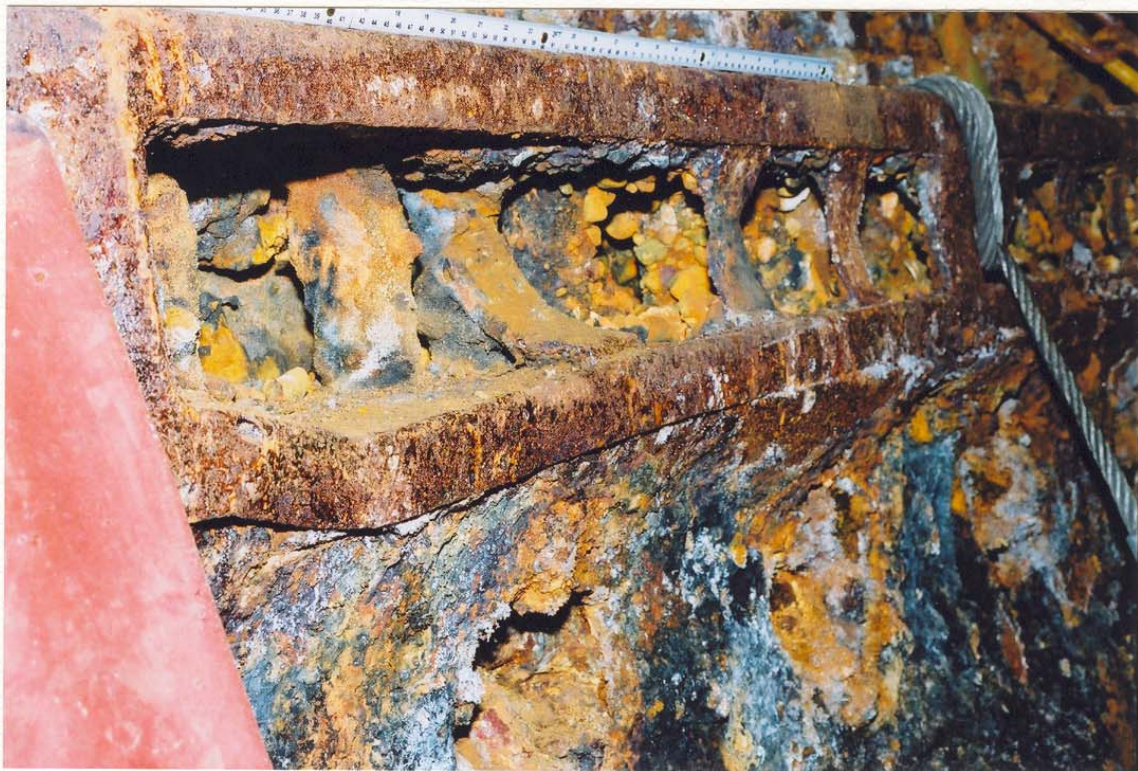
Figure 10 (8/1A): Detail of damage to charge air distributor.

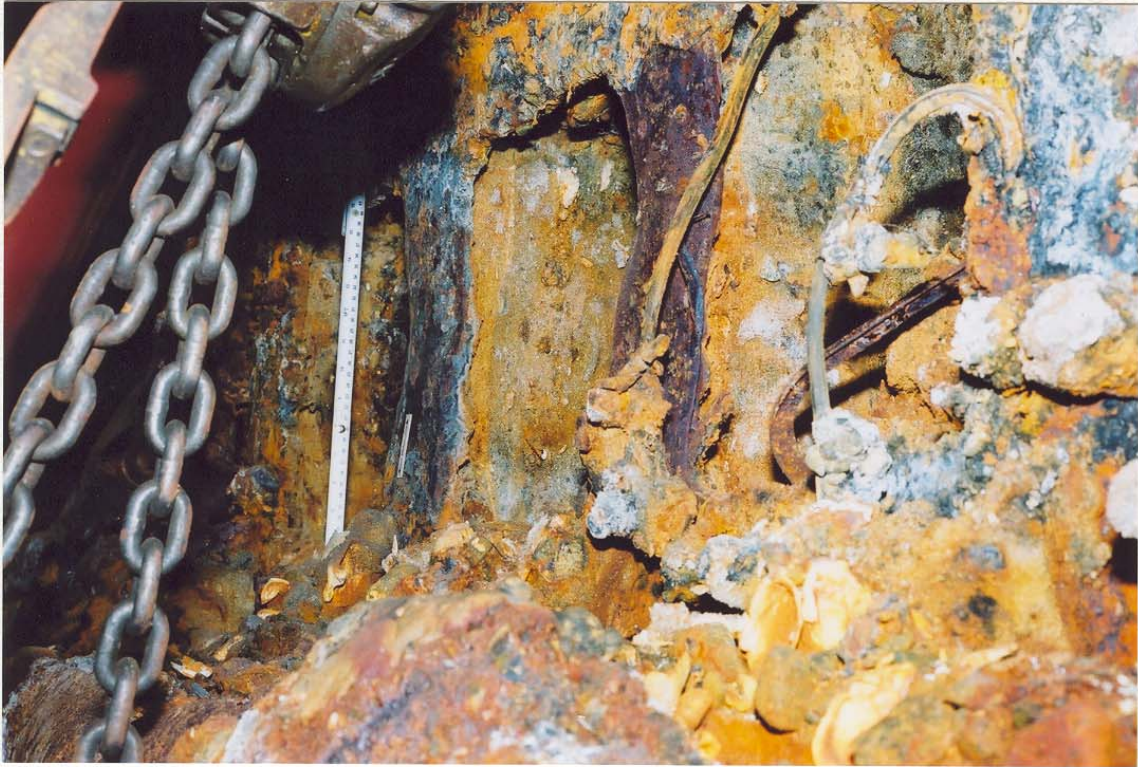
Figure 11 (08/22A): Damage to starboard side crank case door frame.

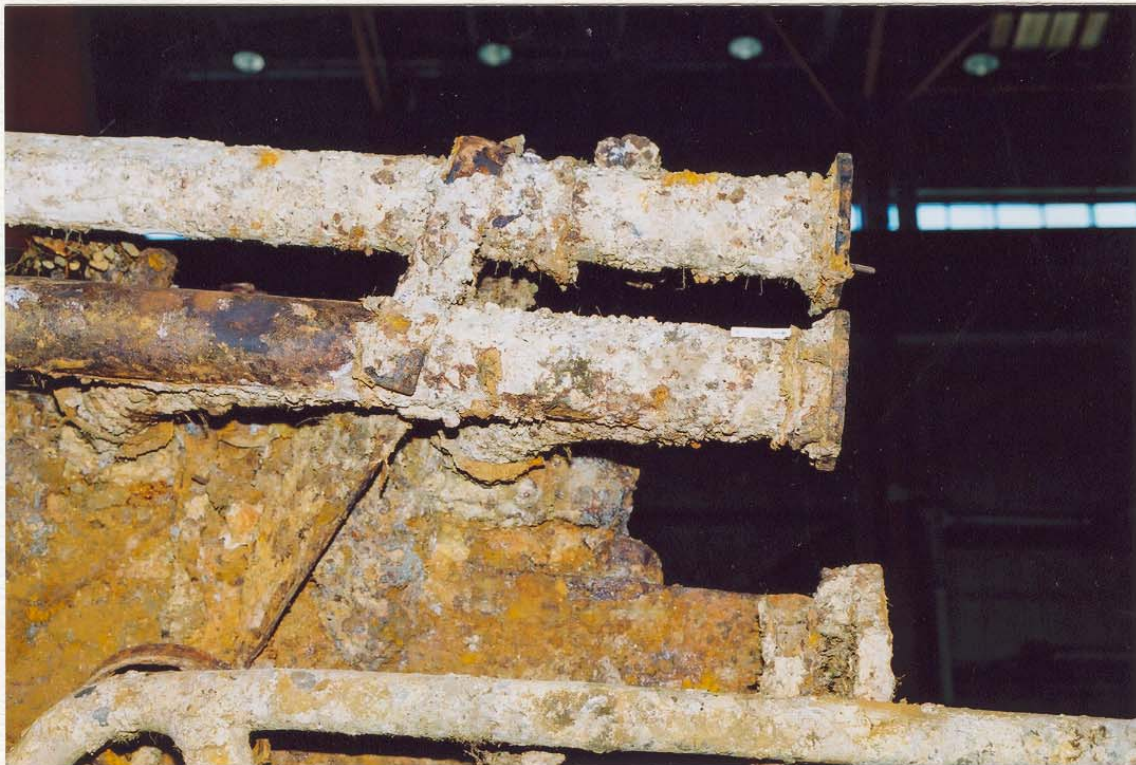
Figure 12 (08/16A): Exhaust flange connections - viewed from aft port side.

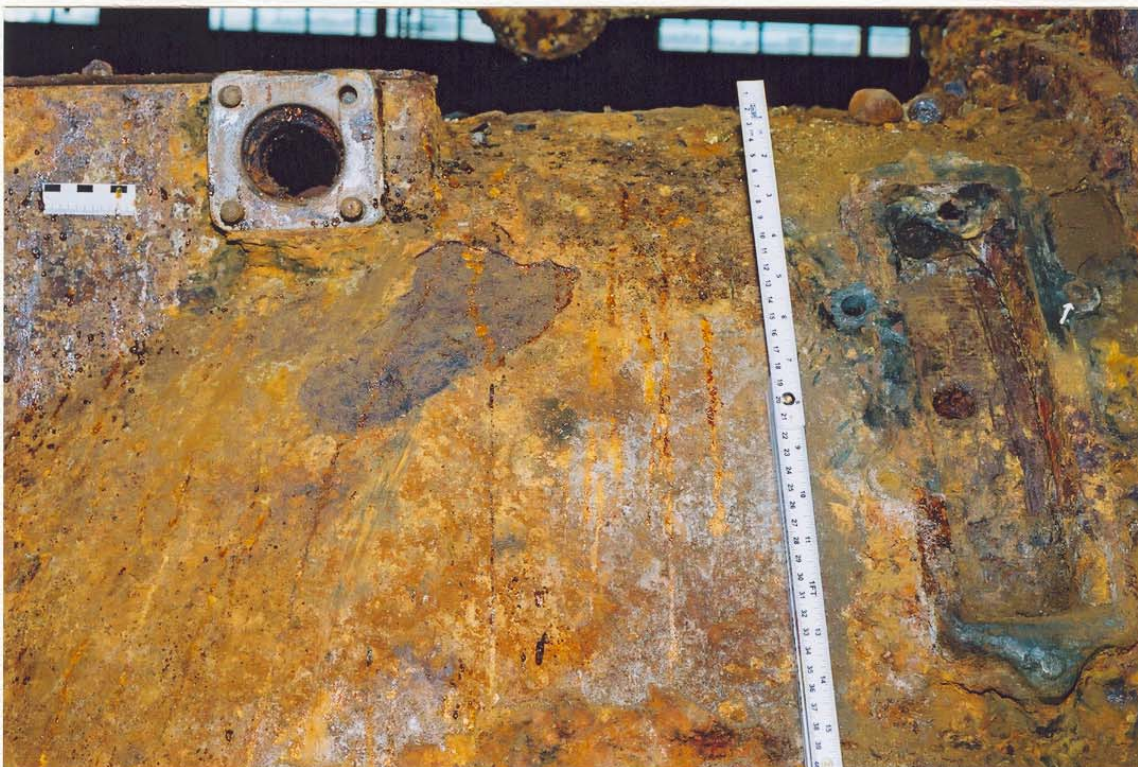
Figure 18 (8/12A): Starboard aft engine side showing missing cover plate at the figures right side (fracture direction of stud arrowed) and mounting flange upper left-hand side of
• figure.

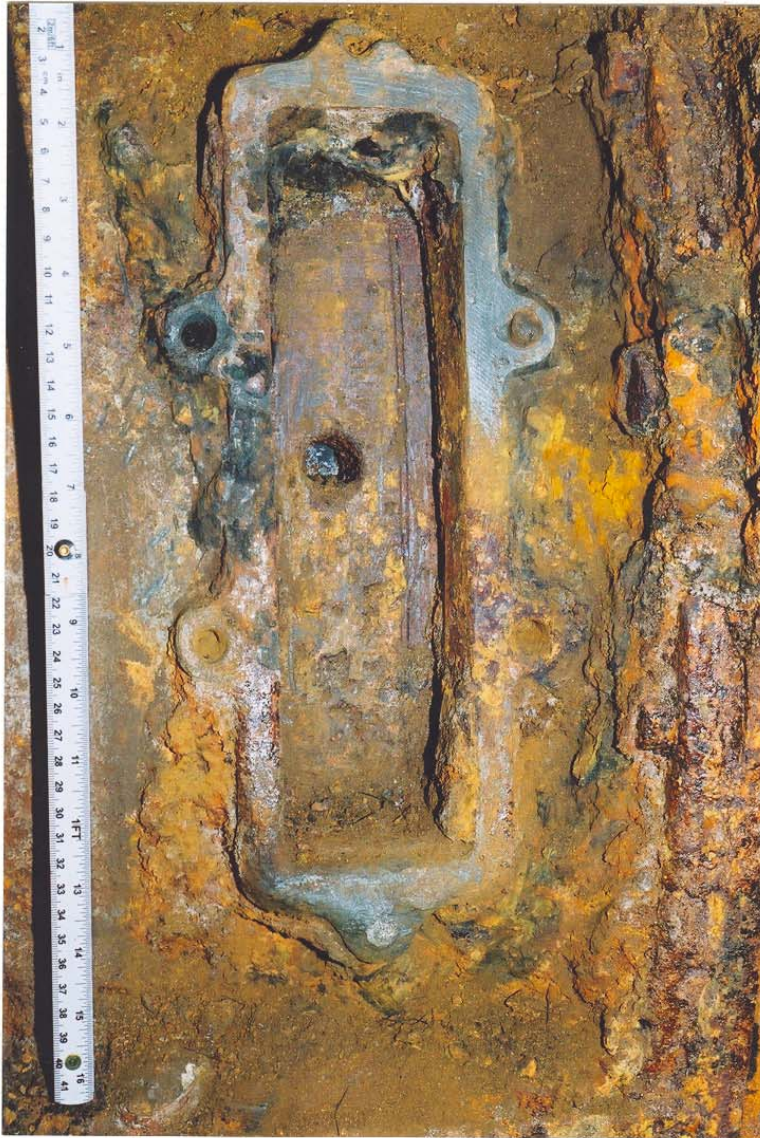
Figure 19 (8/10A): Detail of cam shaft drive cover location.

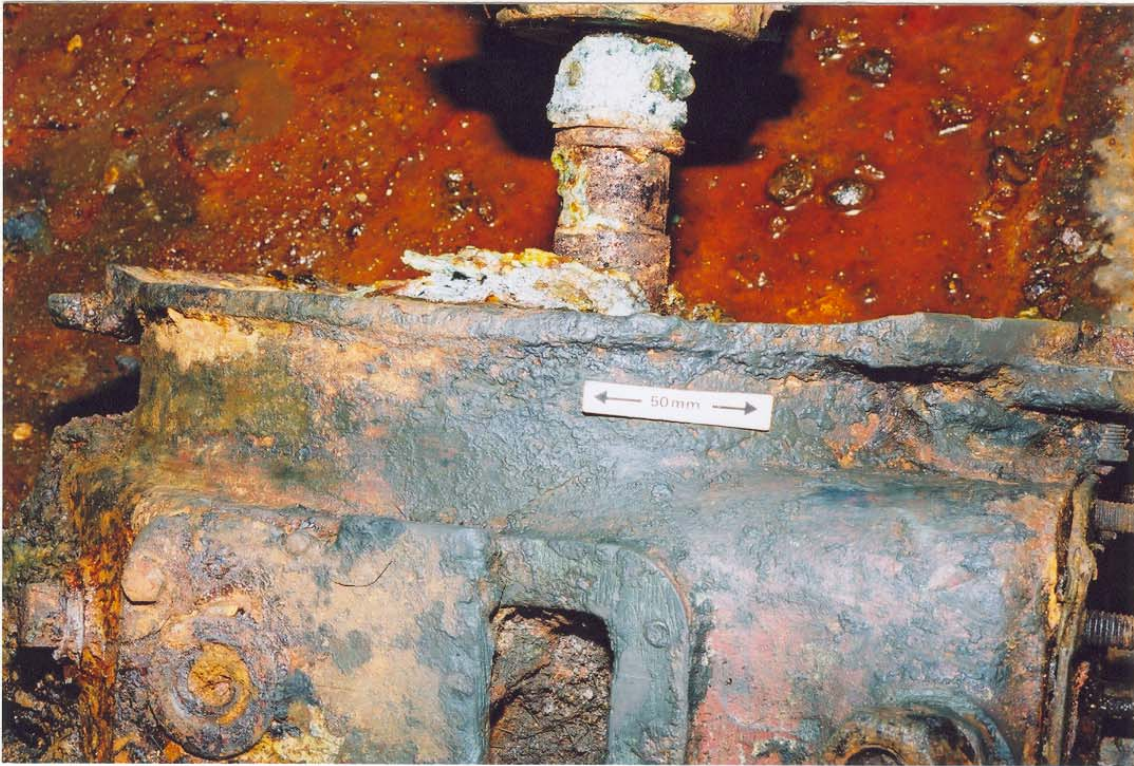
Figure 22 (3/3A): Detail of turbocharger showing fractured rim of casting.

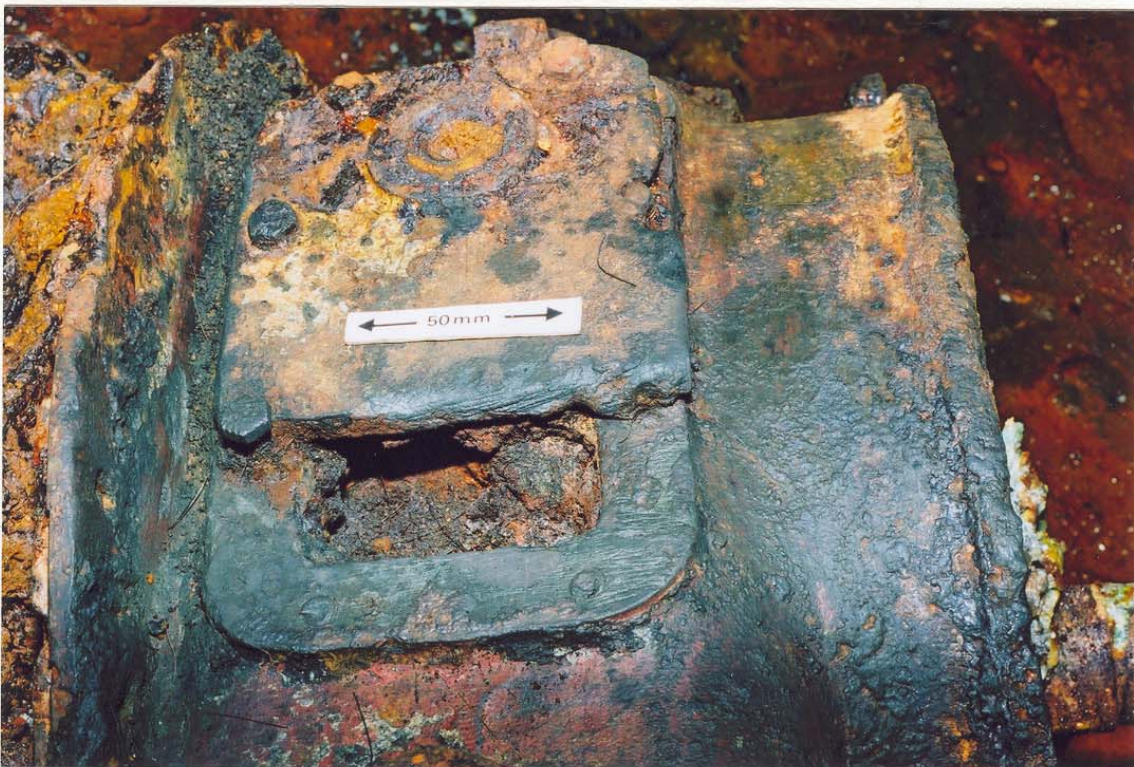
Figure 23 (3/2A): Detail of turbocharger showing fractured cover-plate.

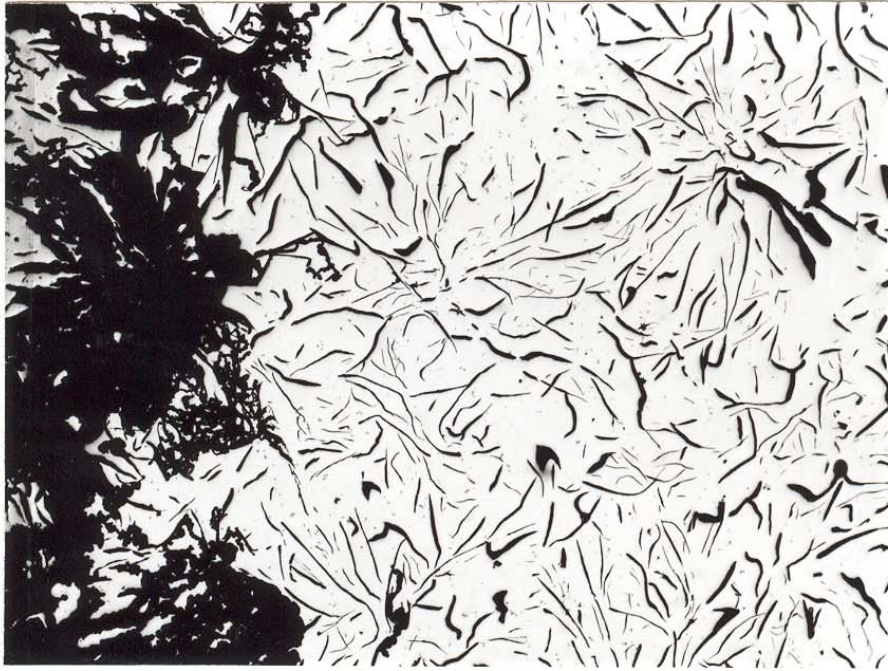
Figure 24 (N5055): Micrograph x50, specimen unetched. Section from turbocharger case mounting flange, showing graphitisation corrosion (left of field) and graphite morphology.

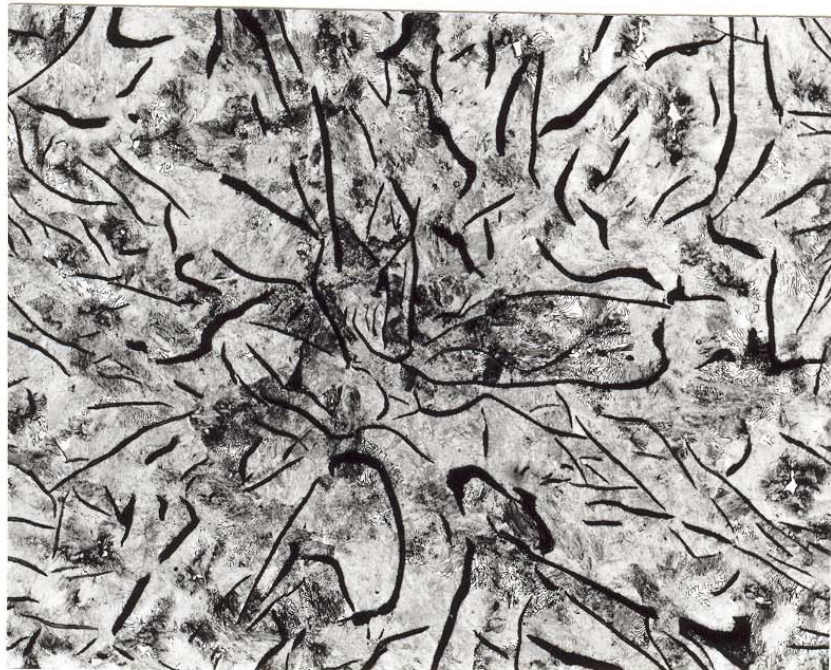
Figure 25 (N5056): Micrograph x100, specimen etched in Nital. Section from turbocharger case mounting flange, showing pearlitic matrix and graphite morphology.

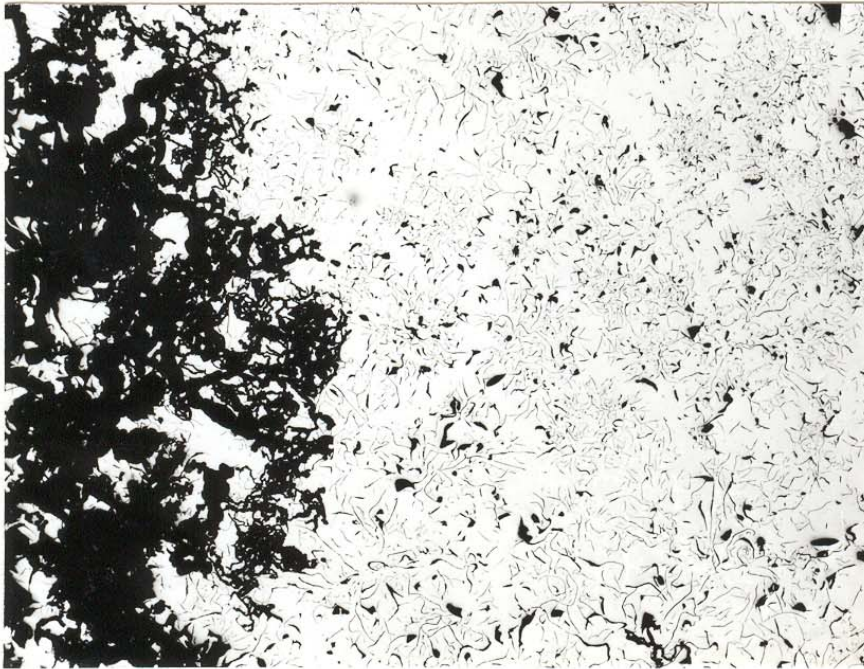
Figure 26 (N5057): Micrograph x50, specimen unetched. Section from turbocharger cover plate, showing graphitisation corrosion (left of field) and graphite morphology.

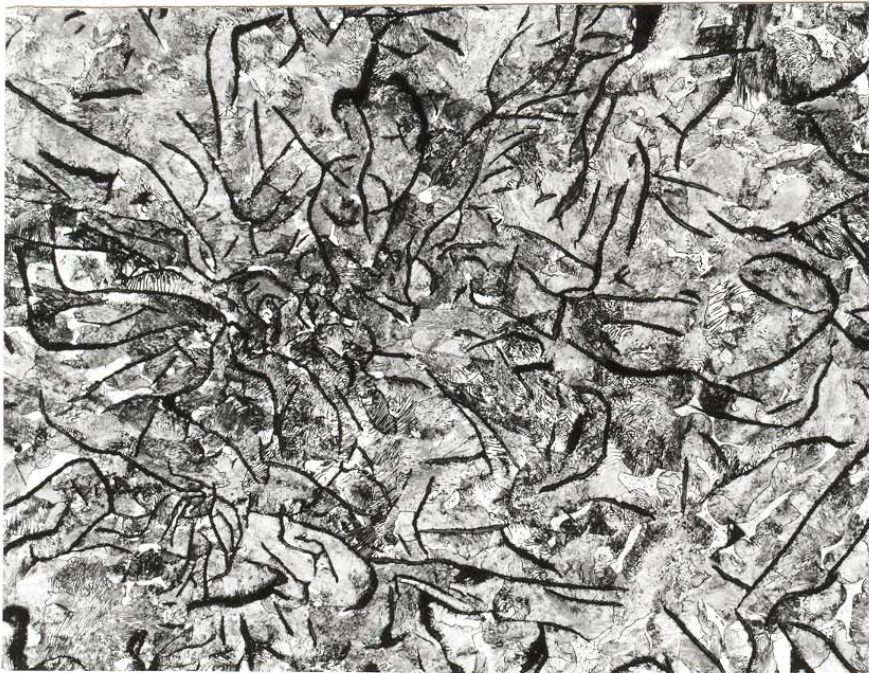
Figure 27 (N5058): Micrograph x200, specimen etched in Nital. Section from turbocharger cover plate, showing pearlitic matrix and graphite morphology.

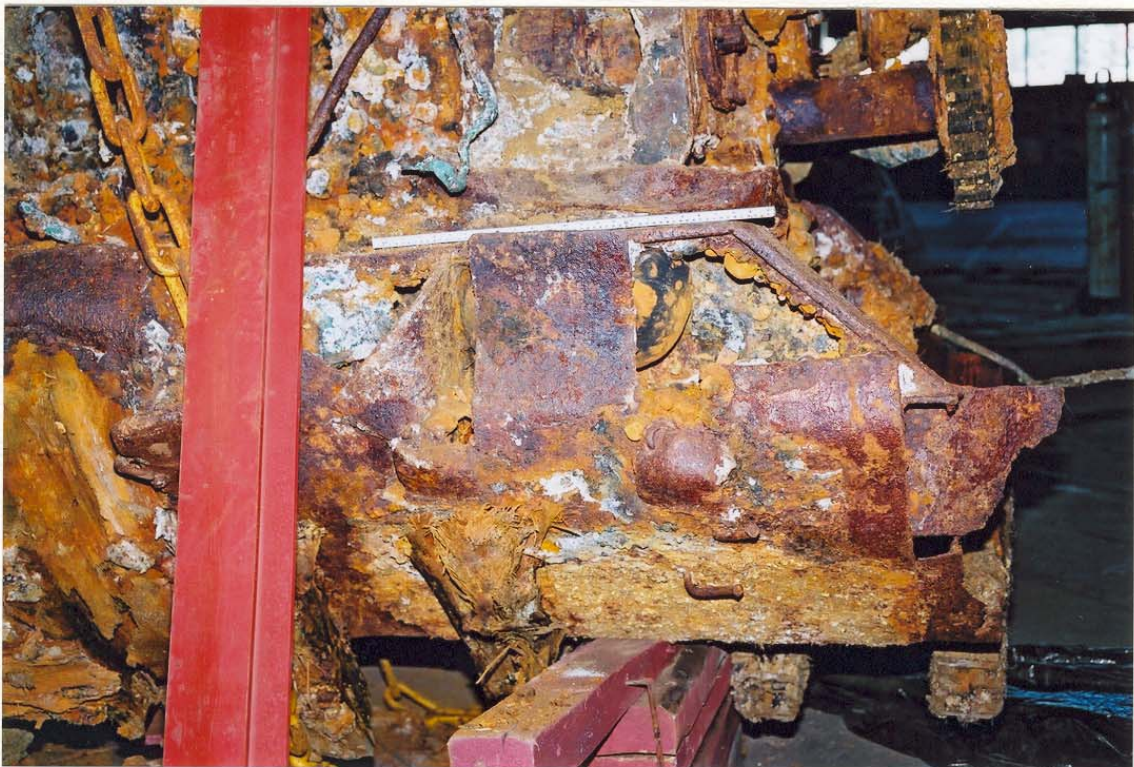
Figure 29 (02/19): Detail of front starboard side damage, showing pebble trapped behind upwardly bent foundation plate.

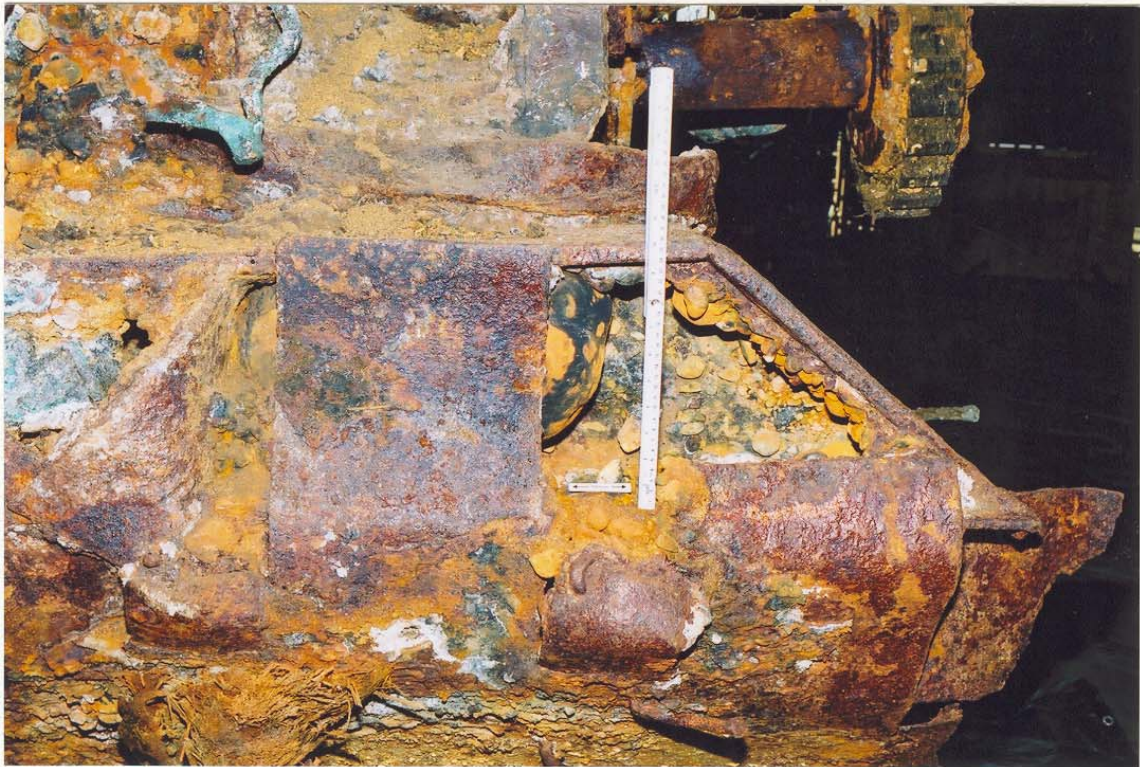
Figure 30 (03/7A): Detail of trapped pebble and backwardly deformed stiffener plate.

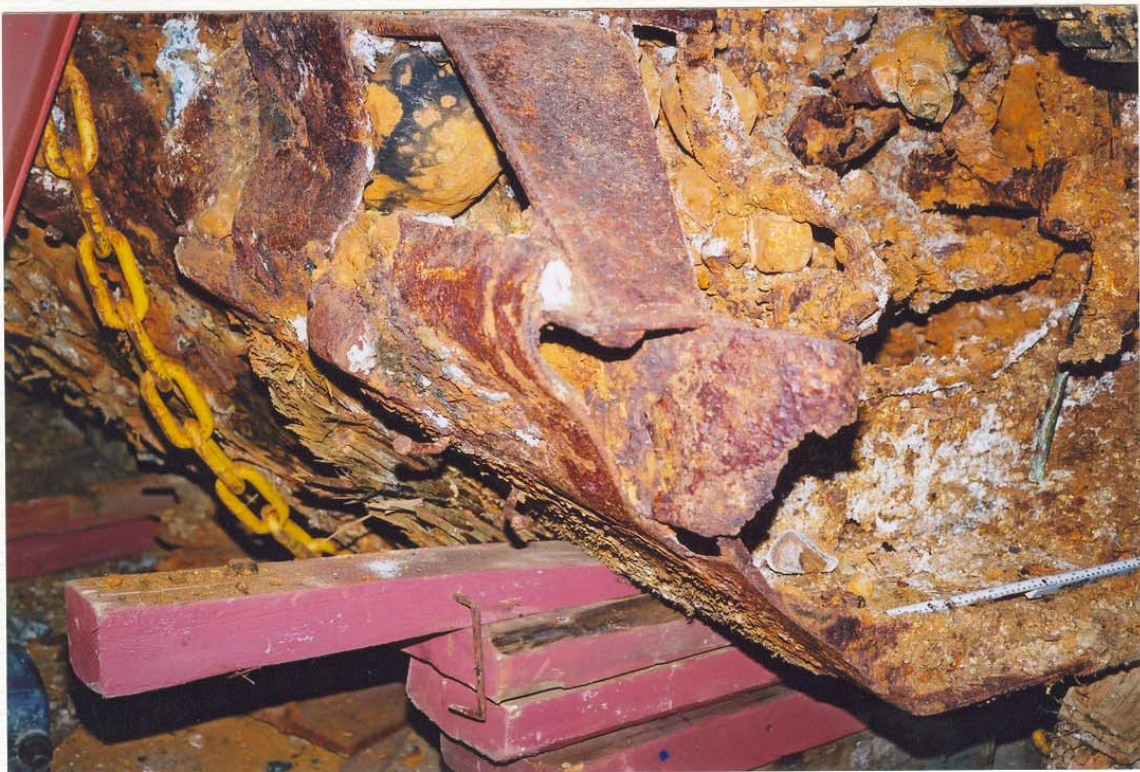
Figure 31 (02/17): Detail of upwardly bent forward starboard side engine foundation plates.

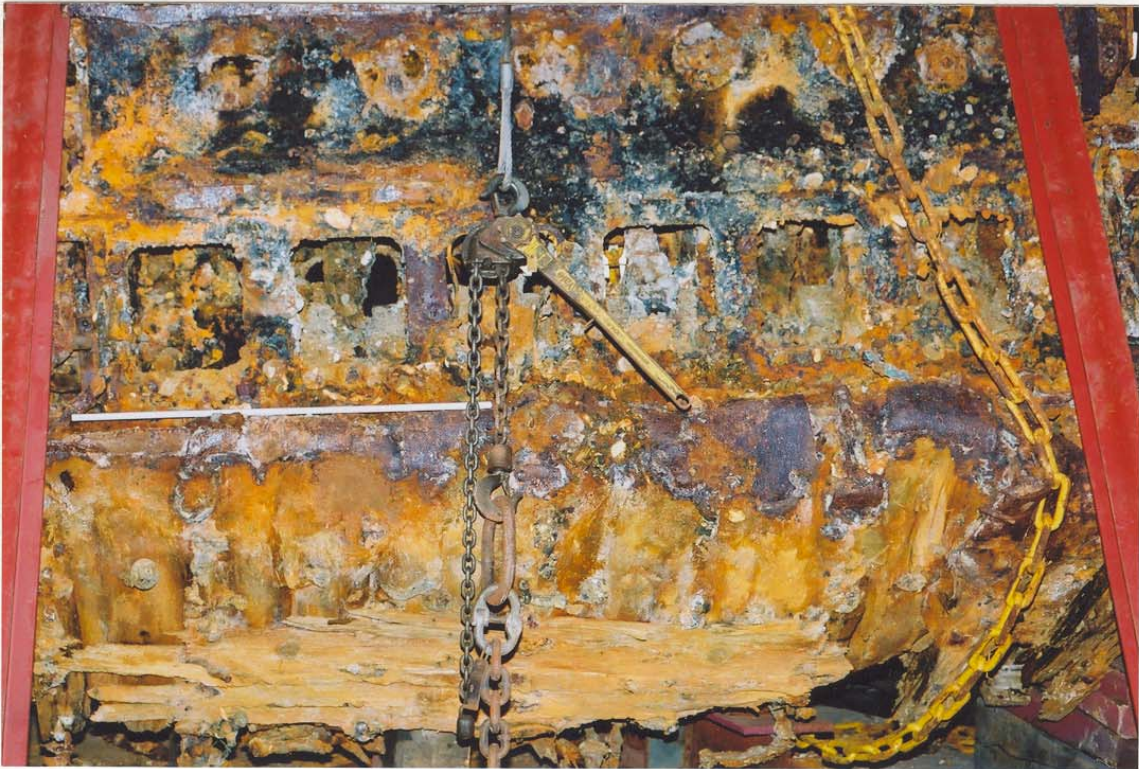
Figure 32 (03/14A): Engine starboard side showing upwardly bent foundation plates.

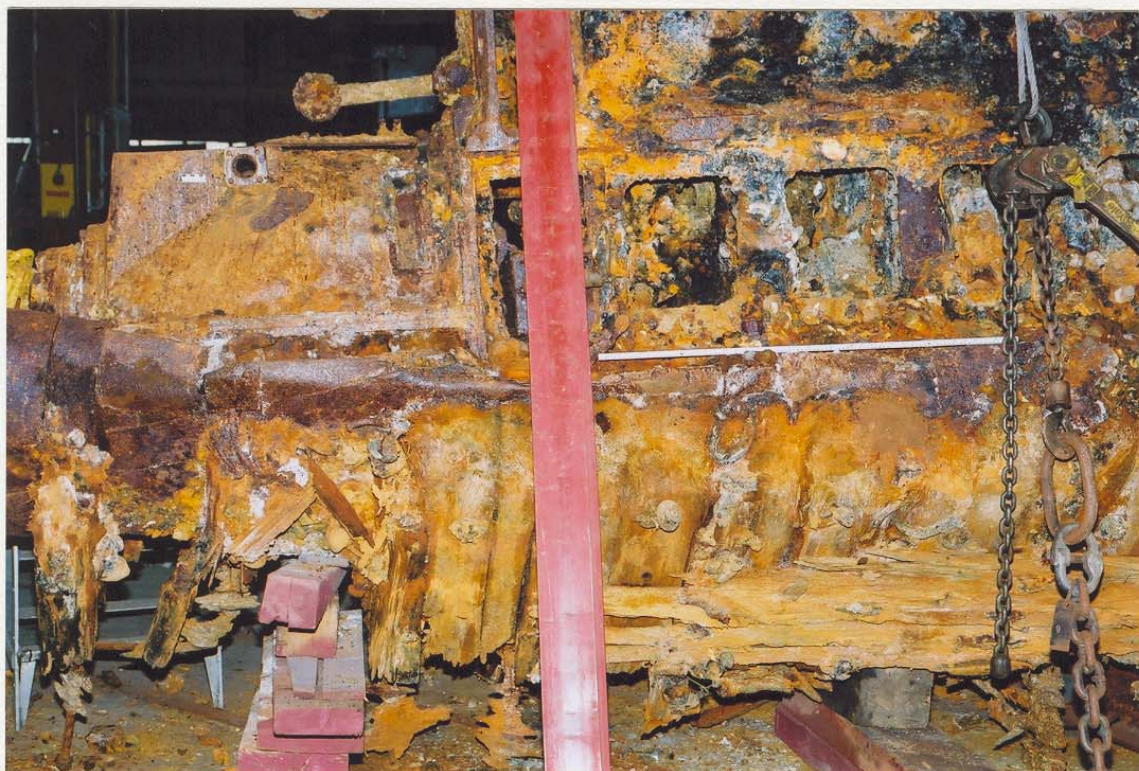
Figure 33 (03/13A): Engine starboard side showing upwardly bent foundation plates.

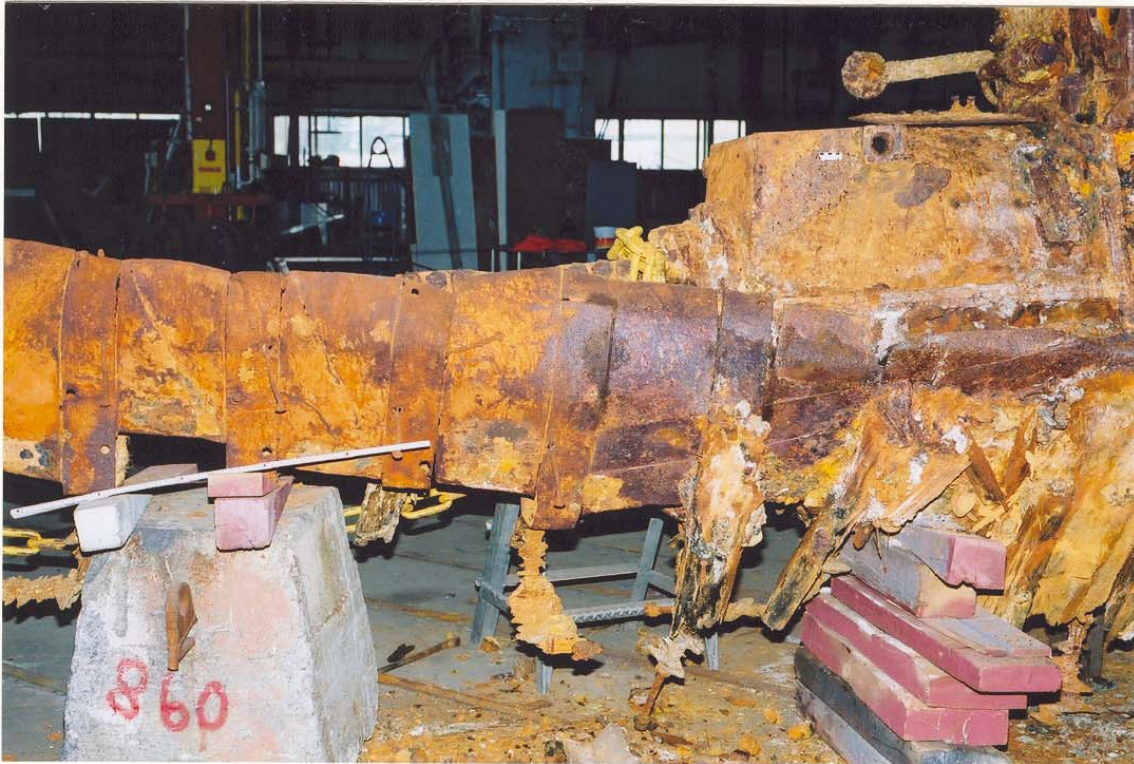
Figure 34 (03/12A): Engine starboard side showing upward bending of foundation plates.

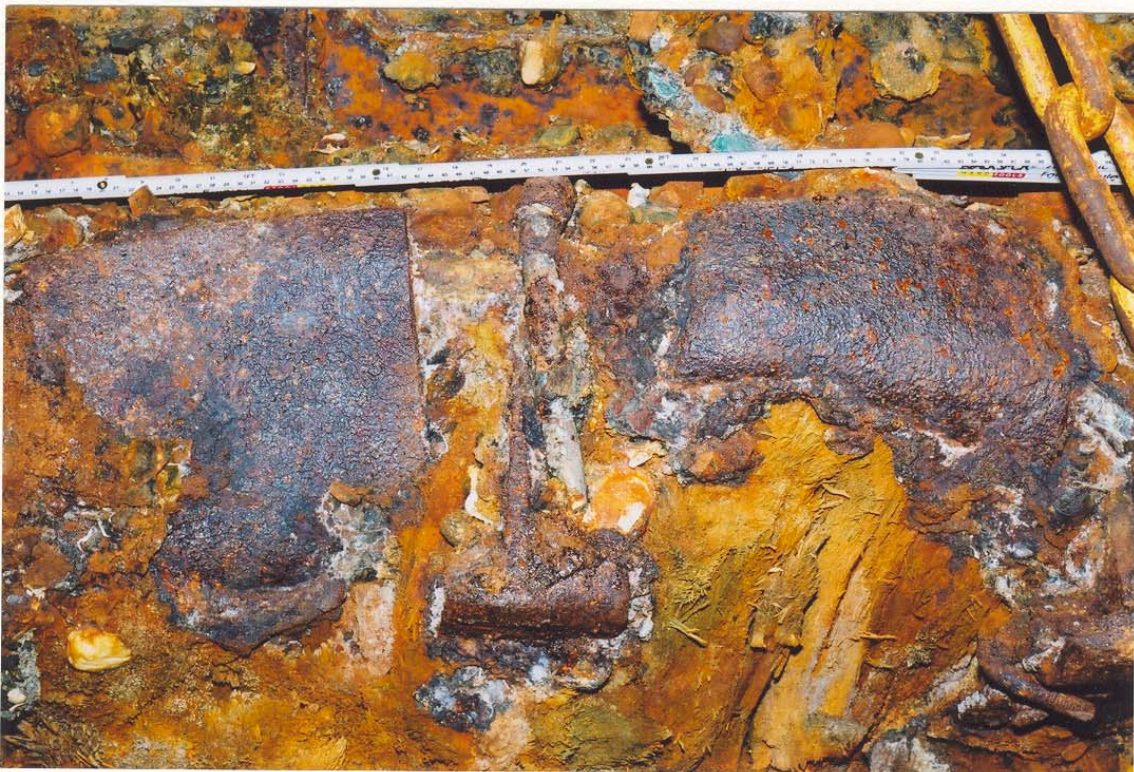
Figure 35 (04/24A): Detail of engine starboard side showing bent foundation plates and stiffener.

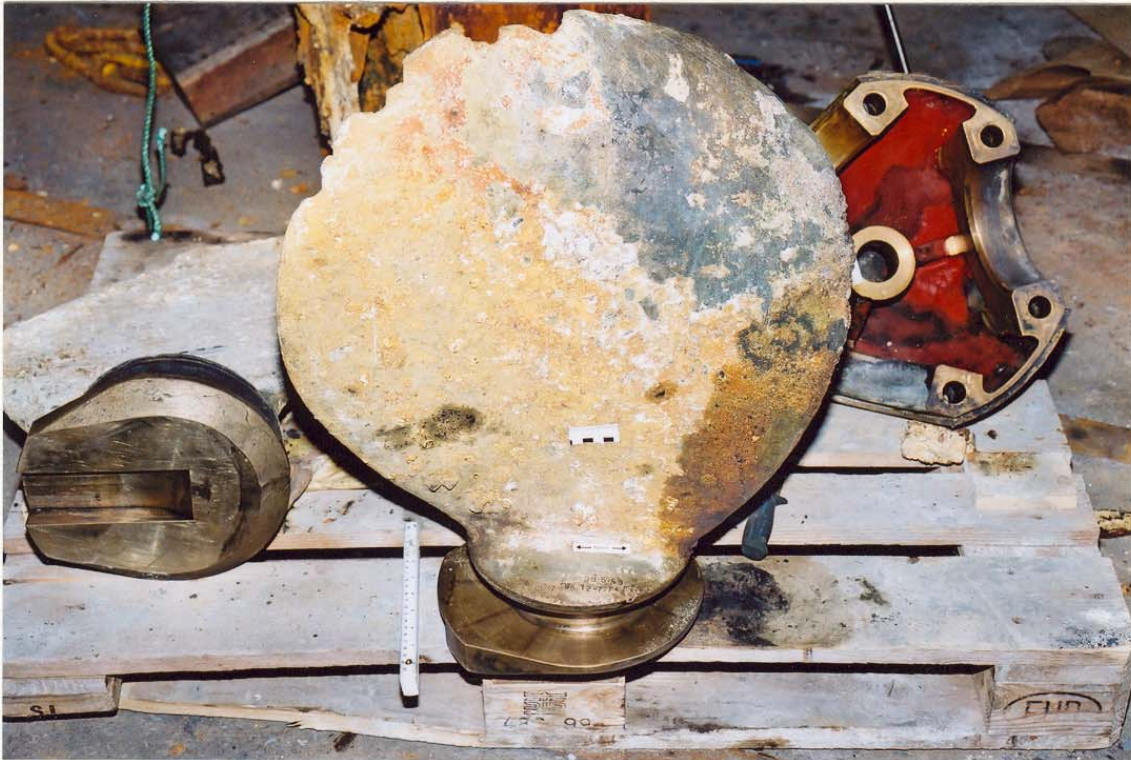
Figure 36 (06/13A): Propeller blade number 3, showing damage to tip.

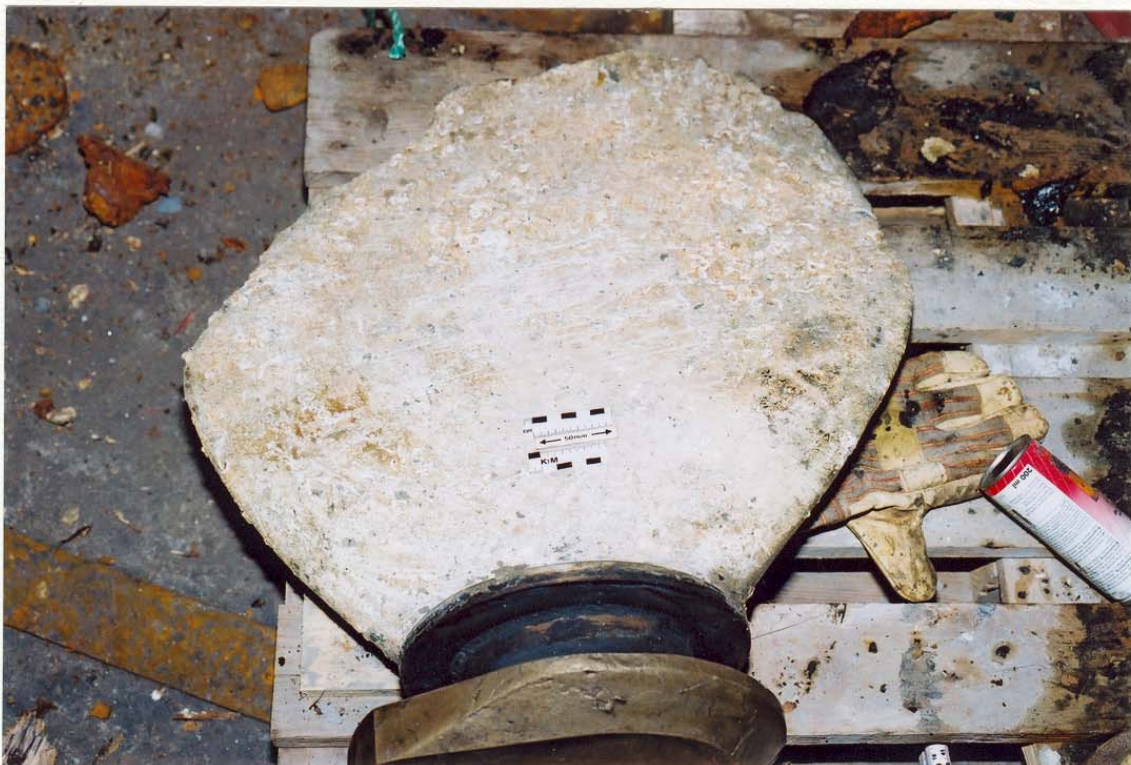
Figure 37 (06/17A): Second propeller blade number 2, showing damage to tip.

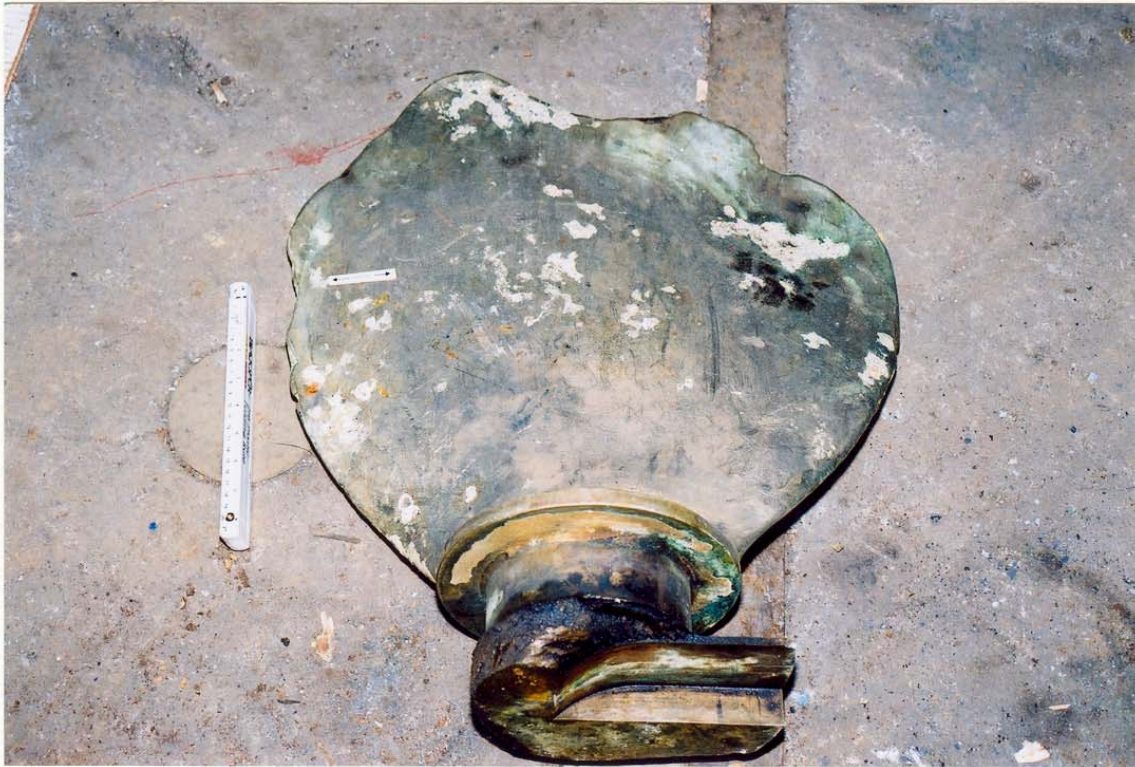
Figure 38 (06/20A): Propeller blade number 1, showing tip bending damage and fracture in root.

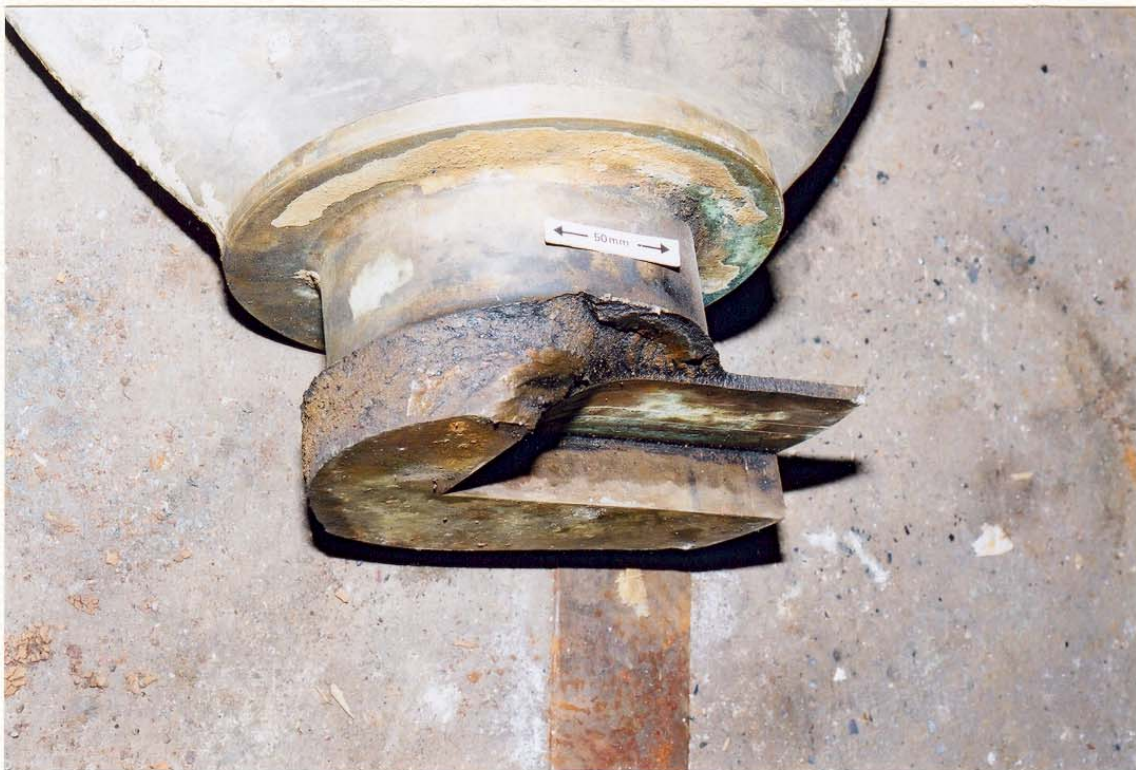
Figure 39 (06/22A): Detail of fracture origin in propeller casting root.

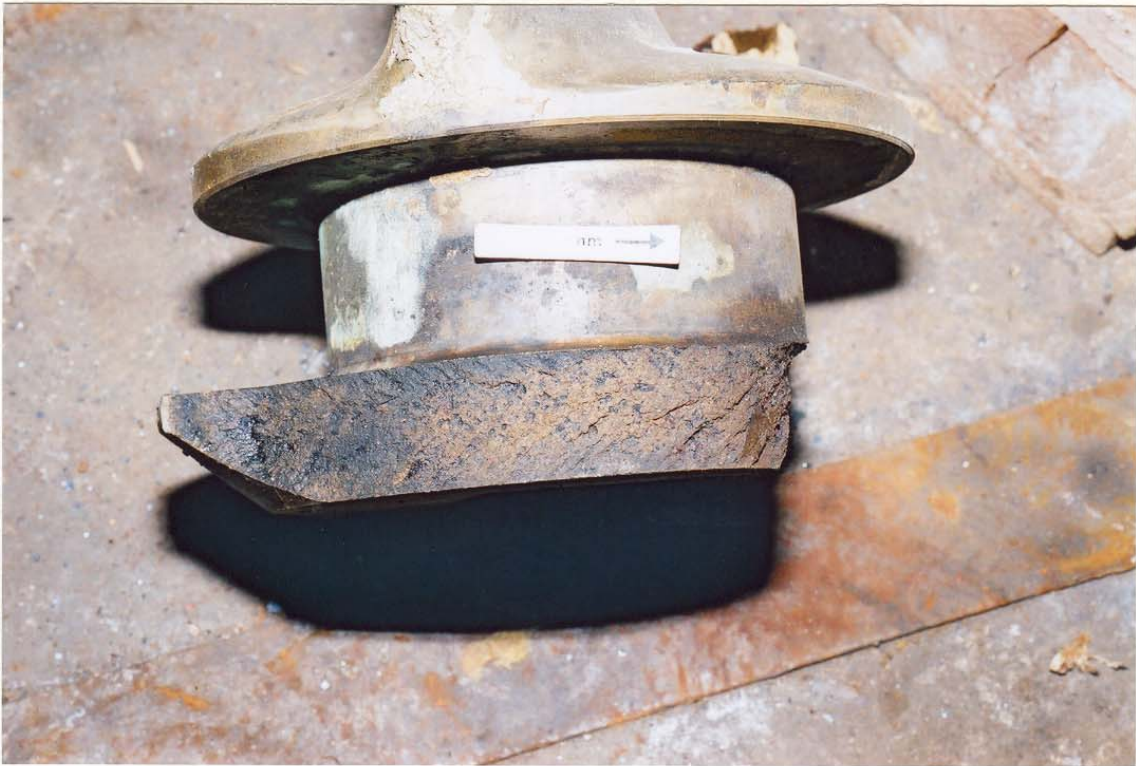
Figure 40 (06/23A): Detail of fracture in propeller casting root, showing fast brittle fracture chevron markings.

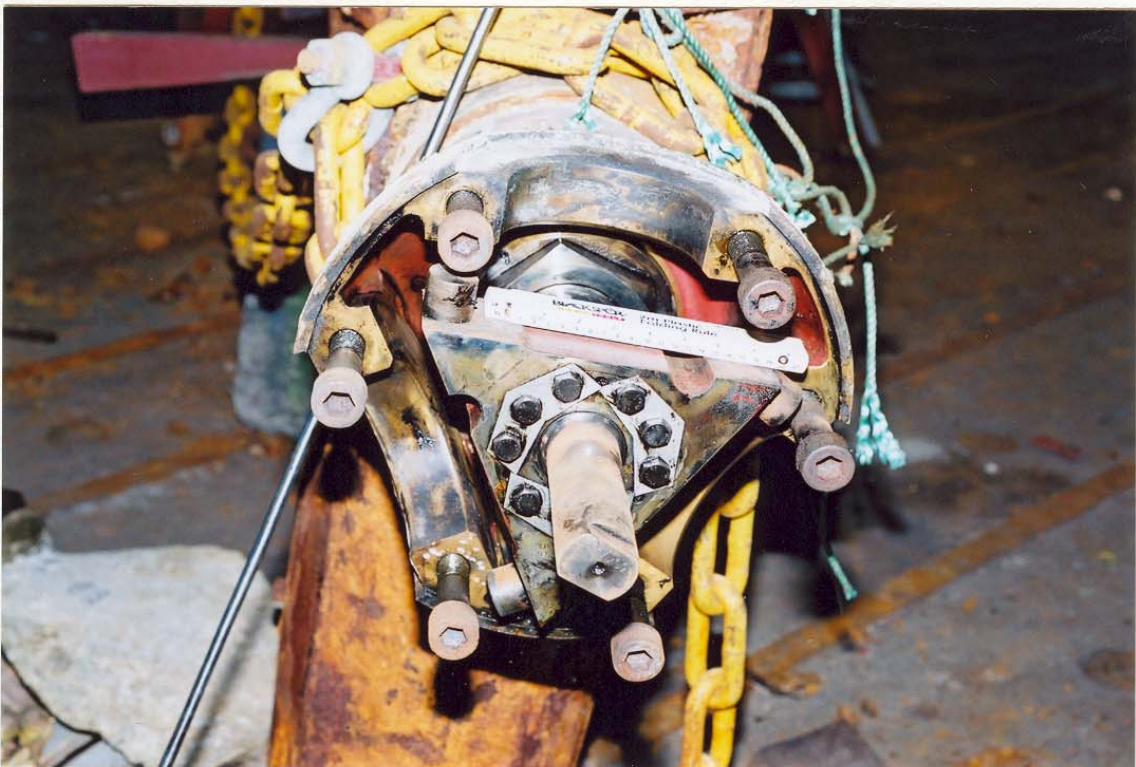
Figure 41 (02/9): Propeller cone internals.
