Client: Undersøkelseskommissjonen etter Utvik Seniors Forlis, Norway
Job reference: T30642 **UTVIK SENIOR**

Figure 1 (4/00A): General view of engine from forward port side.

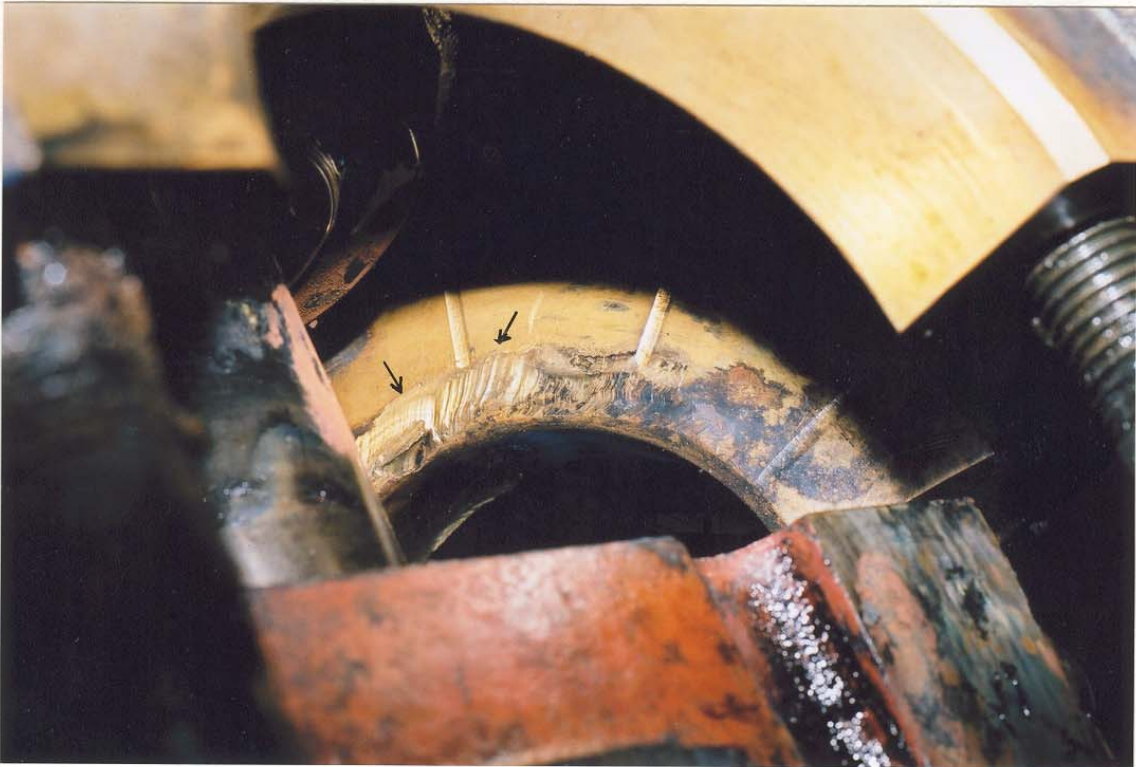
Figure 42 (06/12A): Detail of propeller cone internals, showing severe local mechanical contact damage (arrowed).

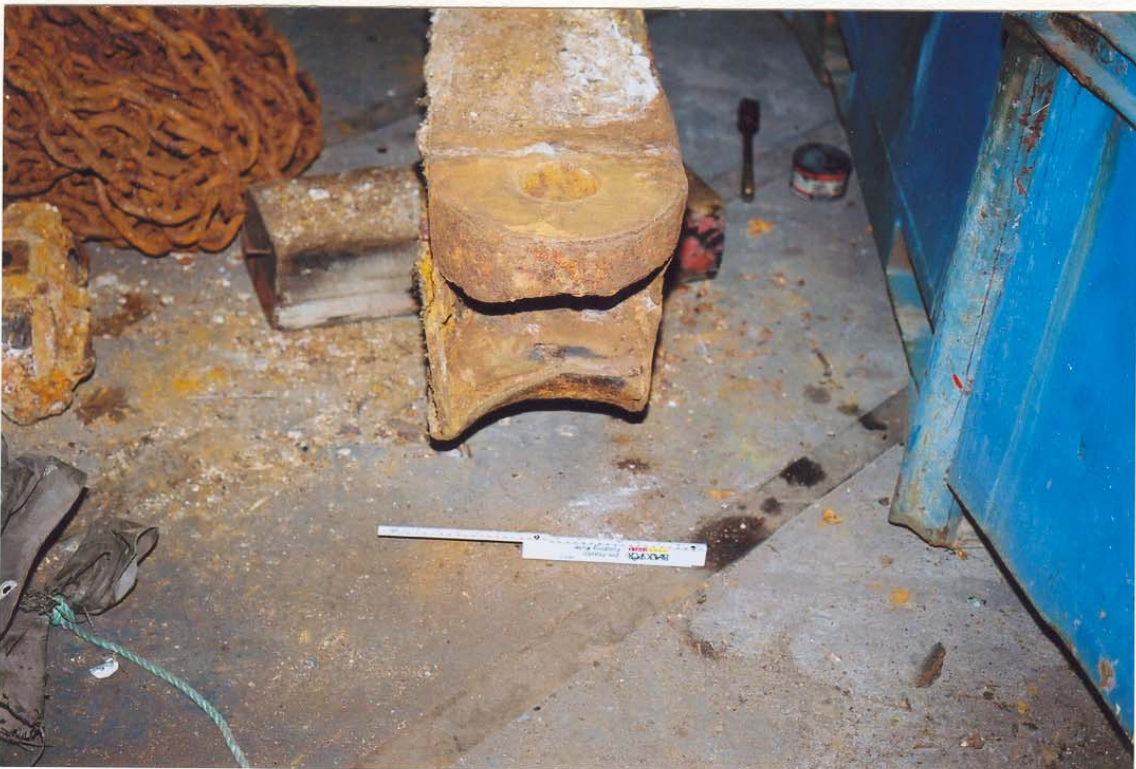
Figure 43 (01/8A): Aft end of keel showing bending damage.

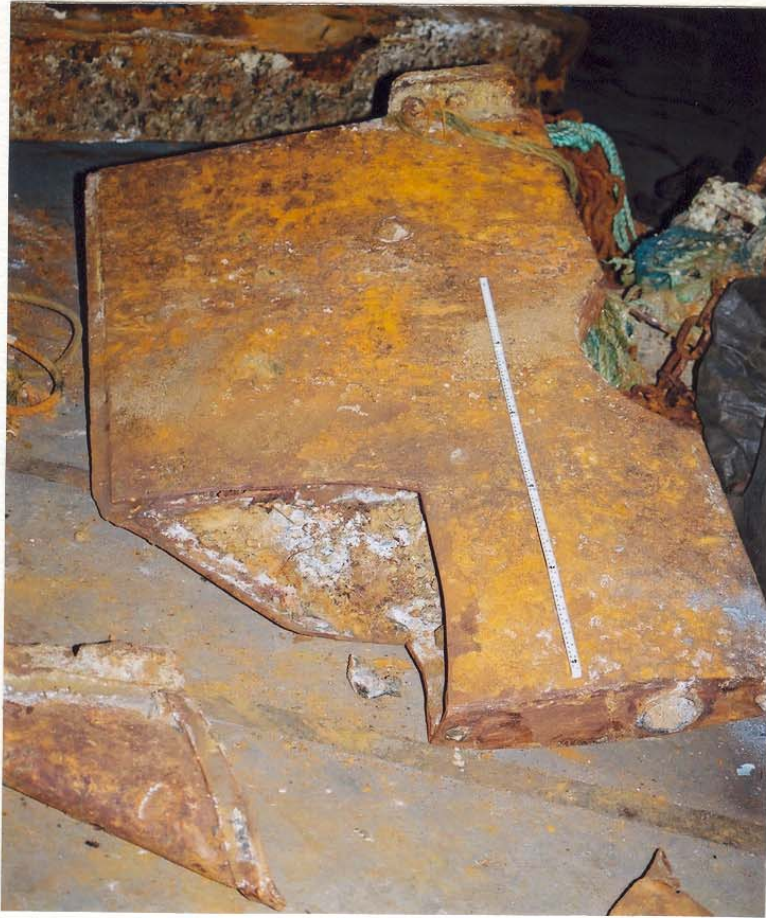
Figure 44 (6/00A): Rudder blade showing site of bending damage - piece removed during earlier examinations.

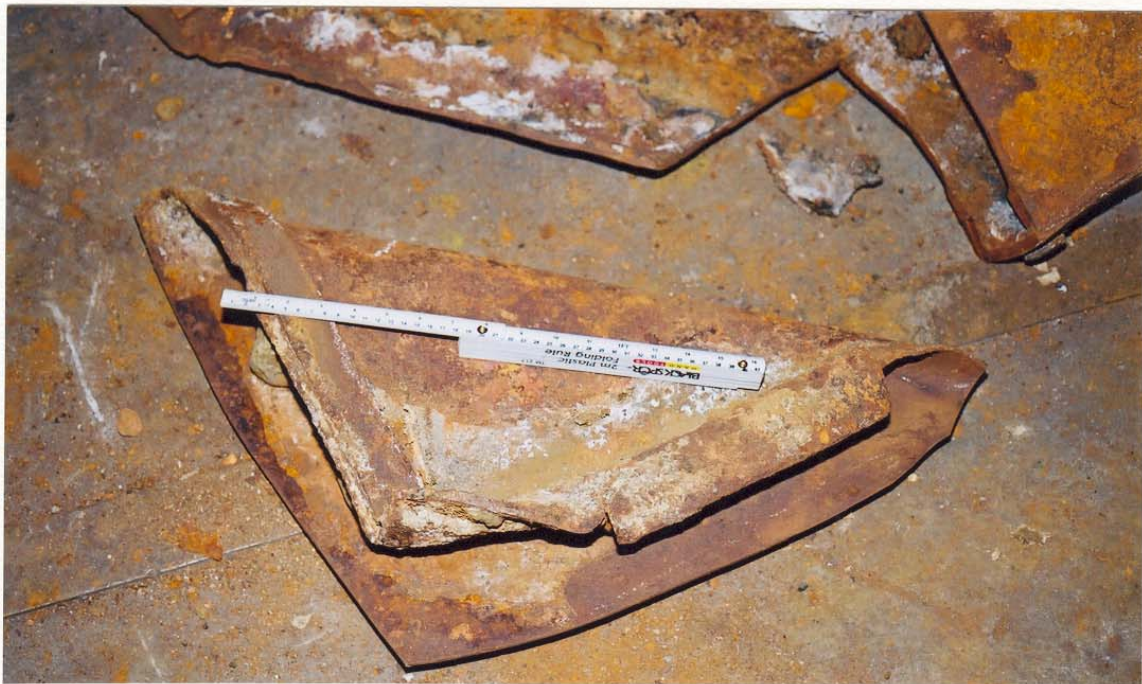
Figure 45 (06/5A): Detail of bent lower aft corner of rudder blade - piece removed during earlier examinations.

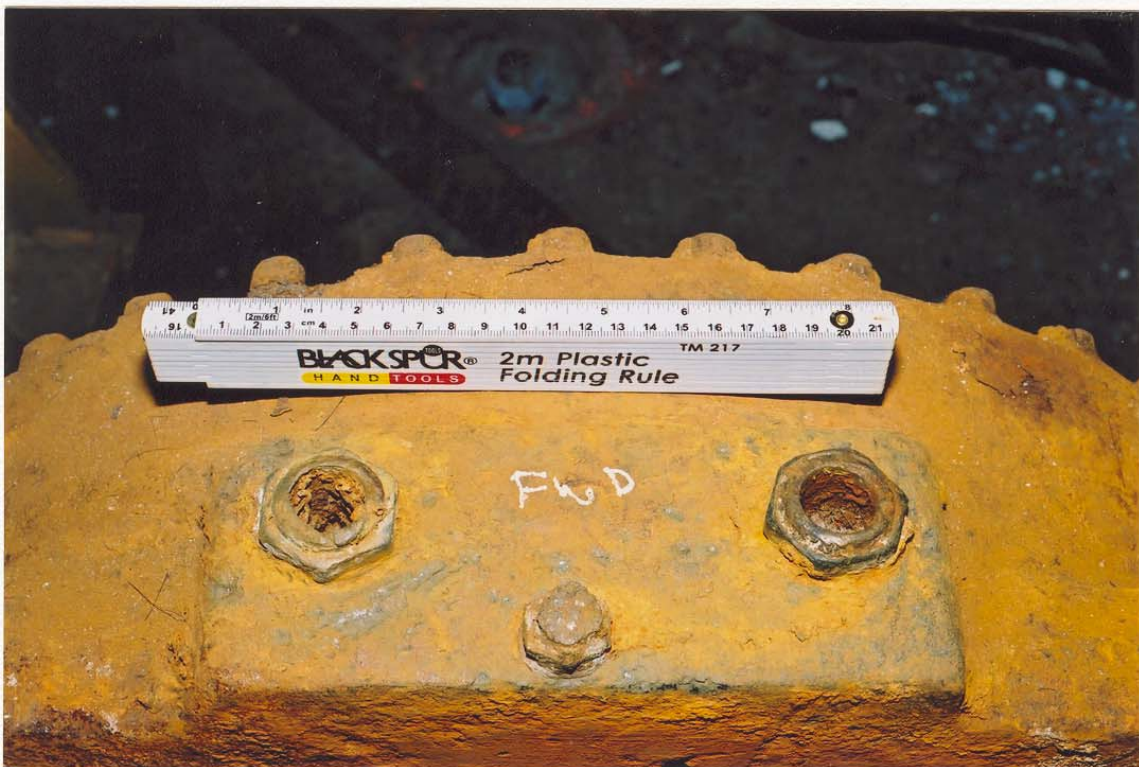
Figure 47 (7/18A): Detail of fractured pilot motor hydraulic pipe connections.

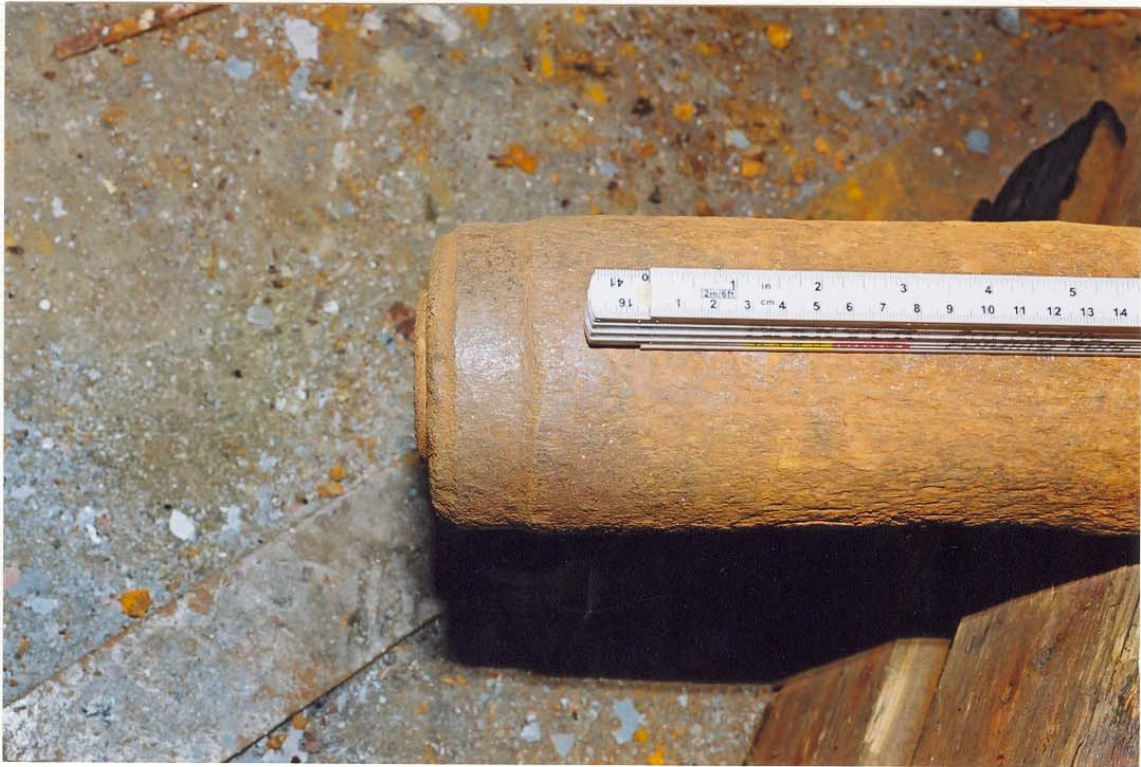
Figure 48 (7/23A): Detail of rudder stock to bolting flange weld sites.

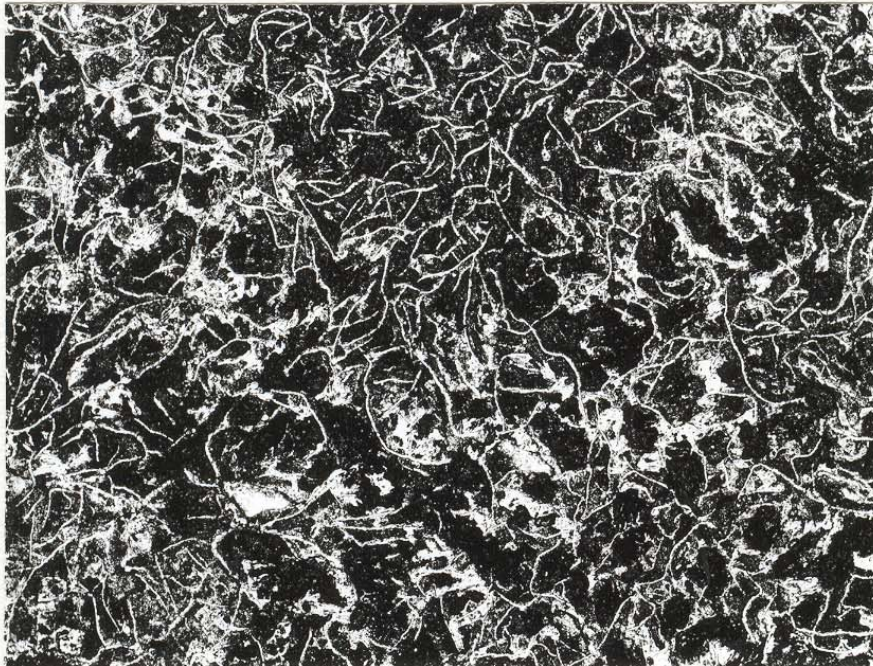
Figure 53 (N5095): Micrograph x100, specimen unetched. Section from drive pulley, showing extensive (total) graphitisation corrosion and prior flake graphite morphology.
