**The Scandinavian Star  
Disaster of 7 april 1990  
MAIN REPORT**

NOR 1991: 1E

**Report of the Committee Appointed by  
Royal Decrees of 20 April and 4 May 1990**

**Submitted to  
the Ministry of Justice and the Police in January 1991**

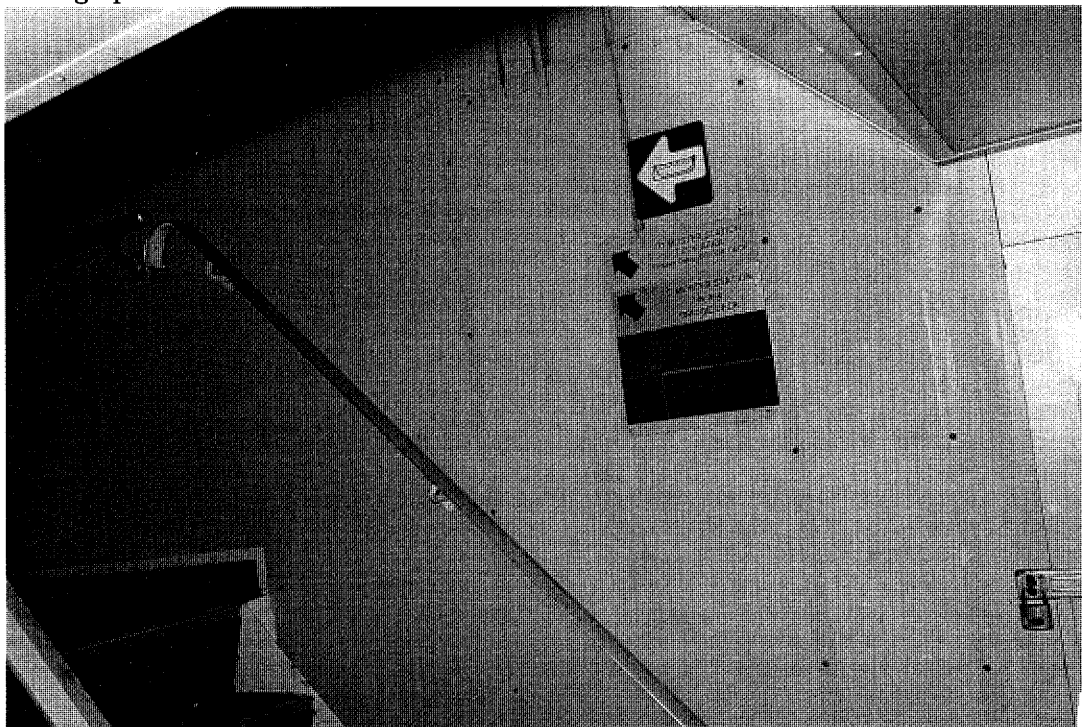
Photograph 1

*Photograph 1* shows the type of notice that was used throughout the ship to indicate the way to muster stations. Four muster stations are indicated, each with a different colour. The arrow indicates the direction to the muster station.

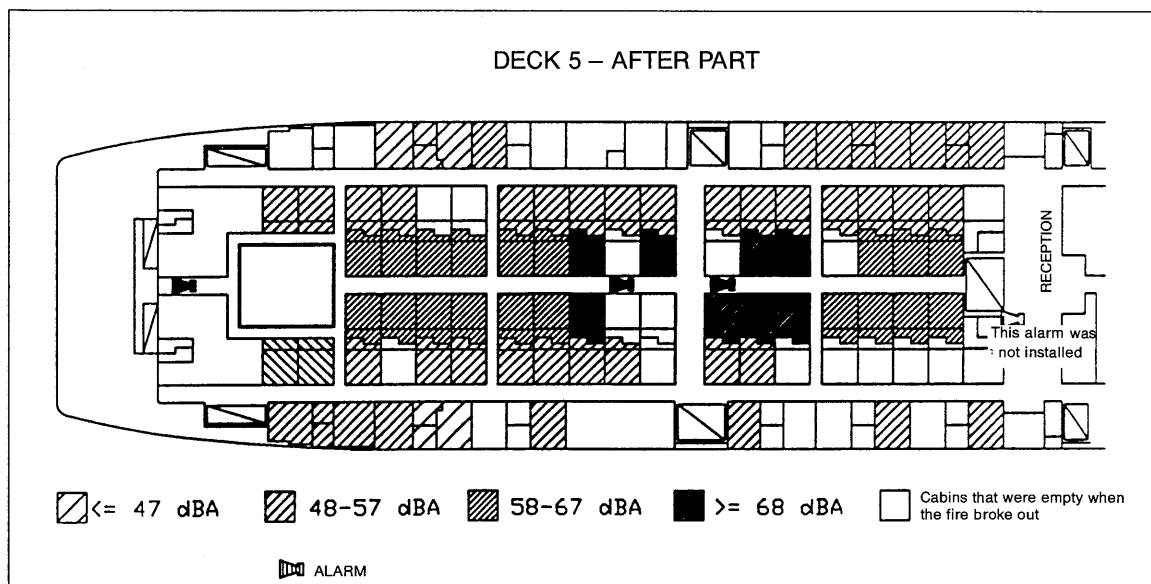
The main alarm system had obvious defects. Three alarm bells appeared to be missing, and the sound level was too low in places. The alarm system was examined and evaluated by experts appointed by the Committee, and the presumed sound levels in the cabins were calculated on the basis of the measurements made by the experts. In a very large number of cabins the sound level was too low for safety.

The Committee has correlated the sound levels in the various cabins with the cabins in which deceased passengers were found. The results showed that cabins with low levels of sound were evacuated to a lesser extent than

Fig. 4.8.1 After part of deck 5 with hatched areas indicating sound levels

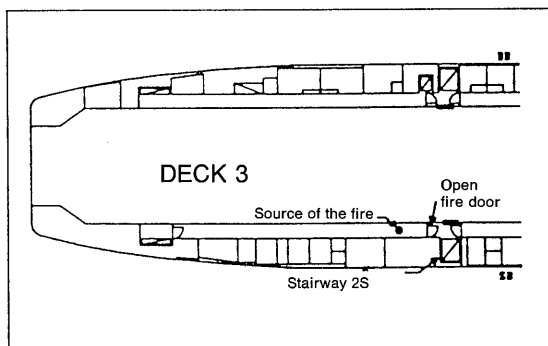
Fig. 8.1 The area where the fire started.

There is little doubt that the fire was ignited with a naked flame, about the size of a match or lighter flame. A glowing cigarette would probably not have been enough to start it. The ignited material is assumed to have been a collection of paper, bedclothes, and blankets that had been deliberately placed at the site.

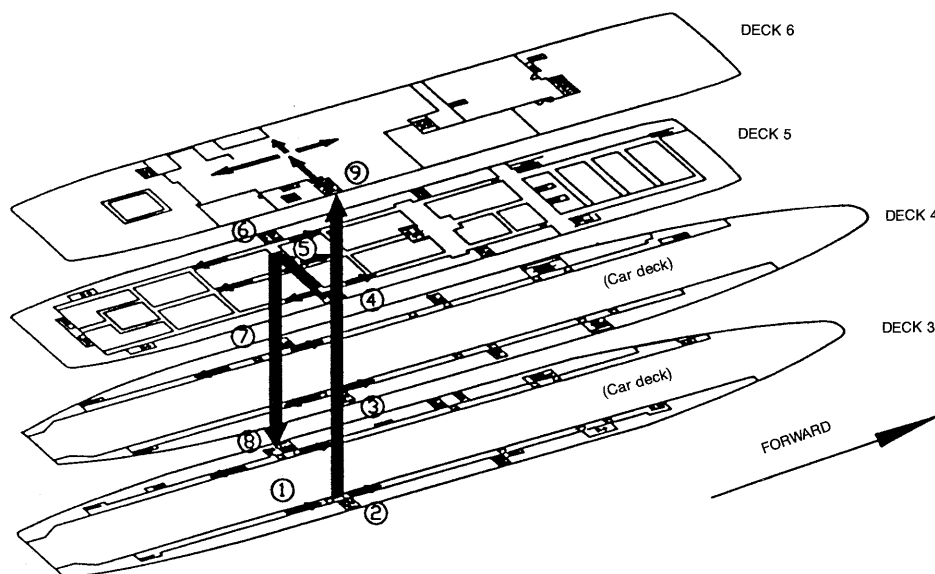
Fig. 8.2 *Course of the fire*

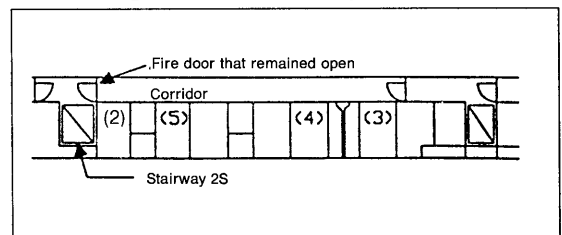
Fig. 8.4 Deck 4, starboard side, forward of stairway 2S (figures in parentheses represent numbers of deceased).

This fire door remained open during the whole fire, which meant that the smoke and flames were able to spread relatively freely. About 6 minutes after the start of the fire the corridor surfaces caught alight, and the fire began to spread along the corridor. After a while the

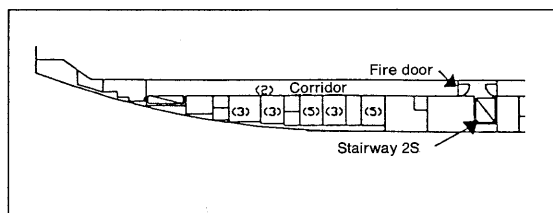
Fig. 8.5 Deck 4, starboard side, aft of stairway 2S (figures in parentheses represent numbers of deceased).

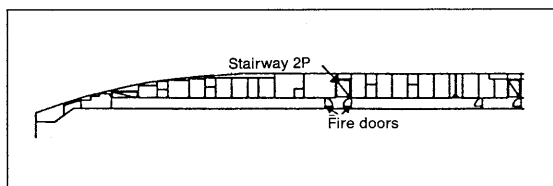
This section consists of two corridors, one fore and one aft of stairway 2P on the port side of deck 4. Smoke began seeping into this section 7 to 10 minutes after the fire had started. The smoke was felt to be dangerous, but was much less dense than in other areas, and probably did not have a temperature or toxicity concentration above critical levels.

Fig. 8.6 Deck 4, port side

The fire doors to these corridors were all finally closed, and the flames did not spread along the corridors. When the ventilation system creating an underpressure on the car deck was turned off, the spread of smoke in this area also stopped.

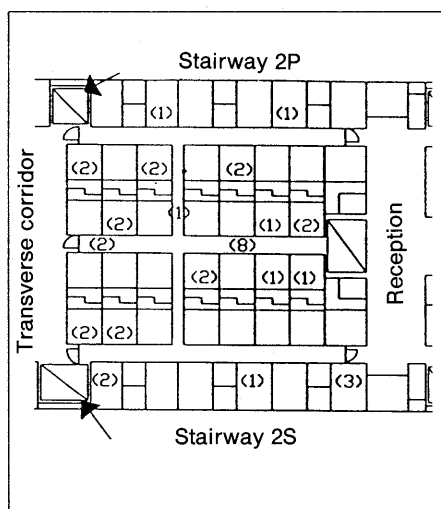
Fig. 8.7 Deck 5, between reception lobby and transverse corridor (figures in parentheses are numbers of deceased).

Thirty-eight bodies were found in this area. Ten of these were found in the corridors and the rest in their cabins (see Fig. 8.7).

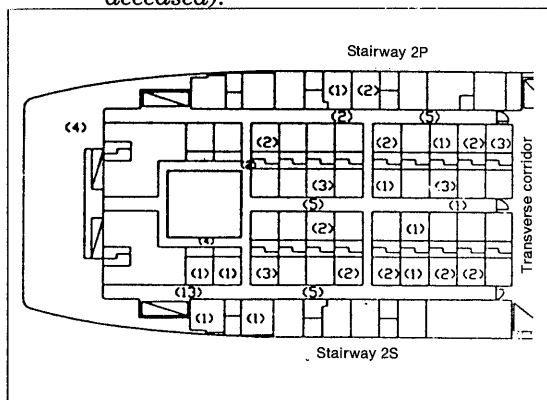
Fig. 8.8 Deck 5 aft of transverse corridor (figures in parentheses are numbers of deceased).

of the fire. The fire doors into this section were all finally closed.

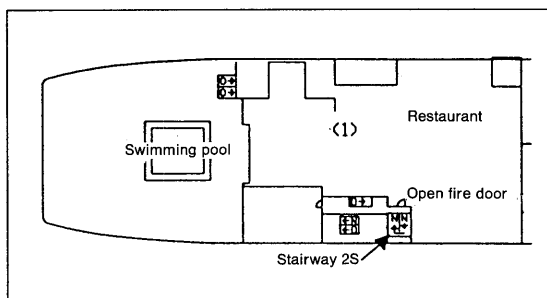
Fig. 8.9 Deck 6.

Twenty-five to thirty minutes after the start of the fire the glazed part of the aft wall on deck 6 collapsed and the flames spread aft.

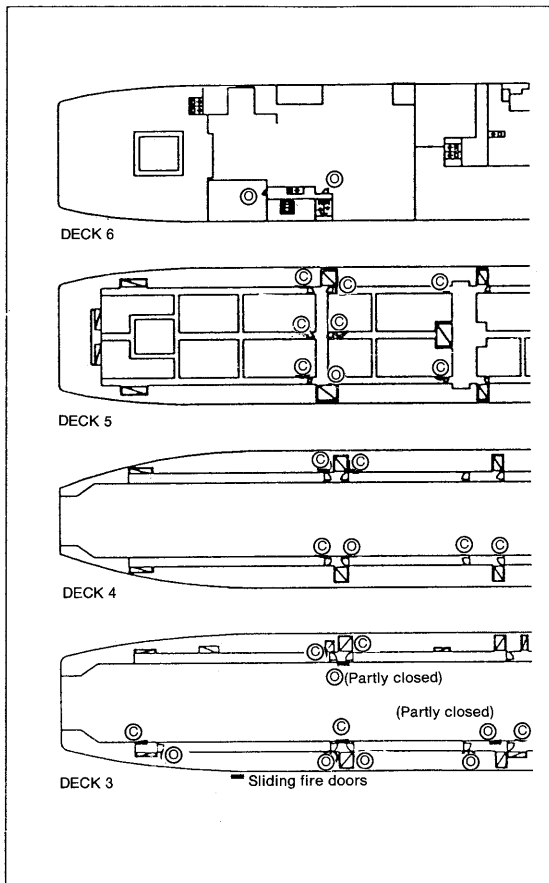
Fig. 8.10 Fire doors in relevant fire zones. (O = open, C = closed)

was no one there to press the alarm button. Thus the fire door leading from this zone to the stairway was never closed, and the fire was allowed to spread. If the door had been closed early enough, further spread could have been avoided.

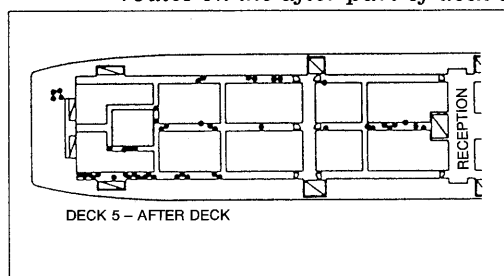
Fig. 8.11 *Positions of deceased found in escape routes on the after part of deck 5.*

Four bodies had been carried out onto the after part of deck 5. One was found to have died on deck 6.

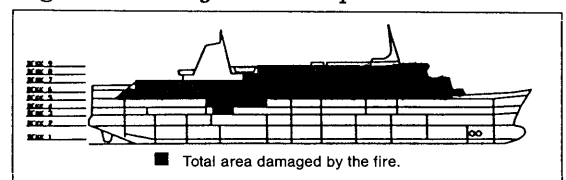
Fig. 8.12 *Damage to the ship*
