## Kystverket - U-864 Wreck Investigation 2025 Campaign 1

28 August 2025

Issued for Review

Revision 2

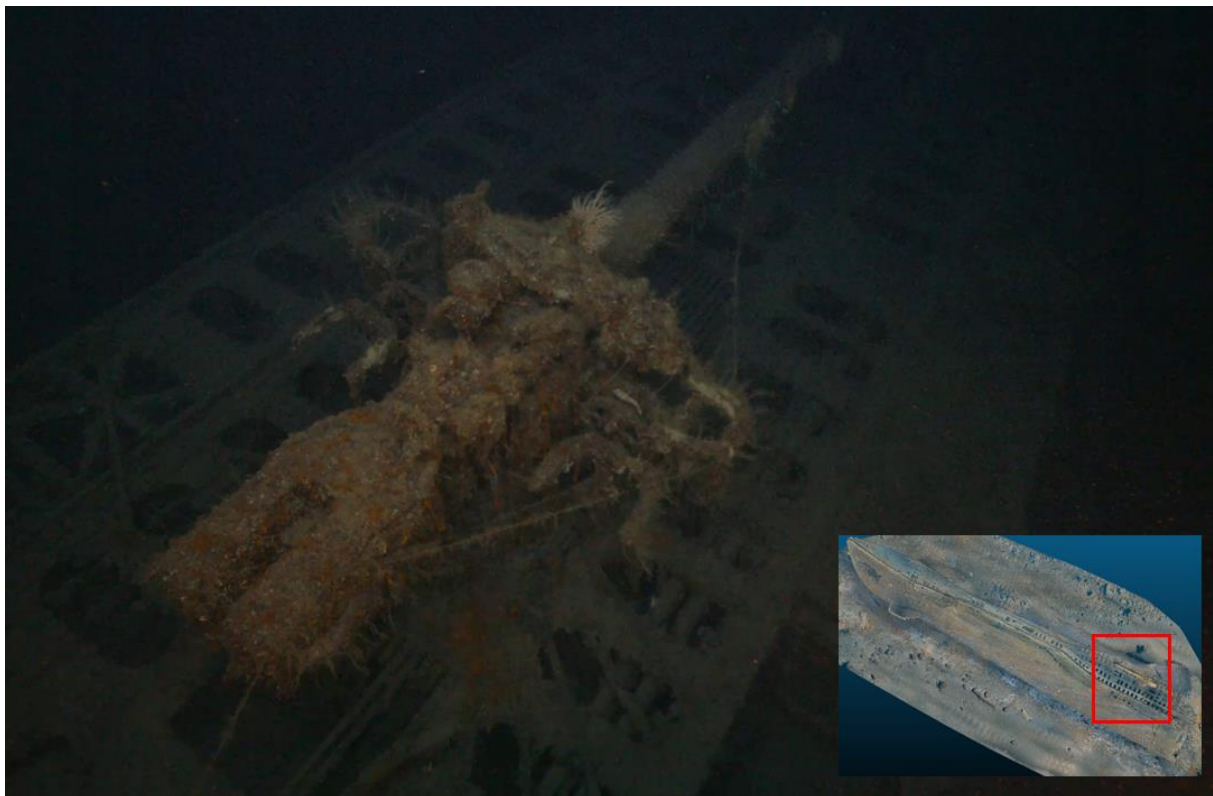
As expected, the wreck was corroding freely with certain areas exhibiting more advanced degradation for reasons unknown. The corrosion and marine growth on the wreck made it very difficult to even identify the locations where the previous thickness measurements had been performed. Figure 4-27 and Figure 4-28 display examples of the corrosion and marine growth observed during the inspection of U-864.

Figure 4-27 Voyis image example showing the deck canon covered with marine growth

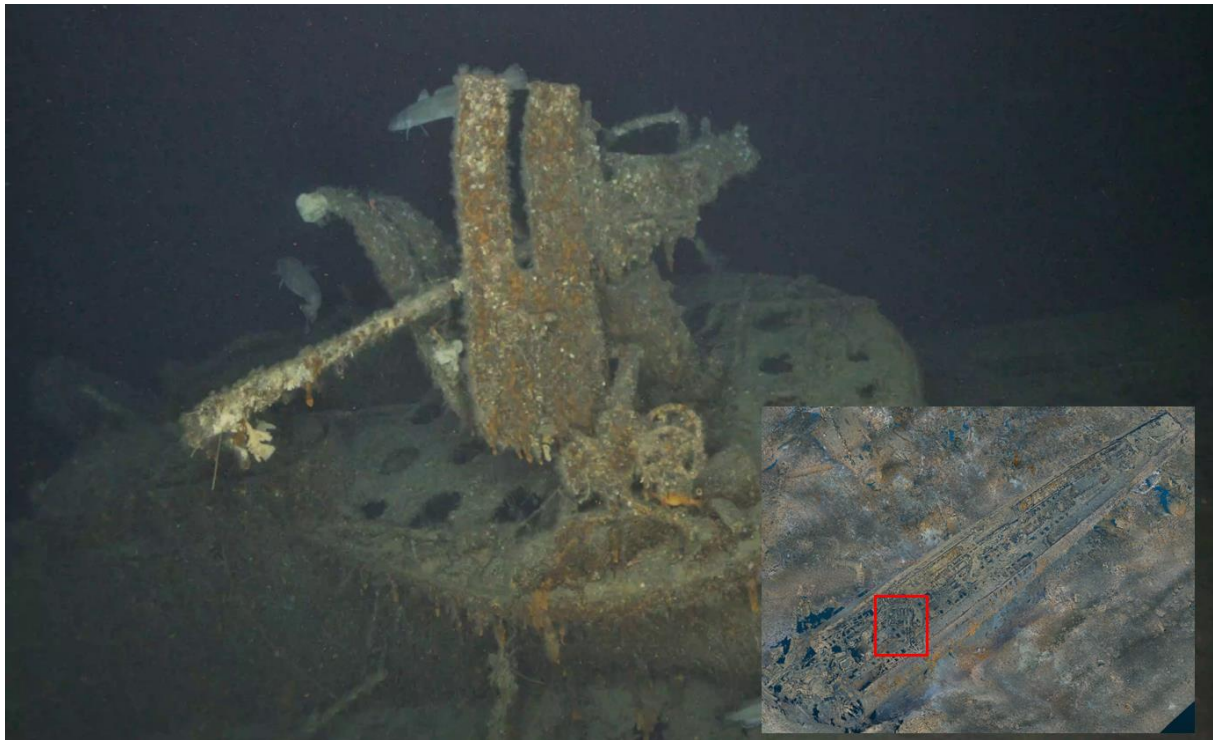
Figure 4-28 Voyis image example showing the 20 mm flank gun covered with marine growth

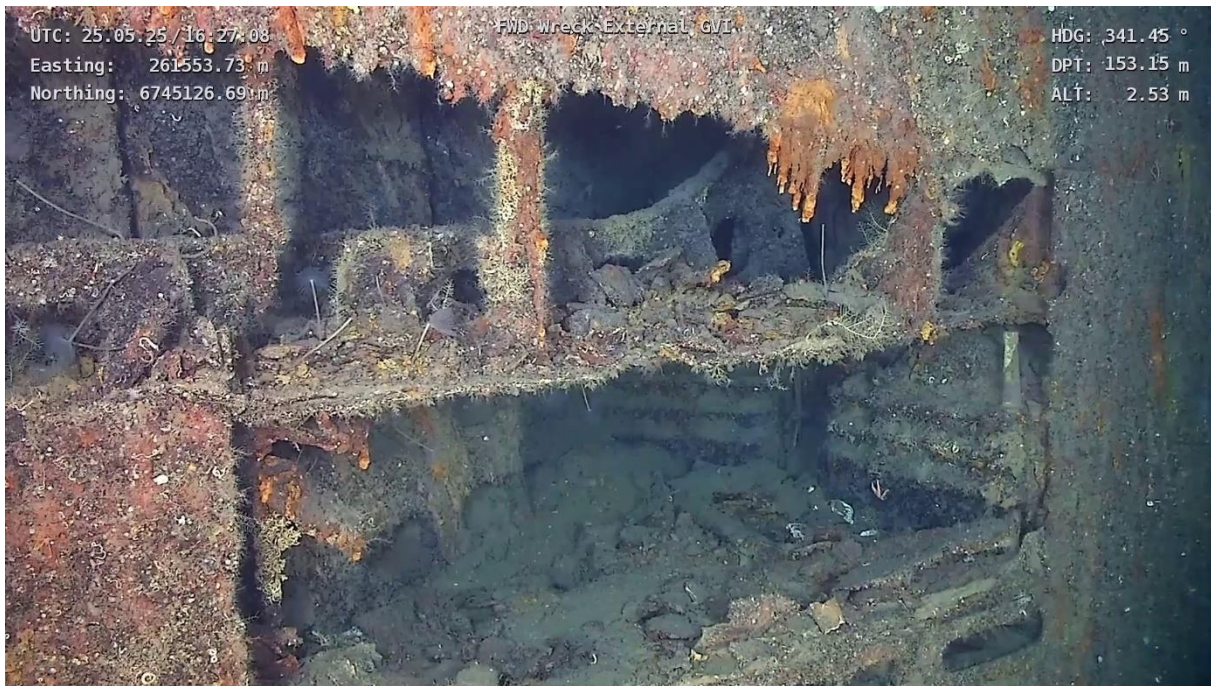
Figure 4-29 Missing panel on the front port side

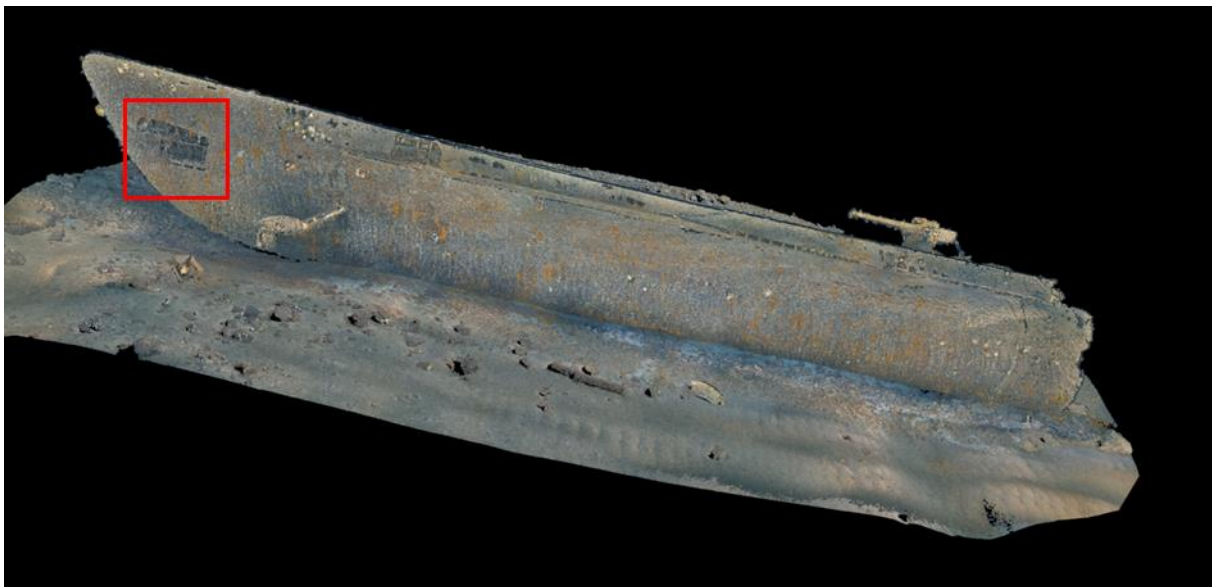
Figure 4-30 Port side view of the bow section showing missing panels at the front

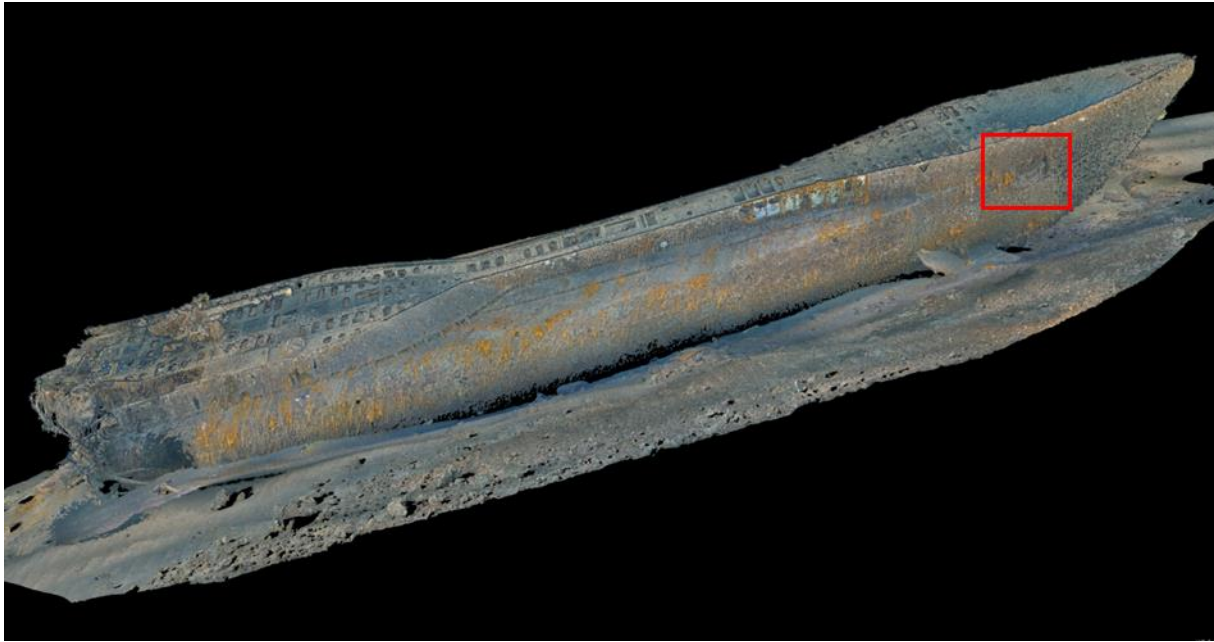
Figure 4-31 Starboard side view of the bow section showing that the side is mostly intact. Note the location of the anchor within the red square.

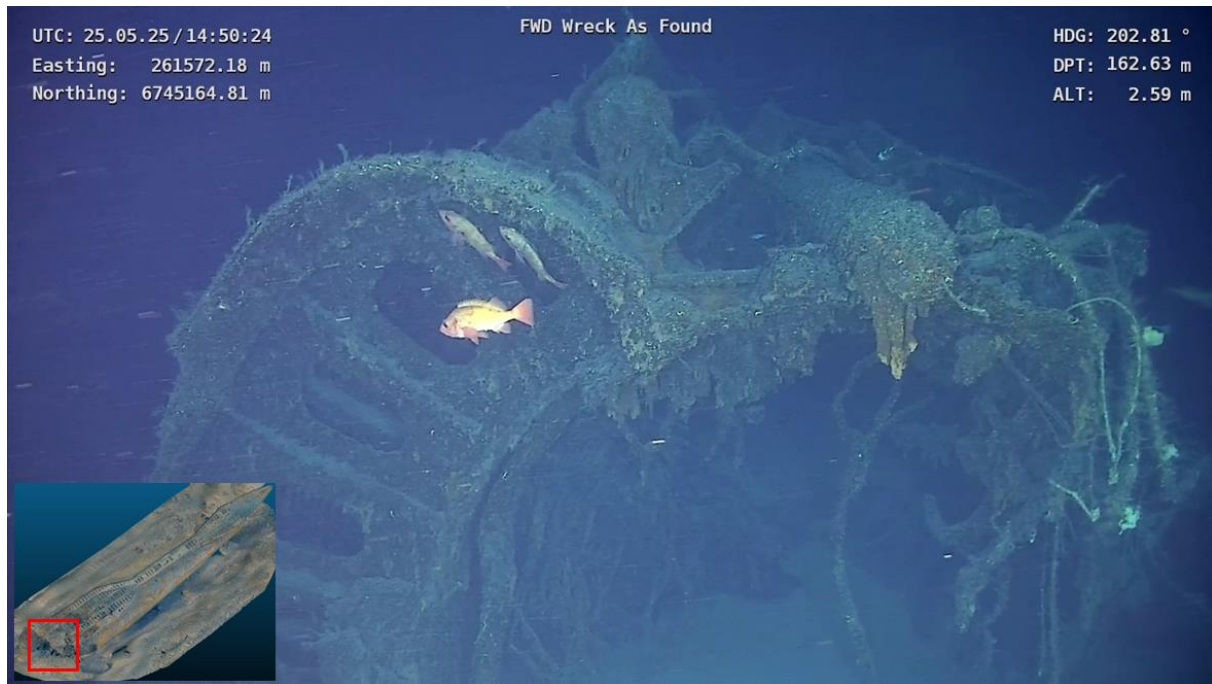
The bow fracture point showed significant damage and was heavily littered with debris. Sediments could be seen on the inside of the wreck, covering a significant part of the submarine base. Access for internal inspection was difficult due to the debris and a possible gas cylinder on the top of the wreck. An example of the fracture point is seen in Figure 4-33.

Figure 4-33 Bow section fracture point showing damages. Significant sedimentation is seen within the opening

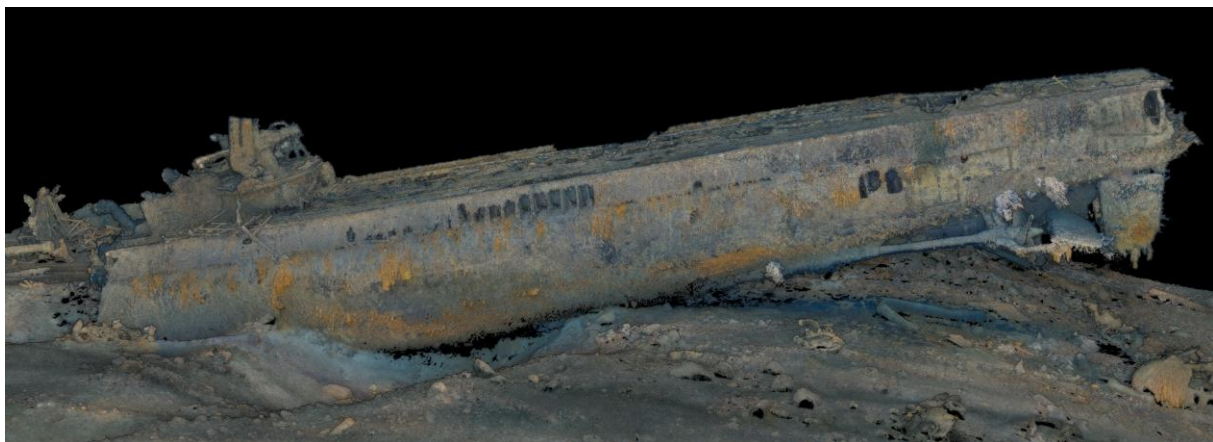
Similar to the bow section, the stern was found to be heavily corroded and multiple steel panels from the outer hull were missing (Figure 4-34 and Figure 4-35). The most notable area was found on the starboard side, close to the propellers, where a large piece of the hull had detached. The cut-out location to the stern torpedo bay is located within that area (Figure 4-36).

Figure 4-34 Port side view of the stern section

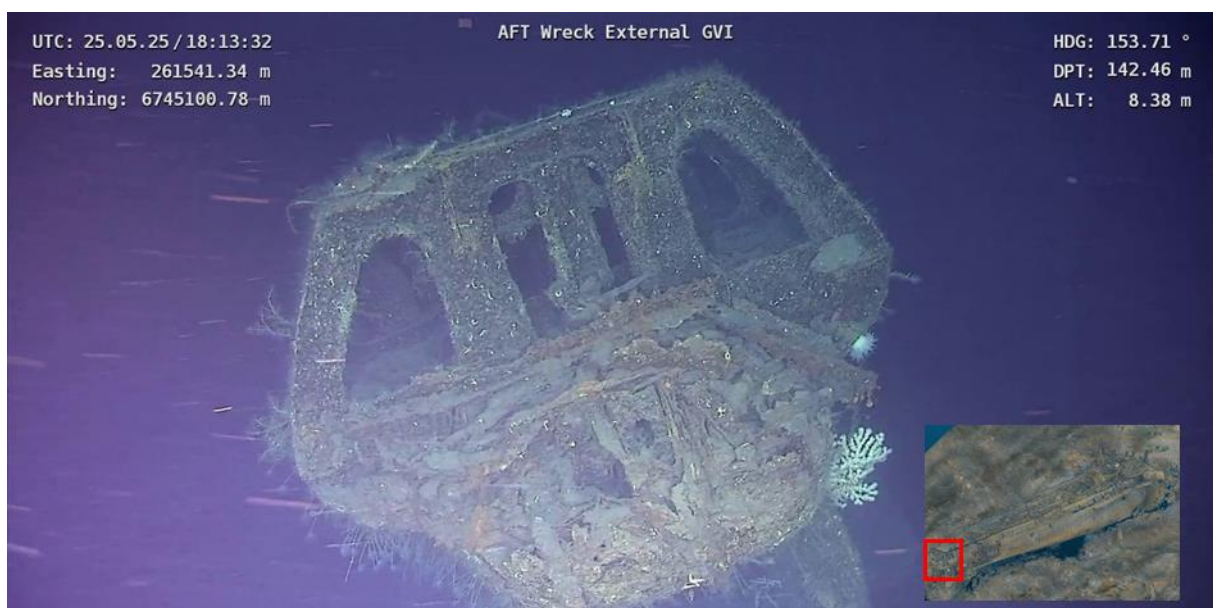
The back of the stern wreck was mostly detached and fallen to the seabed, exposing the torpedo tubes. The tubes were obstructed by a significant amount of small metallic debris from the wreck itself. The propellers and rudders were found to still be in place and appearing to be relatively securely attached to the wreck (Figure 4-37). The fracture point at the stern section was difficult to access due to the inclination of the wreck. The entrance had significant damage and was riddled with debris. An example of the significant damage to the fracture point is the missing conning tower. Figure 4-38 shows that the security hatch, from the submarine to the conning tower, is exposed.

Figure 4-37 Back of the stern section showing the rear torpedo tubes

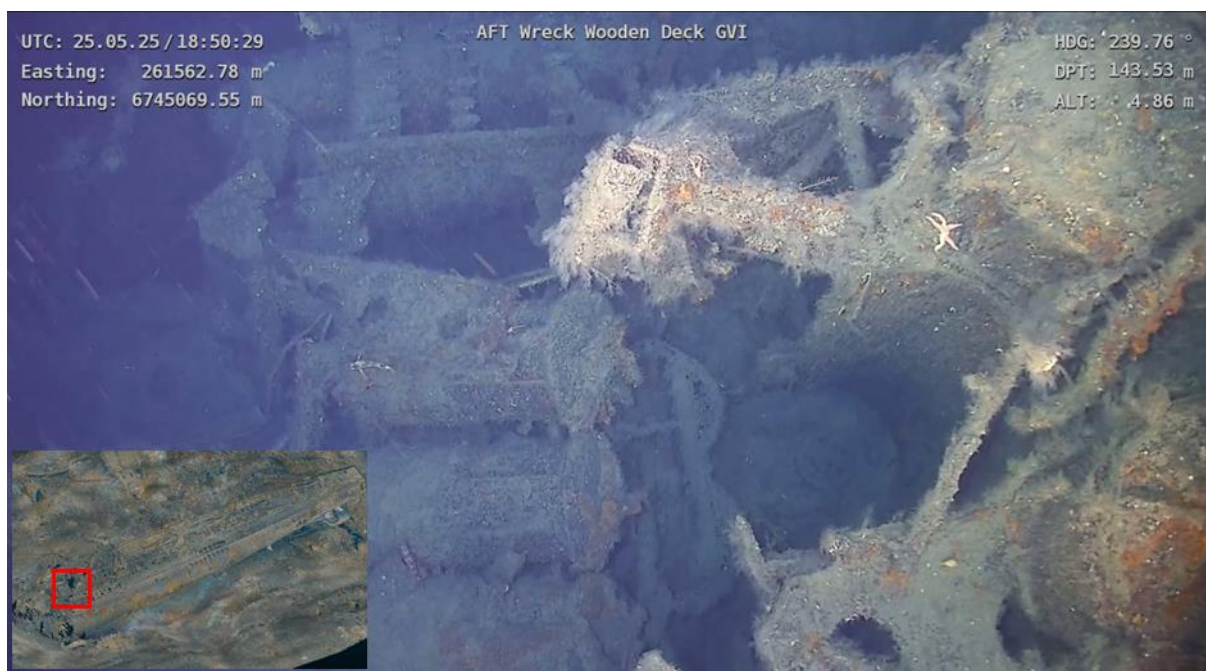
Figure 4-38 Securing hatch for the entrance of the missing conning tower close to the fracture point

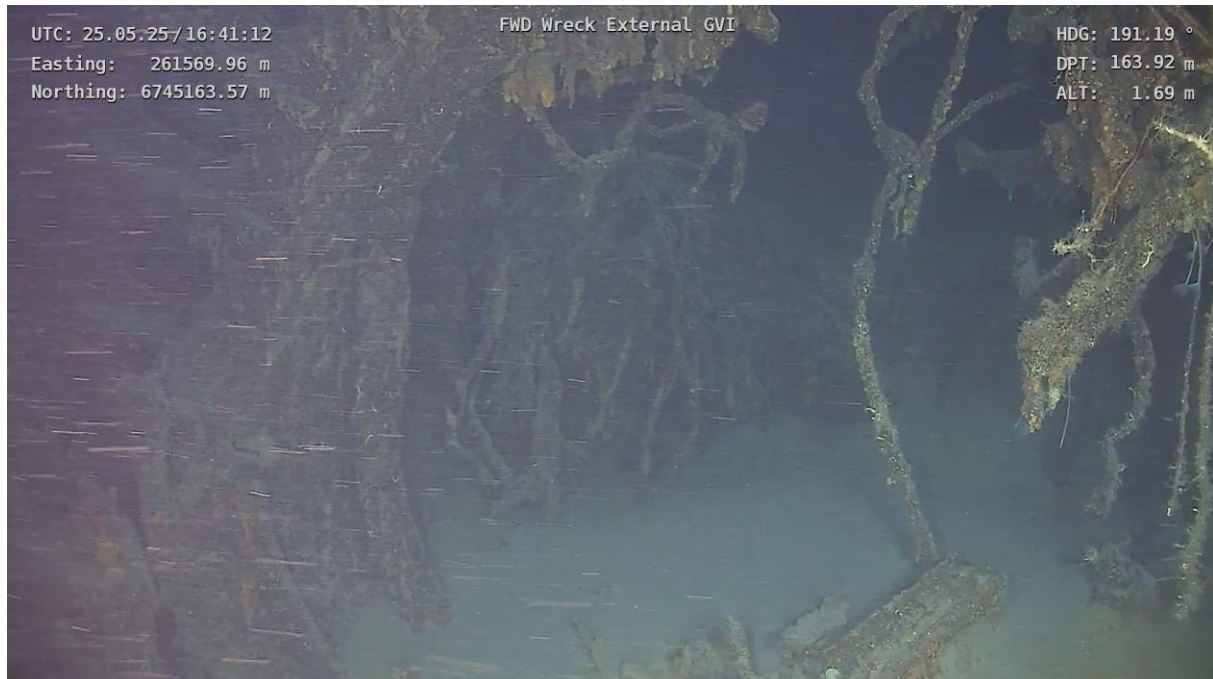
In order to get a better view of the insides of the fracture point a much smaller ROV would be required. However, debris blocking the path would make safe navigation difficult, with a high risk of damage or loss; therefore, it is not recommended.

Figure 4-59 Video image from the bow fracture point showing debris blocking the entrance

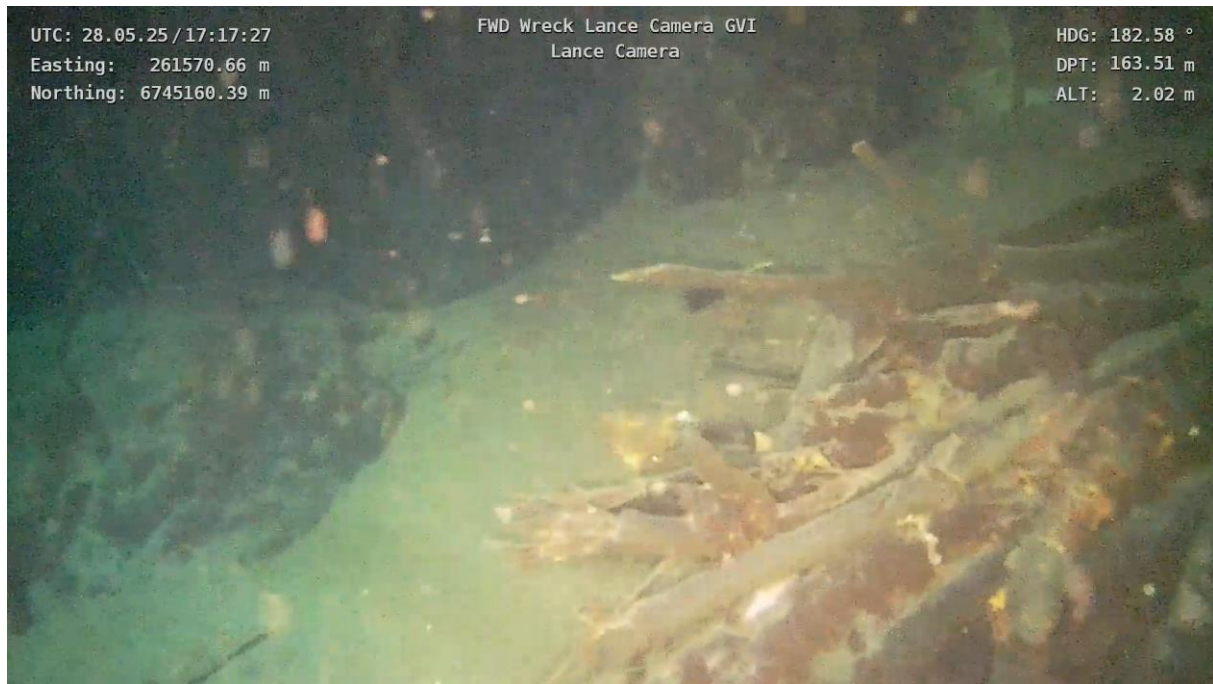
Figure 4-61 Lance camera example showing sediments within the wreck

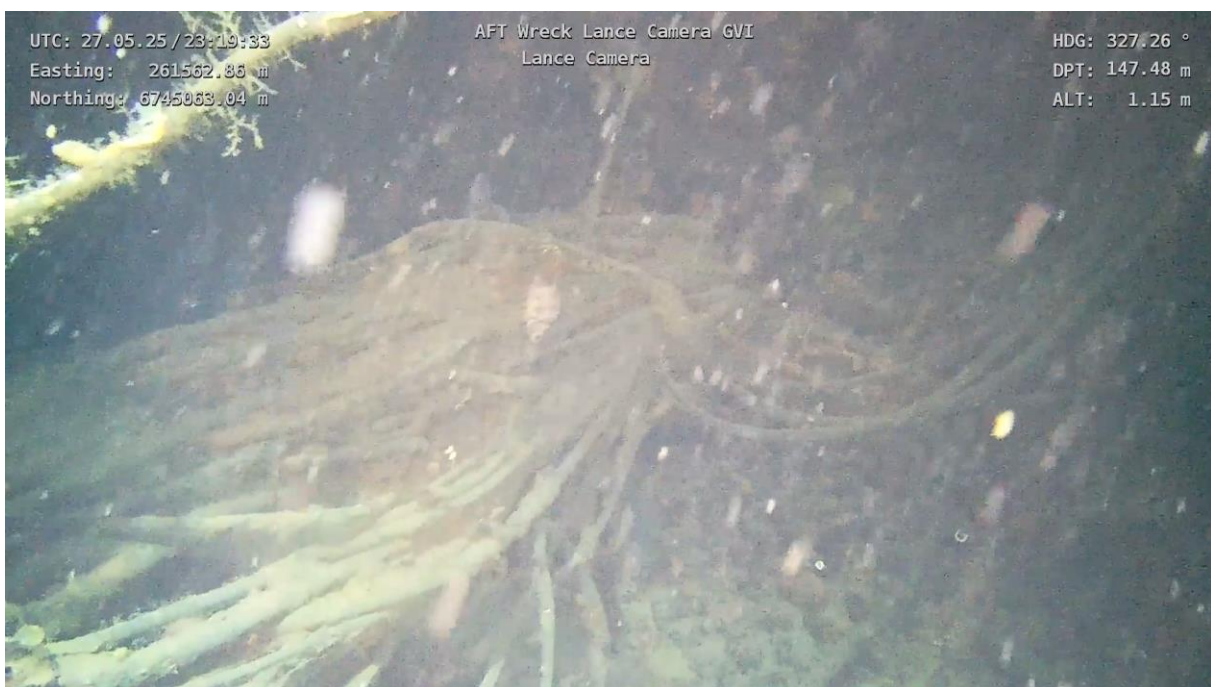
Similar to the bow section, the fracture point at the stern was difficult to access due to debris blocking the entrance. The angle of the wreck also made it difficult to access the fracture point, as it was tilted down into the seabed surface. Consequently, the ROV was positioned slightly above the fracture point with no visibility into the wreck (Figure 4-65). The inside of the wreck showed significant damage, with debris and cables exposed (Figure 4-66 and Figure 4-67).

Figure 4-66 Lance camera example showing several cables inside the fracture point

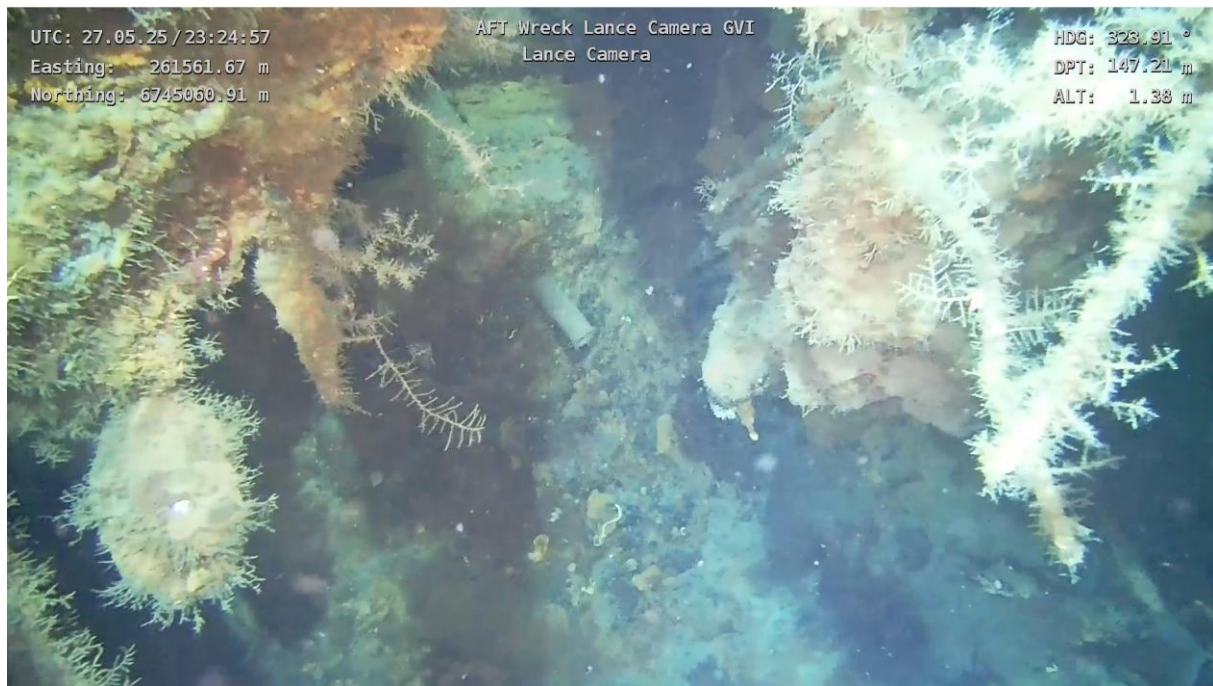
Figure 4-67 Lance camera example showing the inside of the stern fracture point

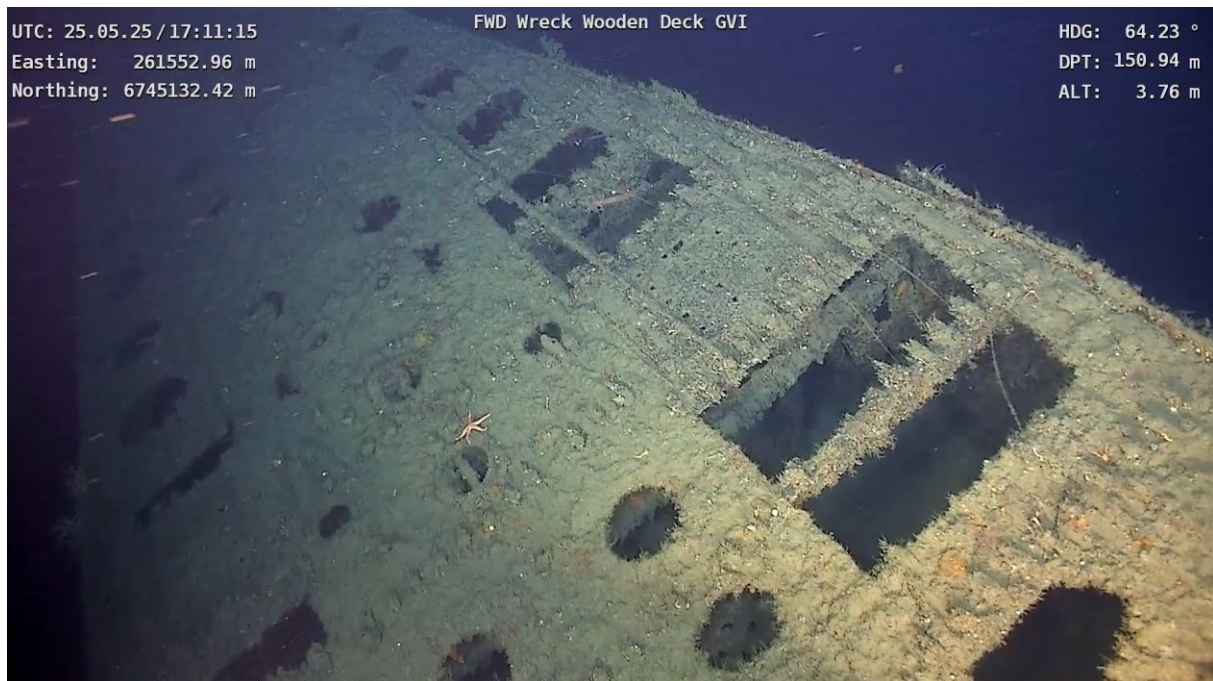
The inspection of the bow wreck showed that the deck was mainly intact up to the fracture point, with occasional missing panels (Figure 4-71 and Figure 4-72). Even though some parts of the deck were open, none of the external storage containers were open and their contents could not be observed. At the fracture point, a gas container was protruding out of the wreck (Figure 4-73). The location of the protruding gas container is highlighted in Figure 4-74.

Figure 4-71 Video image example of the bow section deck with some missing panels

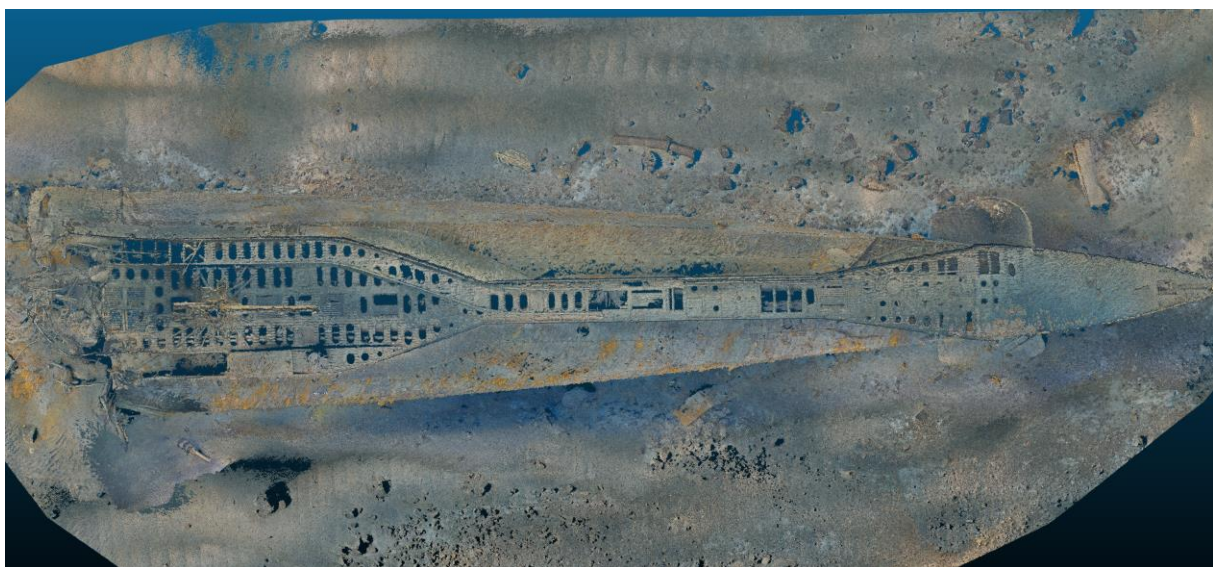
Figure 4-72 Photogrammetry model from above showing that most of the deck is still intact

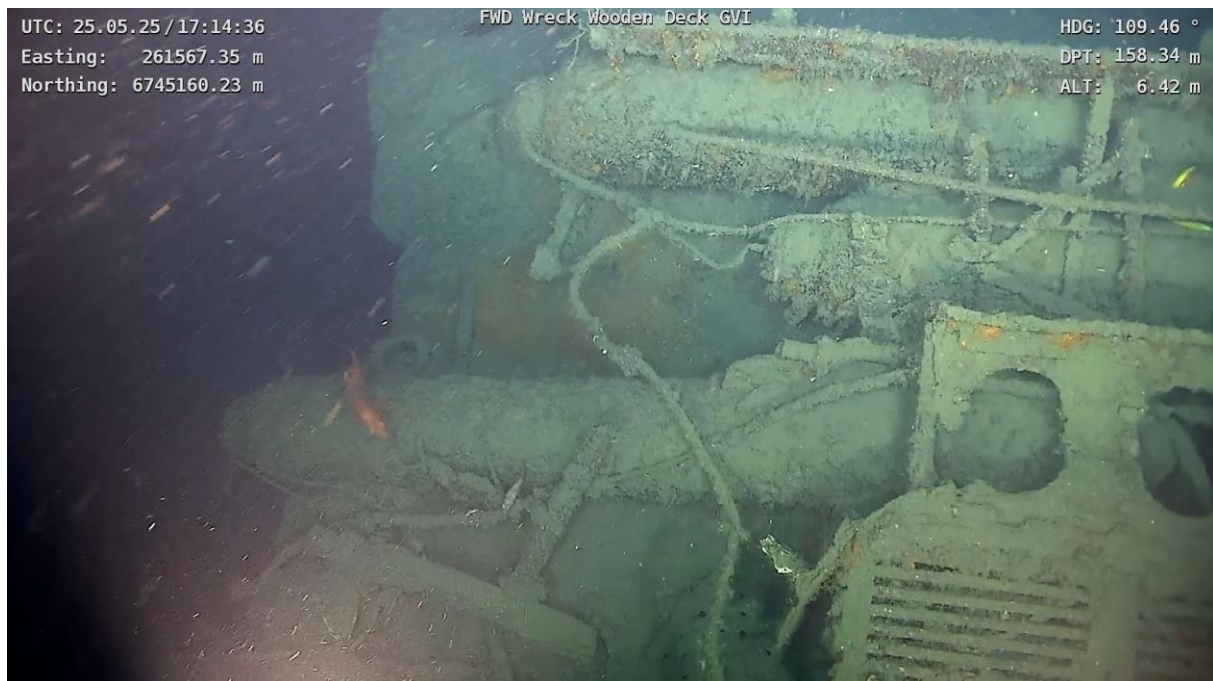
Figure 4-73 Video image example showing what is believed to be gas containers at the bow fracture point

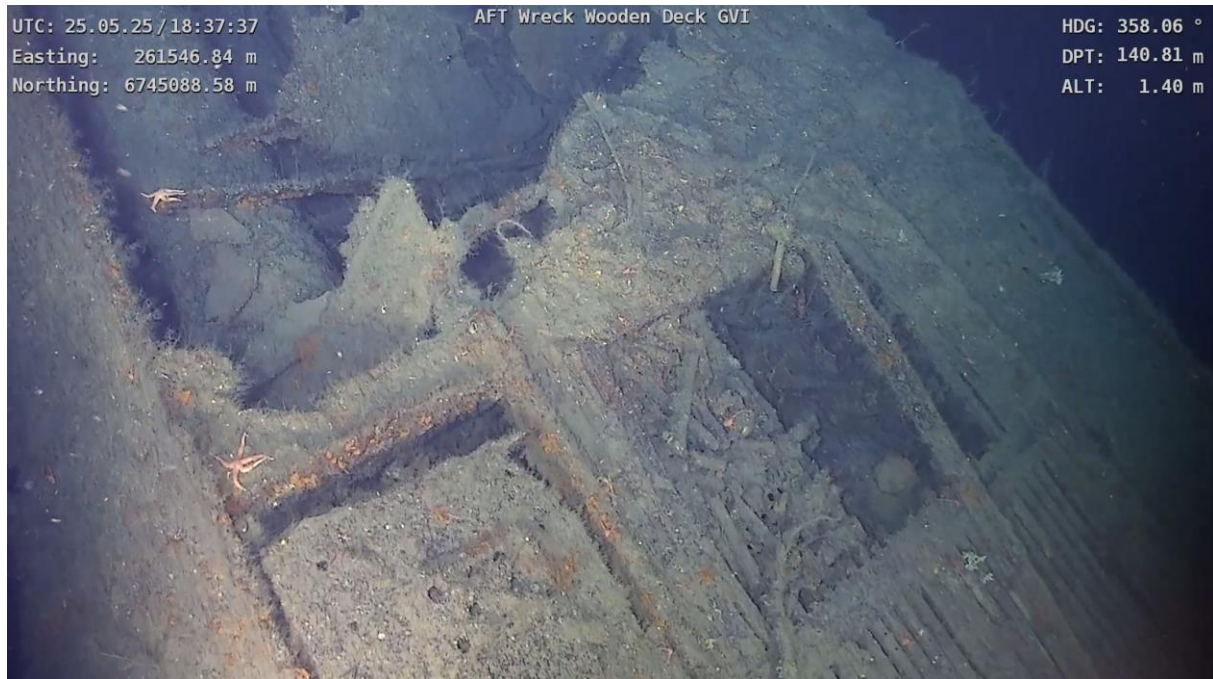
Figure 4-75 Video image example of the stern section showing the degradation of the deck

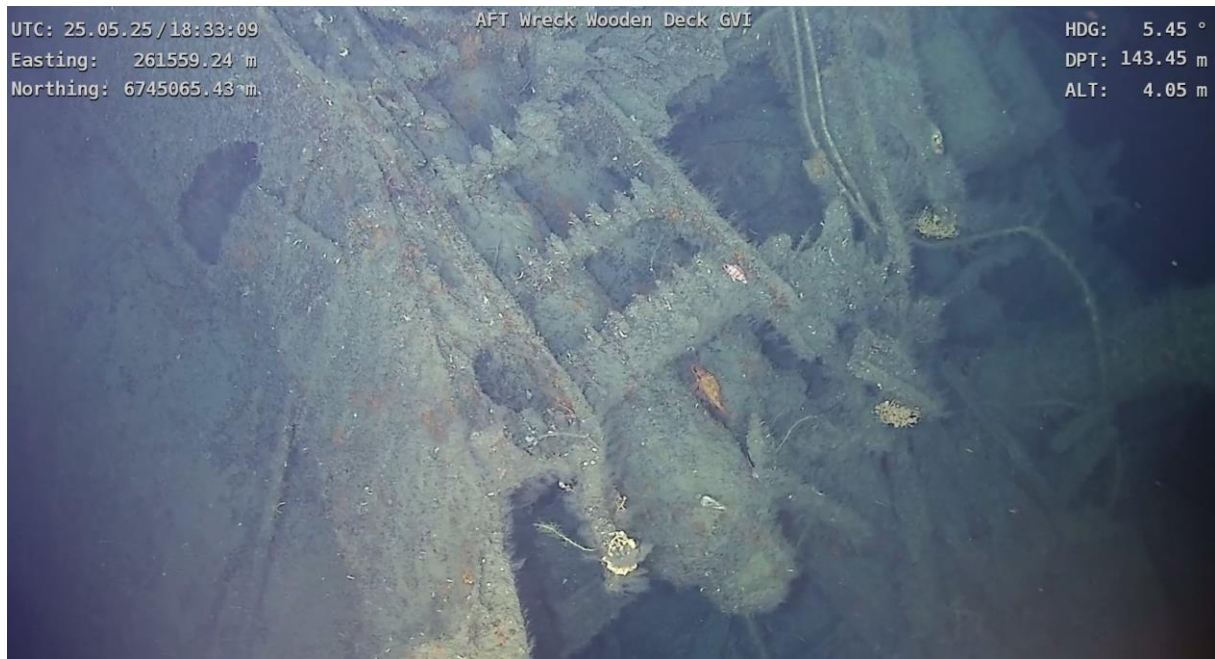
Figure 4-77 Video image example showing what is believed to be gas containers at the stern fracture point

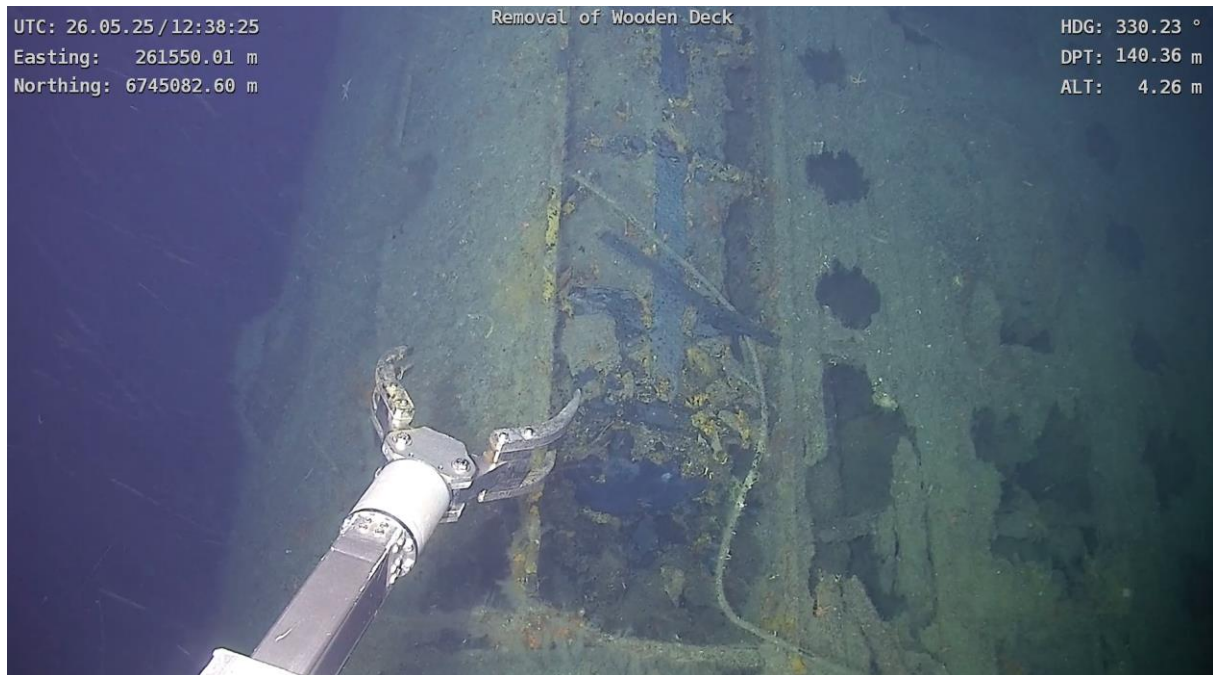
Figure 4-83 External storage container at location 1 after removal showing a large cylinder

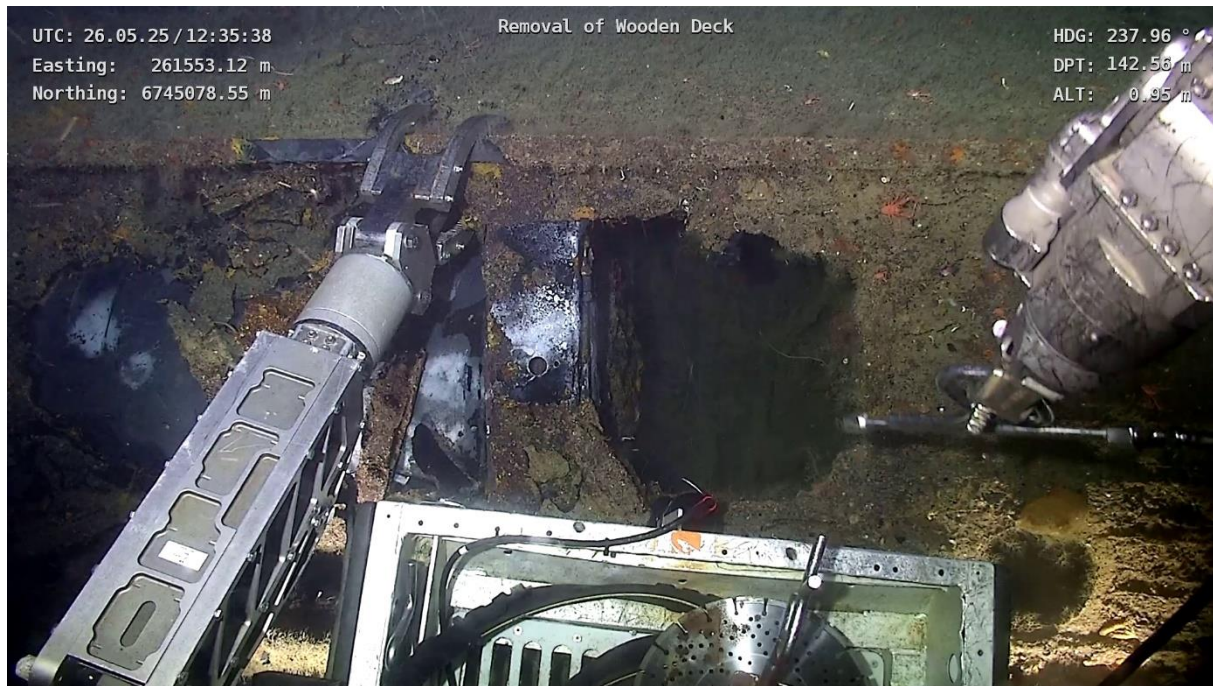
At location 2, the container roof was removed revealing a cylindric container approximately 3m long and approximately 0.6m in diameter. The cylinder had protruding grooves around the radius of the body. During the jetting of the container, bubbles were seen emanating from the container. Figure 4-84 - Figure 4-88 display the conditions of the external storage container before, during and after removal of the deck.

Figure 4-87 End of the cylinder, no visible damages or features observed

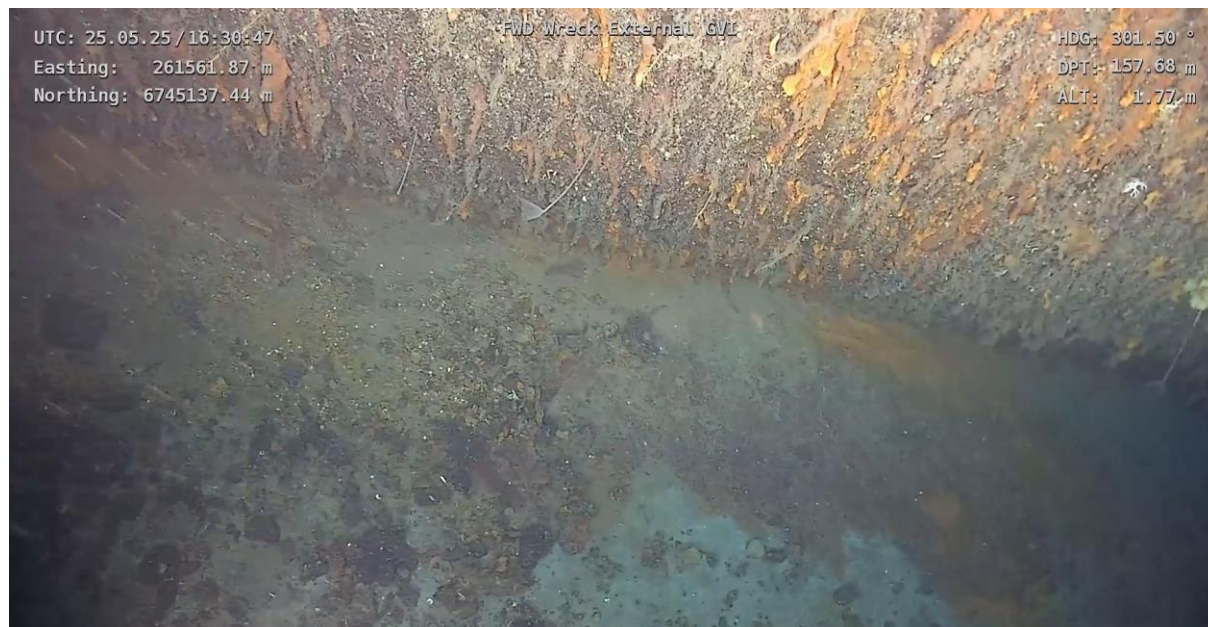
Figure 5-1 Image example from the bow section, showing coarser seabed than anticipated

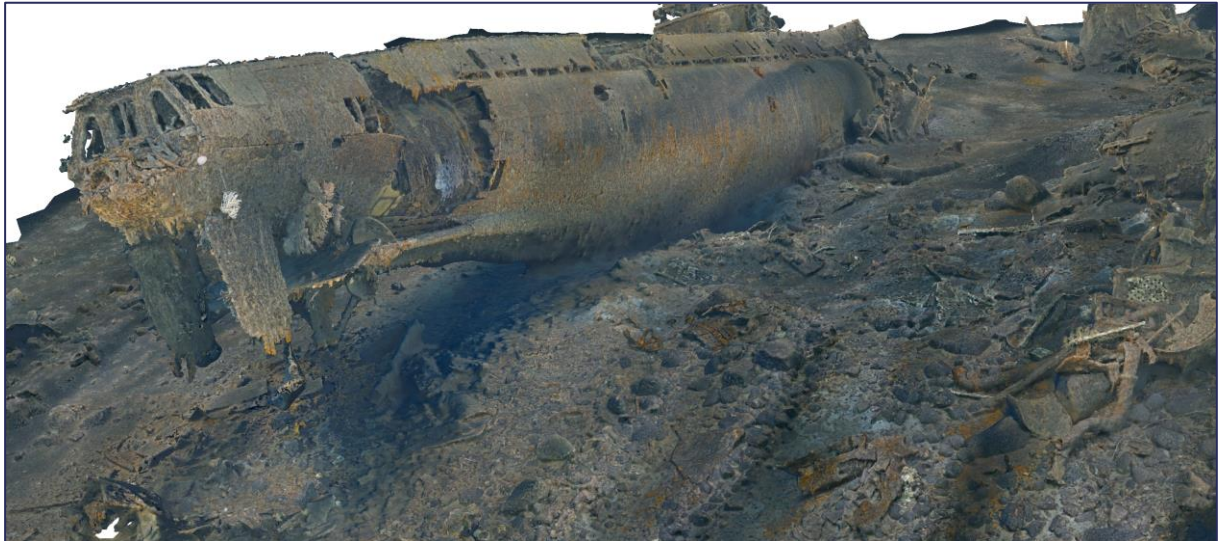
Figure 5-4 Photogrammetry data example, of the stern section, showing coarse sediments. The lack of submersion of debris and boulders support a coarser seabed than initially believed
