MARSTRAND - KYSTVERKET - U-864 2024 KONSULENTTJENESTER

# Assessment of galvanic corrosion inside firing device in a torpedo detonator in U864

Report no.: 2026-3093, Rev. 0

Date: 2026-04-17

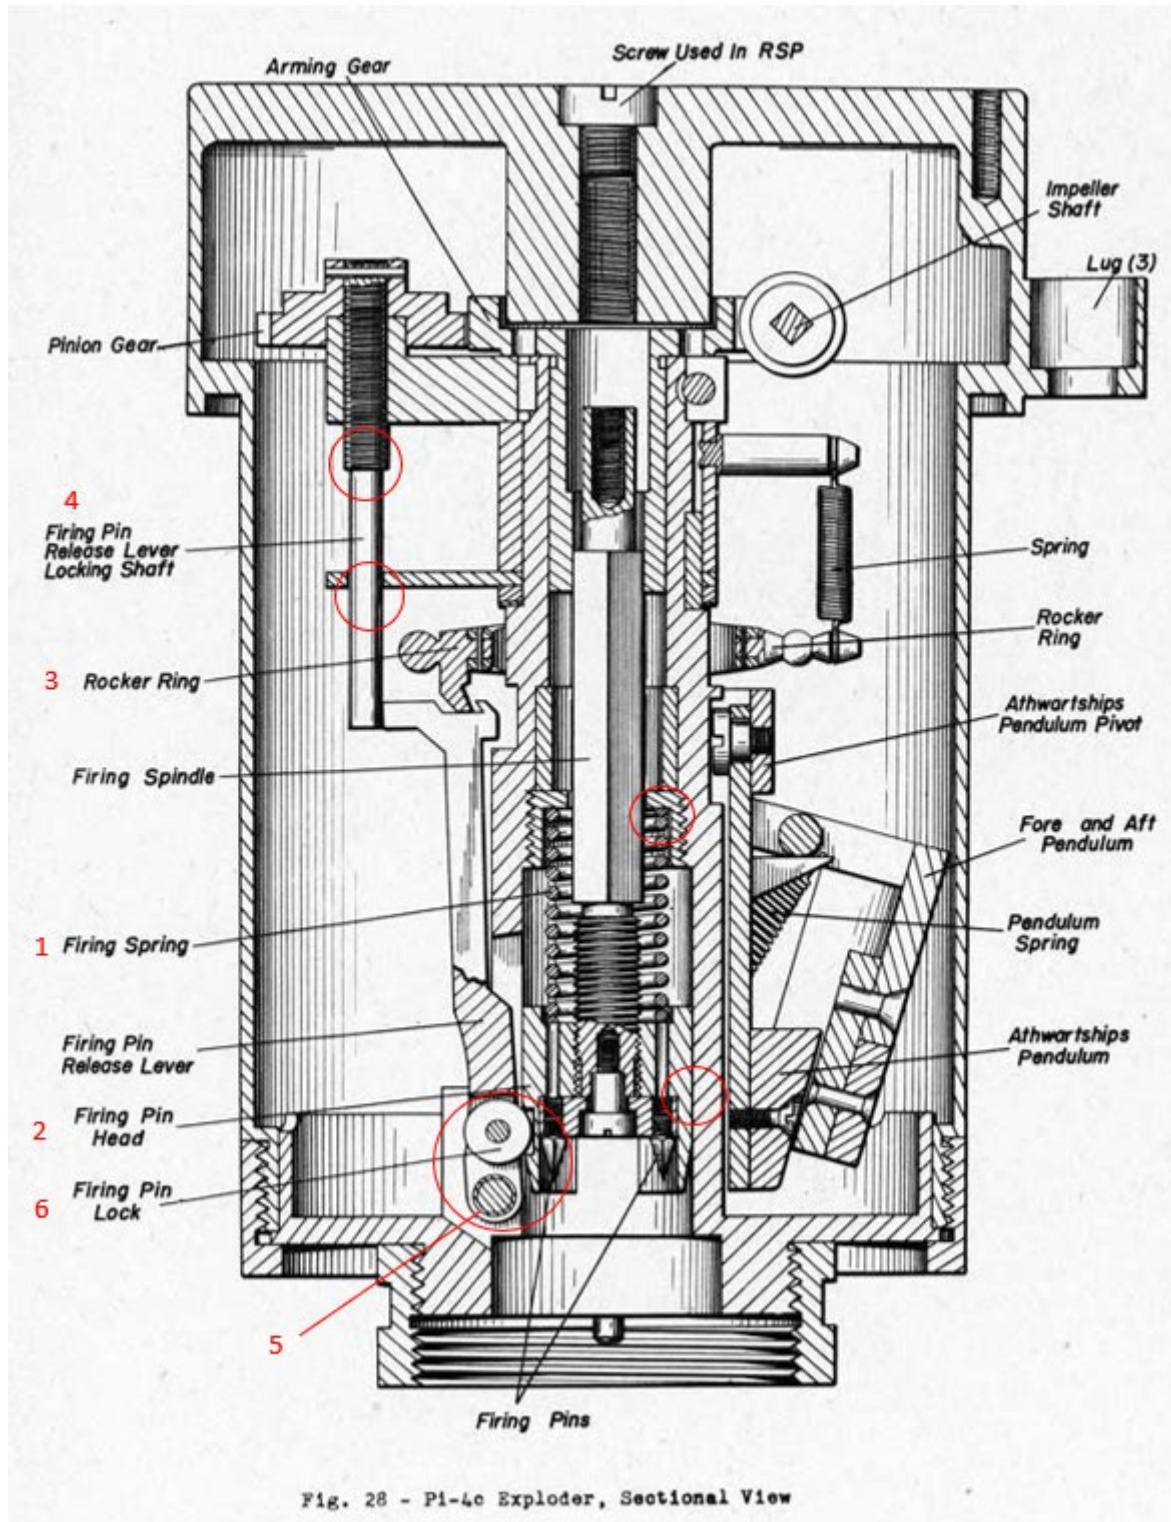
The following components are the most relevant (indicated by red numbers on the drawing in Figure 3-1):

- (1) Firing spring
- (2) Firing pin head
- (3) Rocker ring
- (4) Firing pin release lever locking shaft
- (5) The pivot bearing of the pendulum rod
- (6) Firing pin lock

Figure 3-1 Overview picture of the firing device and housing (torpedo detonator)

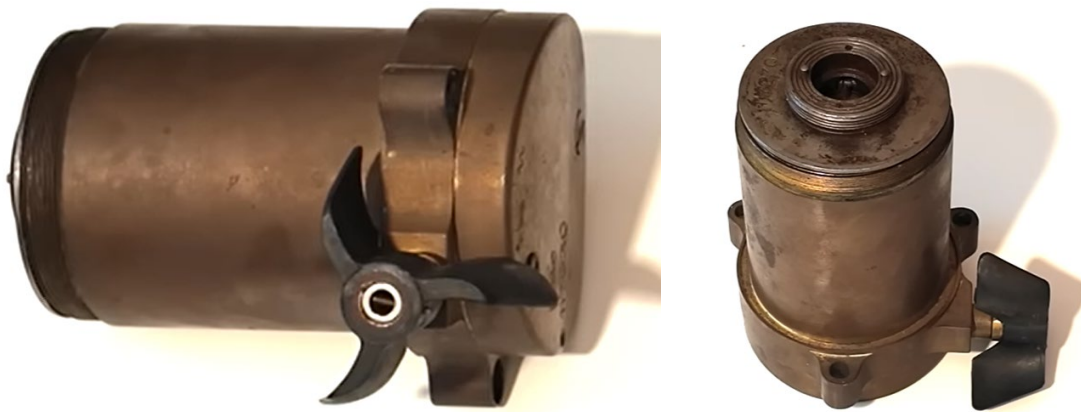
Figure 3-2 shows an overview of a comparable torpedo detonator that was recovered from a torpedo inside U 534, which sank on May 5, 1945, and was salvaged on August 23, 1993, in the Kattegat, 20 km northeast of Anholt Island, Denmark. The detonator was fully functional and comprises of a firing device and housing.

The submarine lay on the seabed for nearly 41 years at a 67 meters depth. No information regarding cleaning after recovery is available, however a comment in Ref. /1/ that original grease is still present might indicate that the firing device has not been cleaned. See also Figure 3-3 to Figure 3-5 for details.

Figure 3-2 Overview pictures of detonator with propeller, firing device and housing

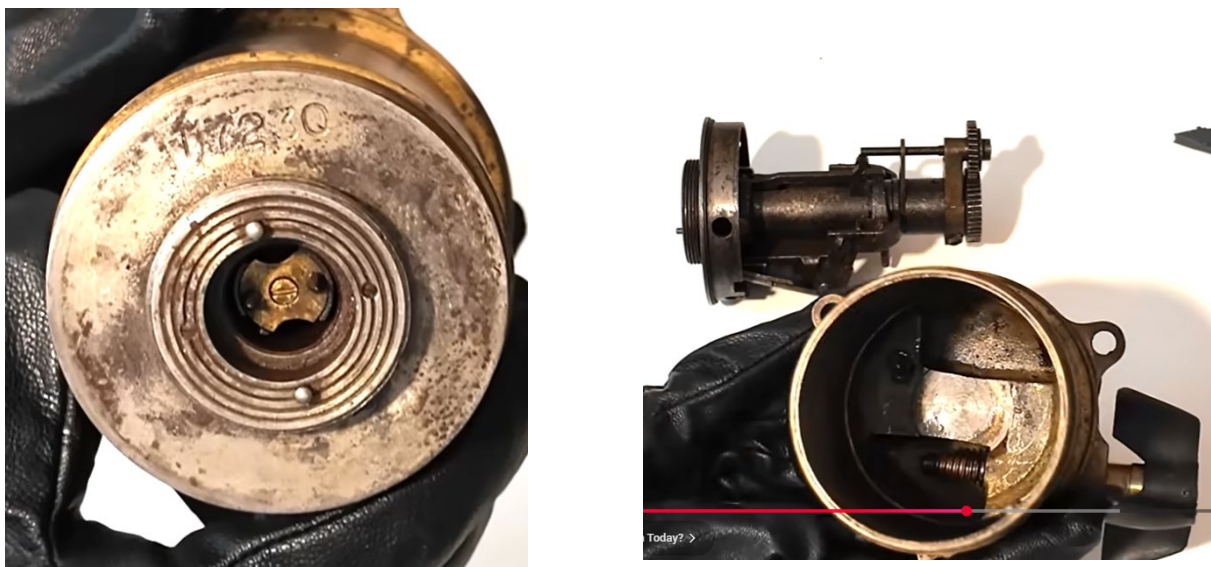
Figure 3-3 Right: Top lock of firing device including firing pin. Left: inside housing with grease firing device in the background

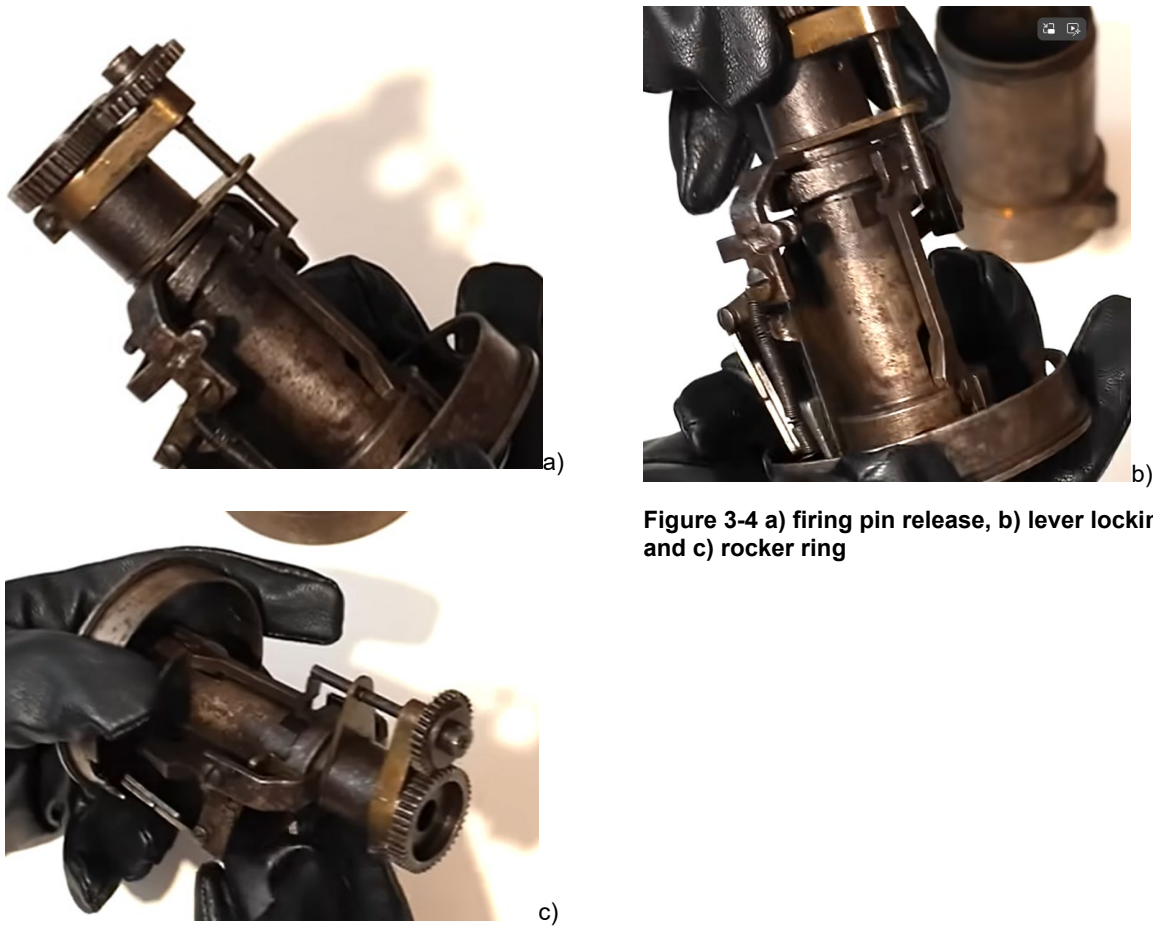
**Figure 3-4 a) firing pin release, b) lever locking shaft and c) rocker ring**

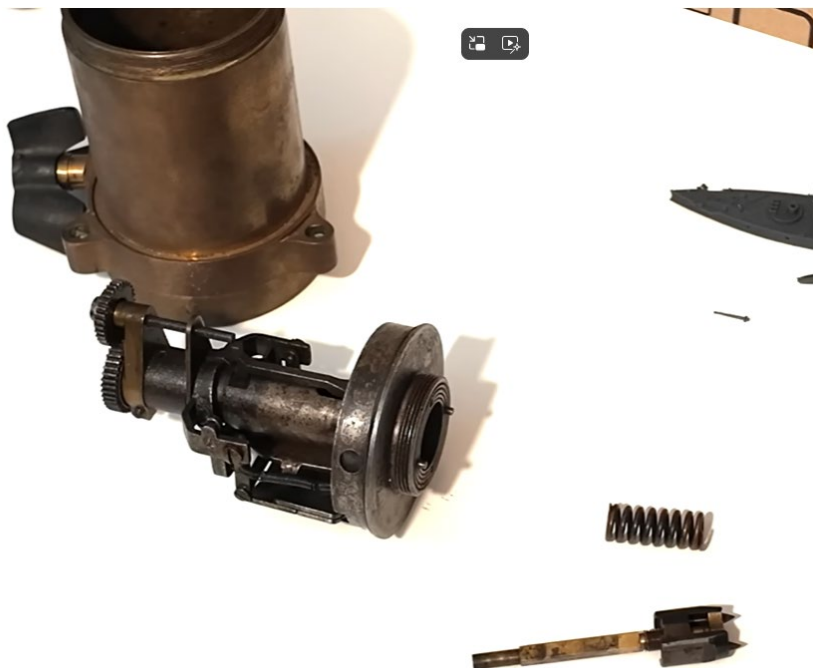
**Figure 3-5 Overview of all components inside the torpedo detonator**
