MARSTRAND - KYSTVERKET - U-864 2024 KONSULENTTJENESTER

# Assessment of corrosion of mercury canisters in the keel of U864

Report no.: 2026-0669, Rev. 0

Date: 2026-05-19

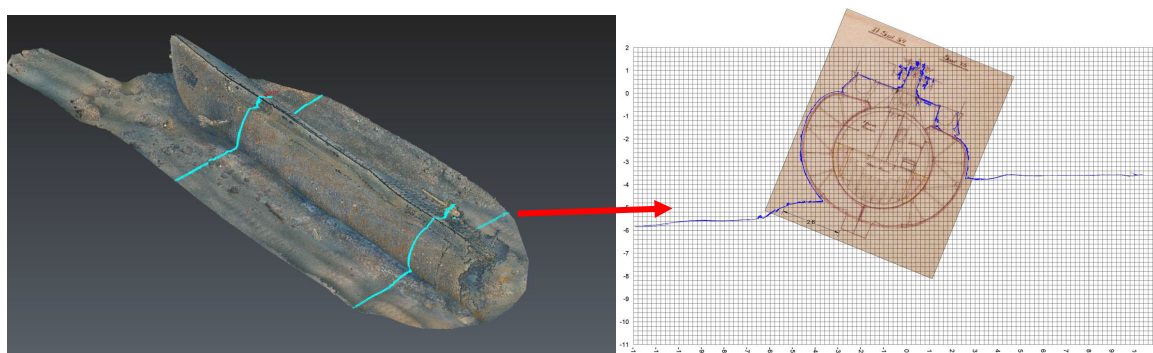
**Figure 2. Cross profile of the bow part, estimating location of the buried keel /2/.**

Previous excursions to the wreck indicated that the rest of the canisters are most likely in the bow part of the keel, as shown in Figure 2 /2/. The biggest challenge faced in this investigation is to properly determine the condition of the buried keel and the canisters, and the exact environment where they are exposed i.e., seawater, buried in sediments, etc.

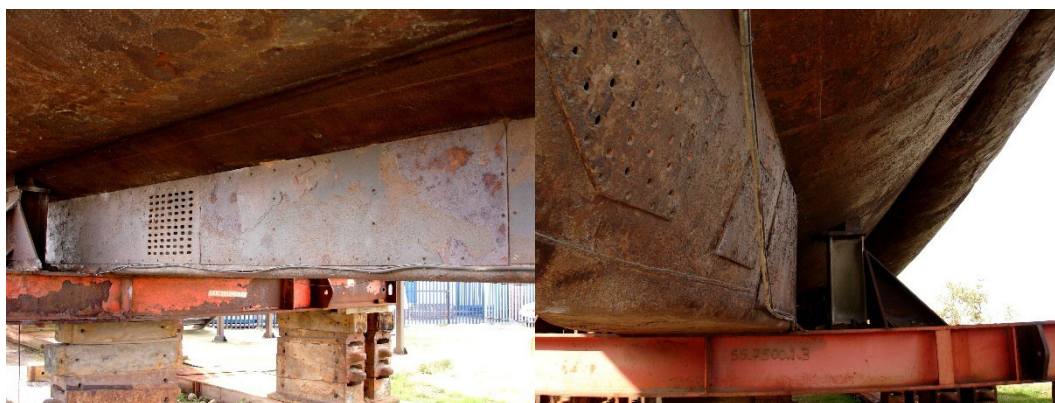
**Figure 3. Pictures from the keel of the submarine U-534.**

From the pictures it is clear that the keel had openings that allowed seawater to flood the chambers to avoid trapped air and enable pressure equalization, meaning that the canisters had been exposed to seawater at all times before being buried. Besides the assumption that the keel is most likely intact, upon burial of the structure, it is also expected that some of the sediment got in the chambers.

The canisters have been exposed to seawater before the submarine was sunk due to the holes on the keel box walls, as shown in Figure 3. The exposure time before the sinking has been short (weeks), and not enough to promote any significant corrosion damage during the transport. When the submarine was sunk, it is assumed that the seawater inside the keel boxes was trapped upon burial in the sediments, meaning that the keel boxes were sealed off from any convective supply of oxygen and organic materials. In these conditions, oxygen was rapidly consumed by microbial respiration and oxidation of reduced species. Experimental and field studies show that oxygen depletion in marine systems can occur over short time scales (hours to days), with anoxic conditions developing quickly in environments with limited mixing or diffusion /5/.
