# Final Report

## Kystverket - U-864 - Wreck Campaign 2

21 August 2026

Revision 2

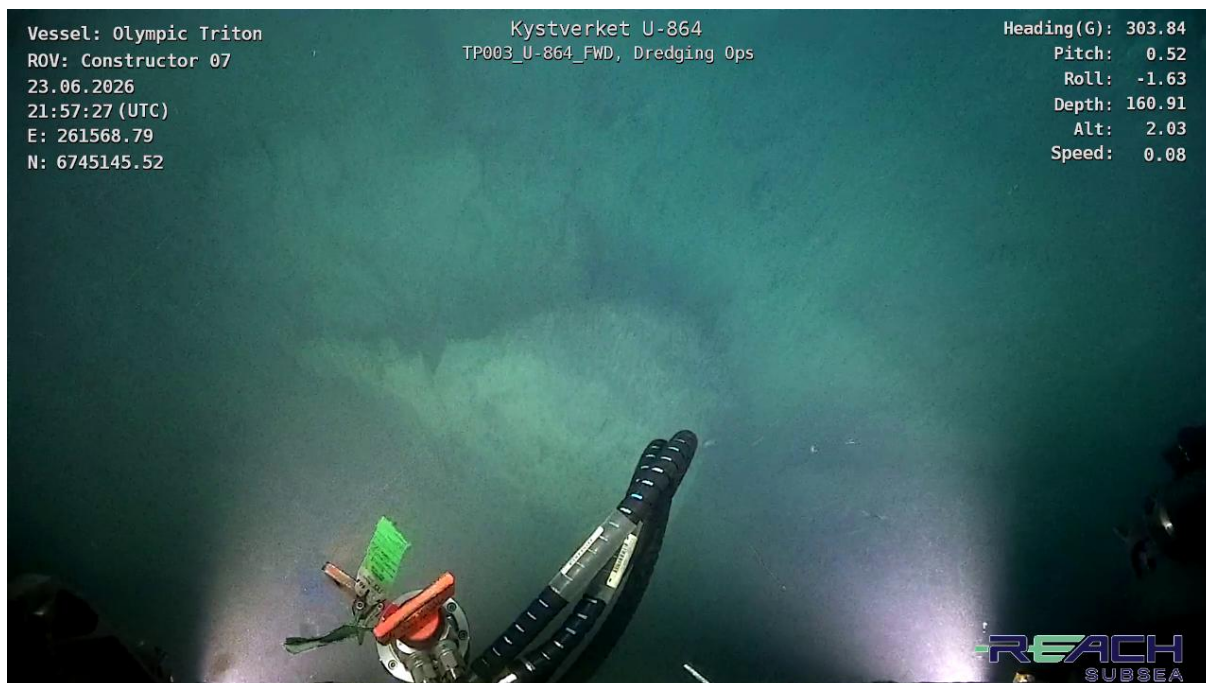
During dredging operations, rocks of various sizes were found. Some small enough to pass through the dredge hose, some large enough to be stopped by the dredge pipe strainer, and some were too large to remove by either RenOcean Spider or the ROVs. Figure 3-18 shows a large rock found in the dredged area, which had to be removed by the large orange peel grab mobilized for the project. Using ROV sonar, the boulder was estimated to be approx. 1.3 x 0.9 x 0.6 meters.

Figure 3-18 Large rock in dredged area

Note that the boulders removed were wet stored to the northwest and northeast of the fore part of the wreck and have been outlined in the delivered GIS database.

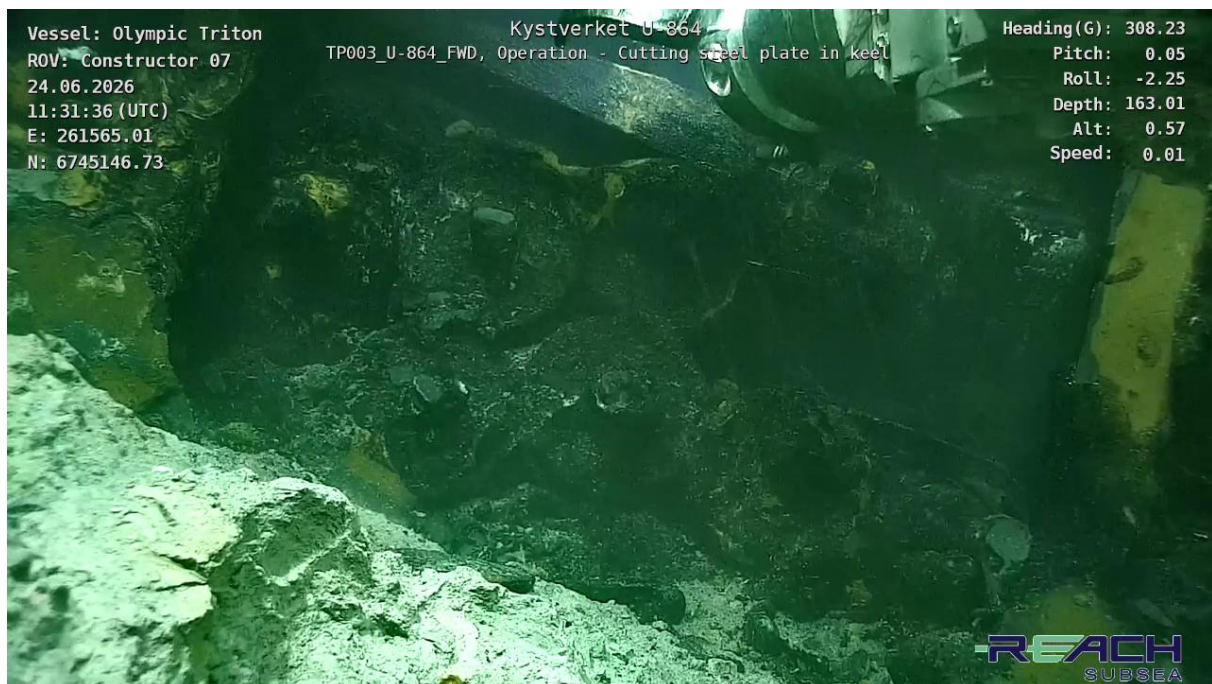
Figure 3-21 Keel compartments at frames #65-#66 (#110-#112) showing mercury canisters

Total 22 mercury canisters were recovered to the mercury recovery basket.

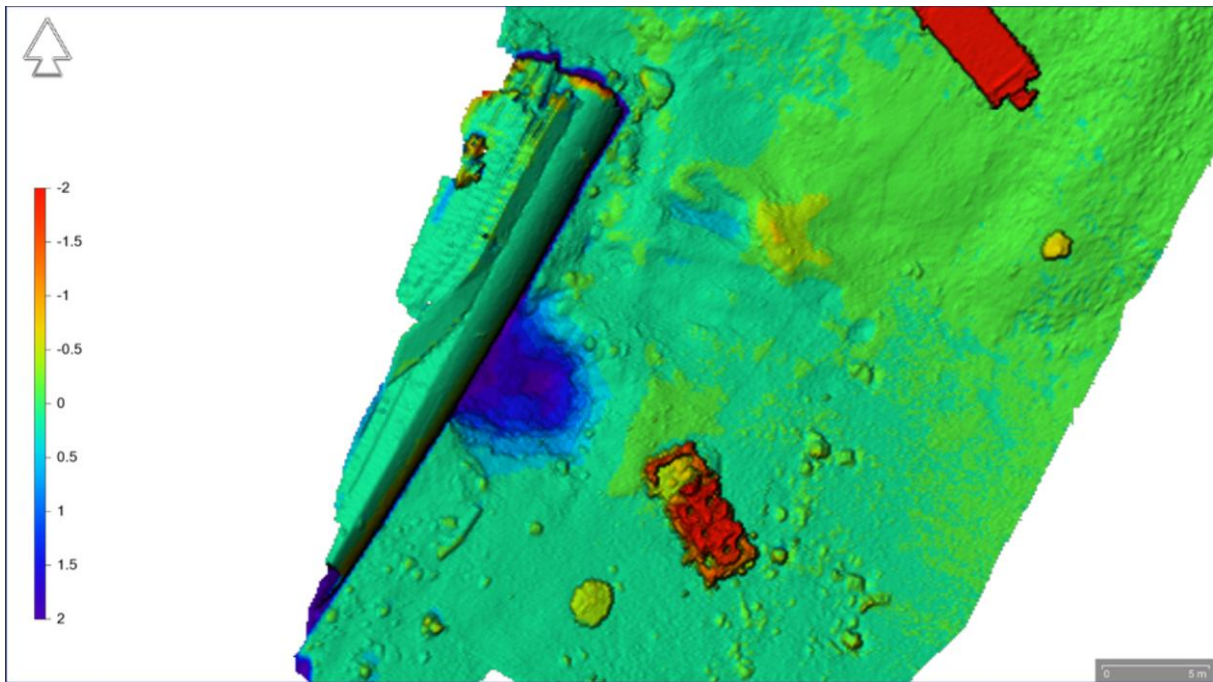
Figure 3-27 MBES showing dredge pit and mercury recovery container

Figure 3-27 show the dredge pit and the mercury recovery container, as well as their relative elevations. The maximum elevation difference between the dredge pit and the top of the mercury recovery container is shown to be around 4 me.

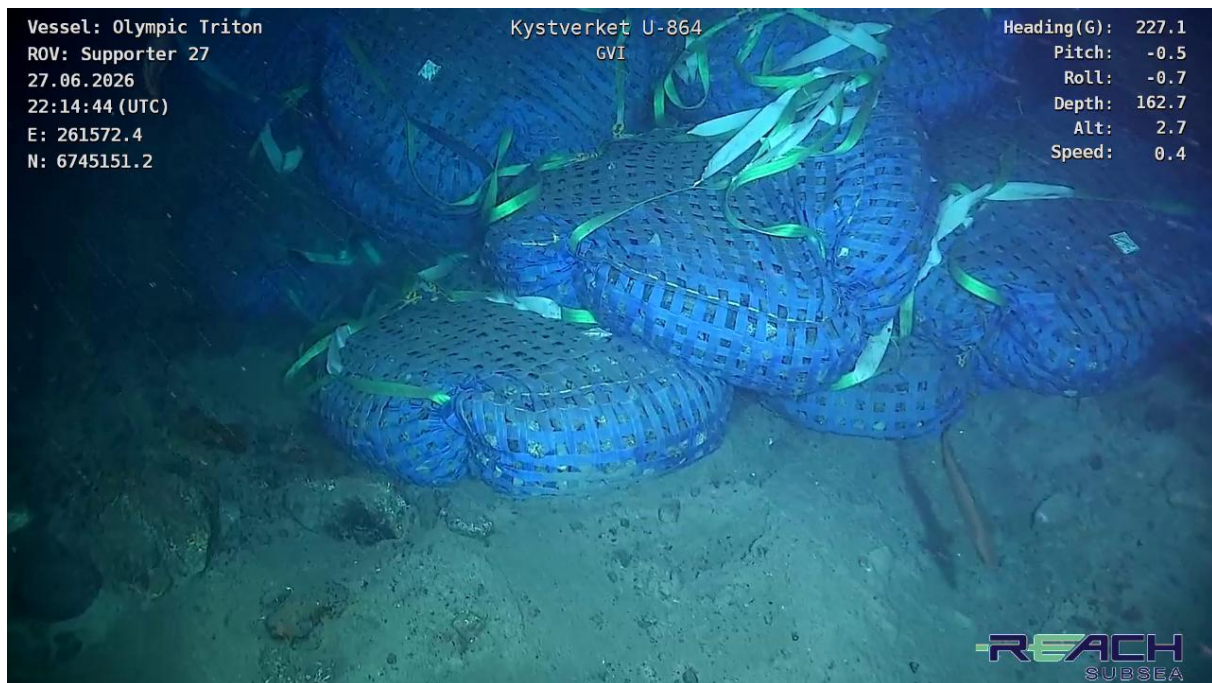
Figure 3-31 Rock bags installed in dredged area

Once mercury recovery operation had been concluded, from the 25 June 2026, filter units were installed in the dredged area (Figure 3-31) to stabilise the area. A total of 43 filter units were deployed to the seabed, and these were comprised of 4T and 2T units. There was a surplus of units lowered to the seabed and due to the mercury contamination hazard, they could not be recovered back to deck. As a result, these were wet stored to the north of the wreck. The associated wet stored units have been marked accordingly in the GIS deliverable.

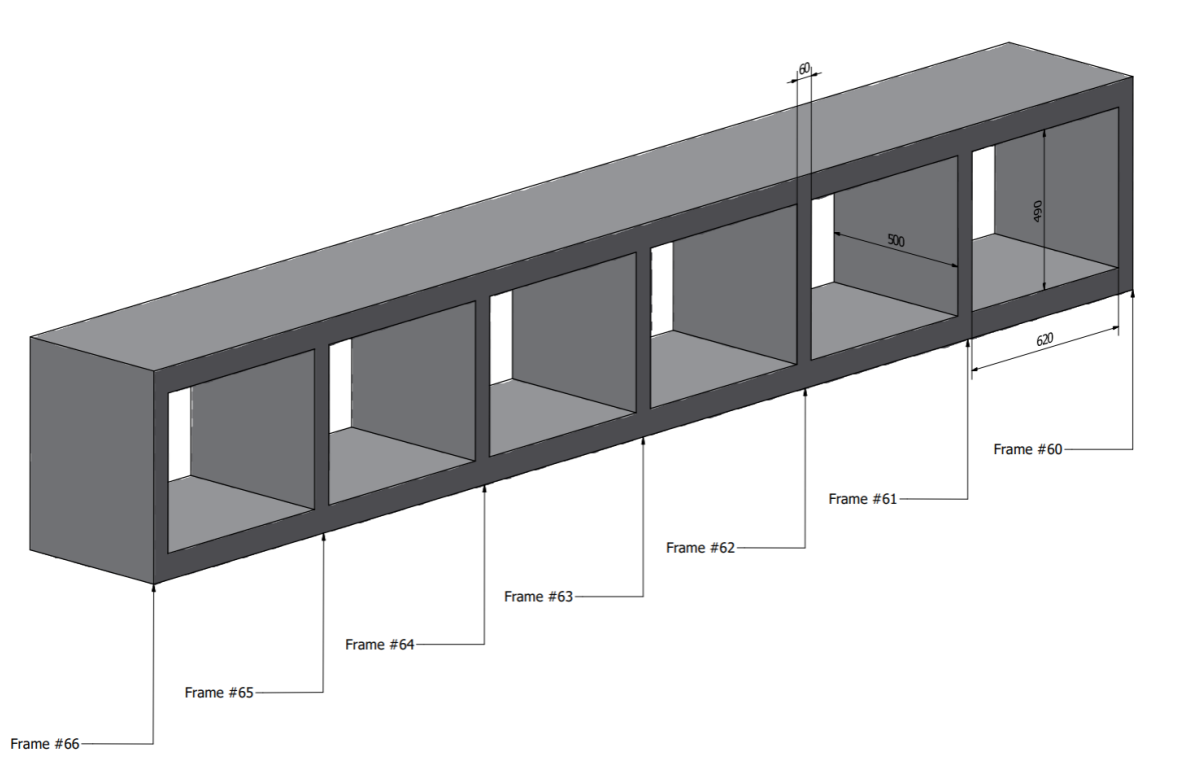
Figure 3-37 Sketch showing measurements of the keel compartments

Measurements of the keel compartment 5 (frame #64-#65) were performed and resulting dimensions were obtained of: 0.62 m (width) x 0.49 m (height) x 0.50 m (depth) x 0.06 m (beam thickness). The process is described in Appendix C.7, REACH-600096-FM-007 Keel Compartment 5 Measurements.

Figure 3-37 shows a sketch of the measurements made of the keel compartments. Note that the dimensions given are for the light opening of the compartments.

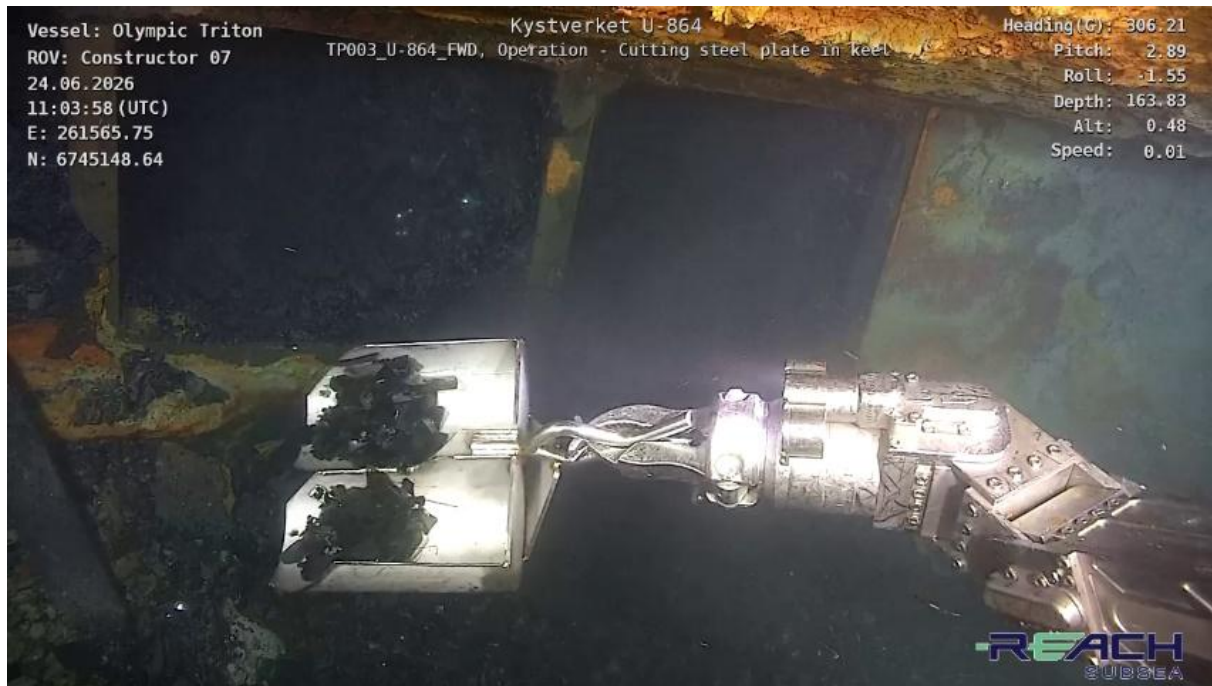
On inspection of the first keel compartment at frame #60, the content seemed to be broken glass, coal and wood. Samples were taken for further study by client on shore.

Figure 3-40 Inspection of keel compartment at frame #60

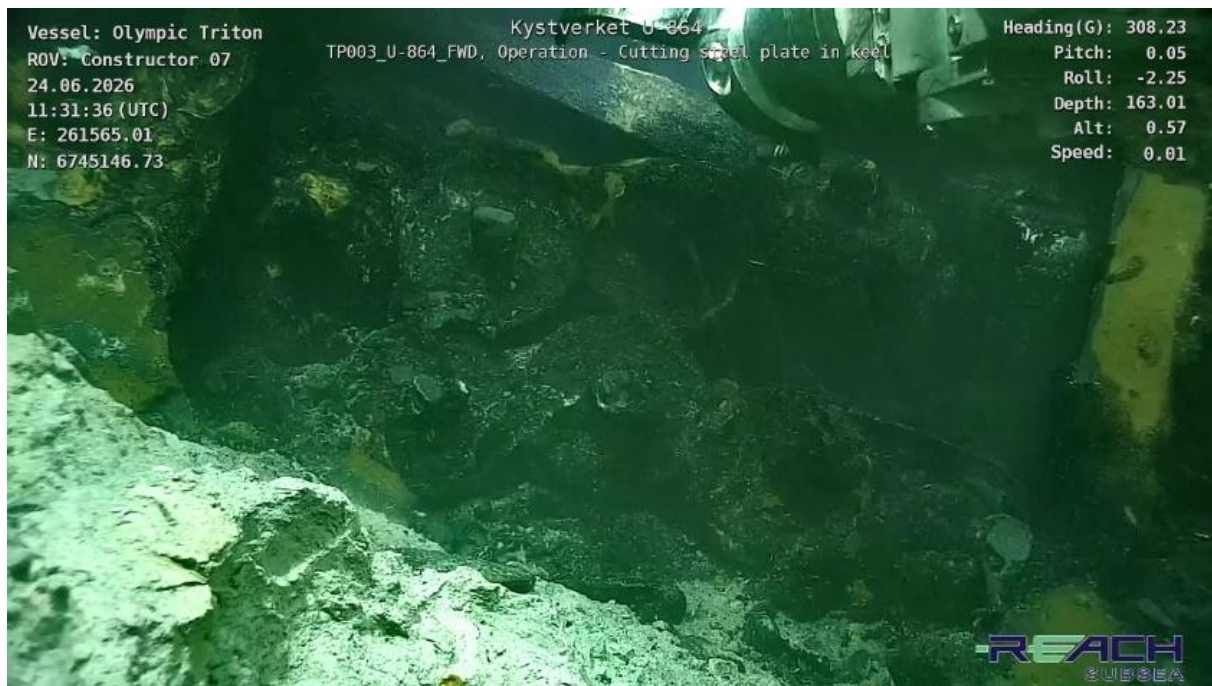
On examination further aft in the keel section, at frame #65, mercury canisters were found.

Figure 3-42 First mercury canisters discovered in keel compartment frame #65-#66 (#110-#112)

ROV performed careful cleaning of the area to obtain access for recovering mercury canisters.

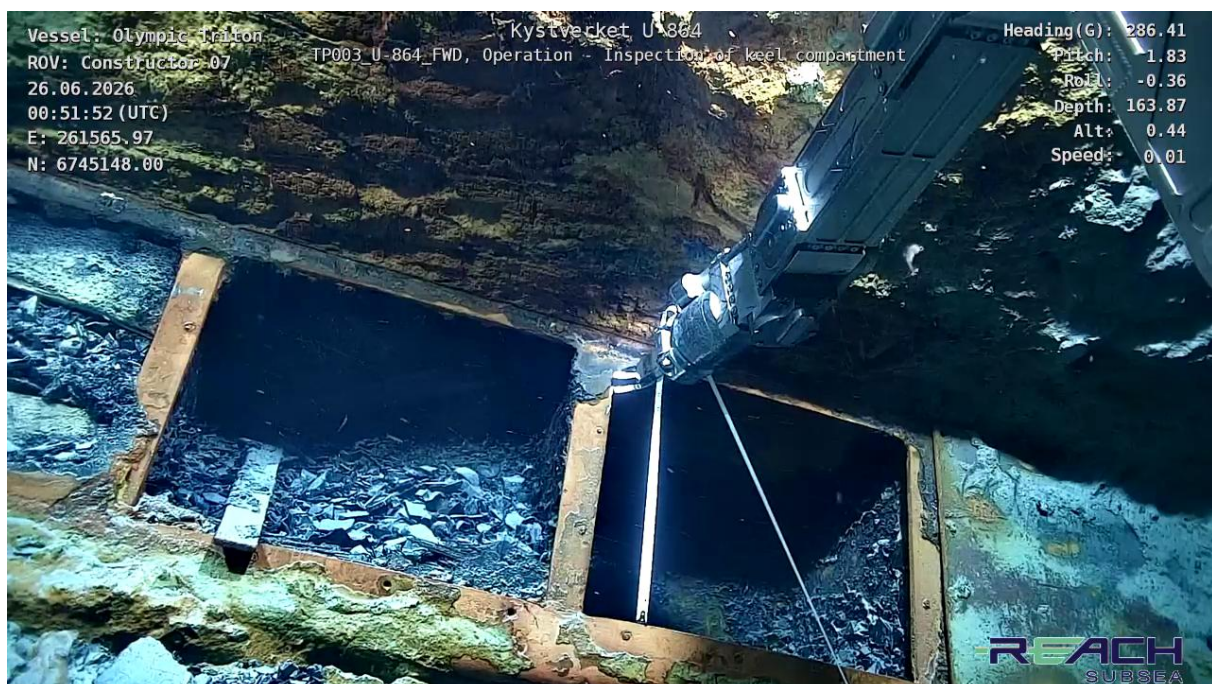
Figure 3-43 Measurements of the canister compartment aperture - He 50cm - Width 62cm - Depth 50cm

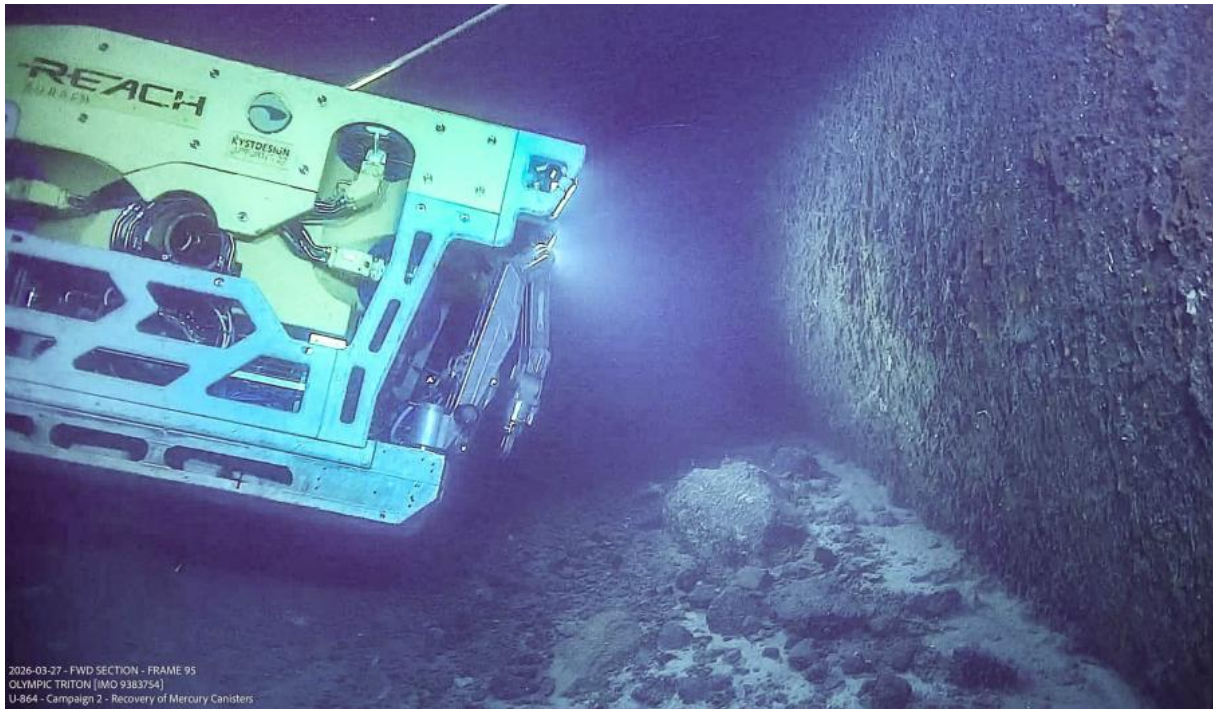
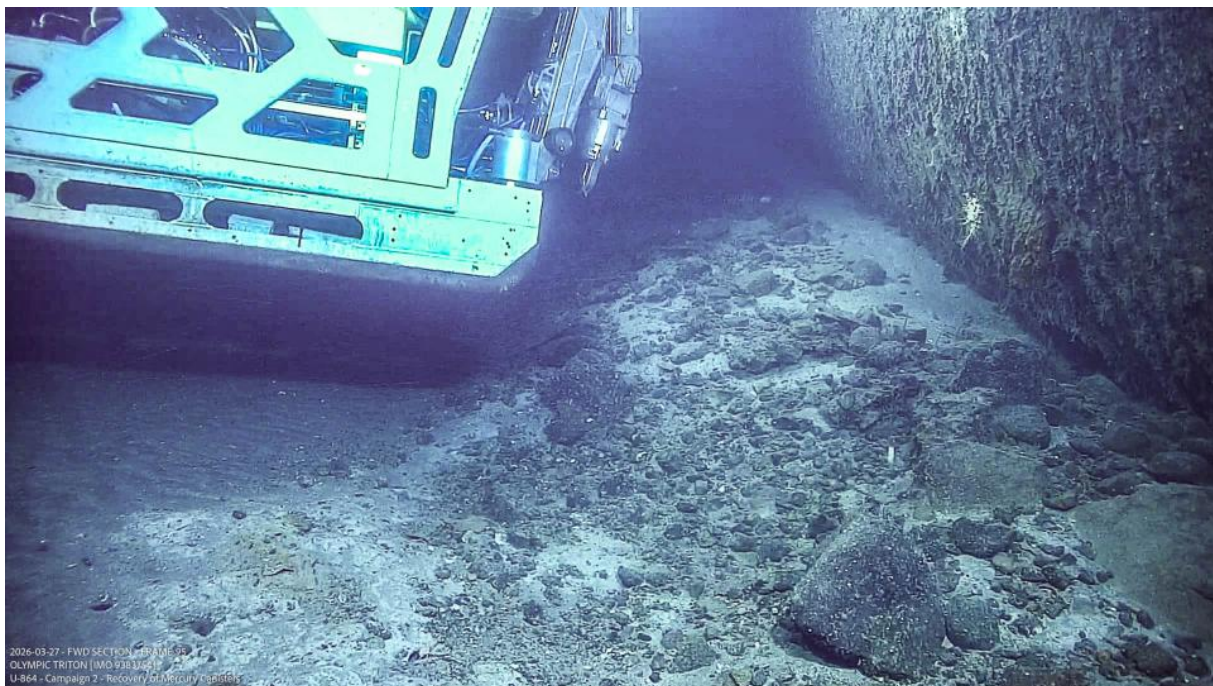
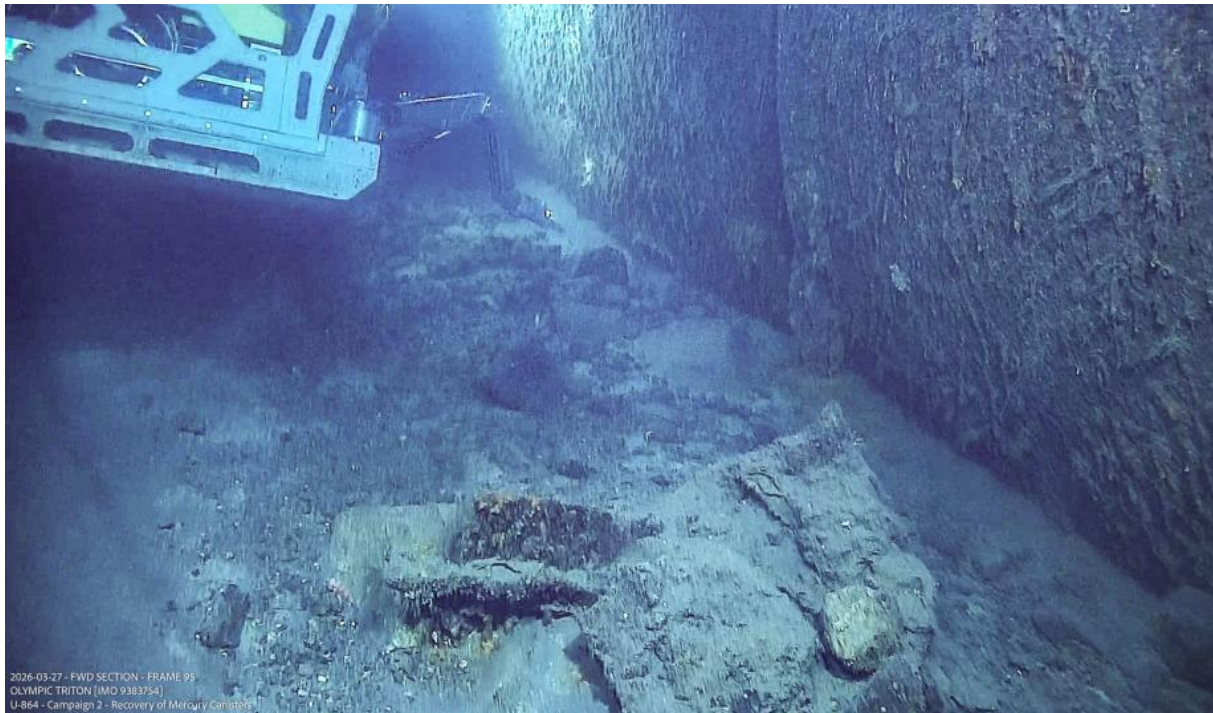
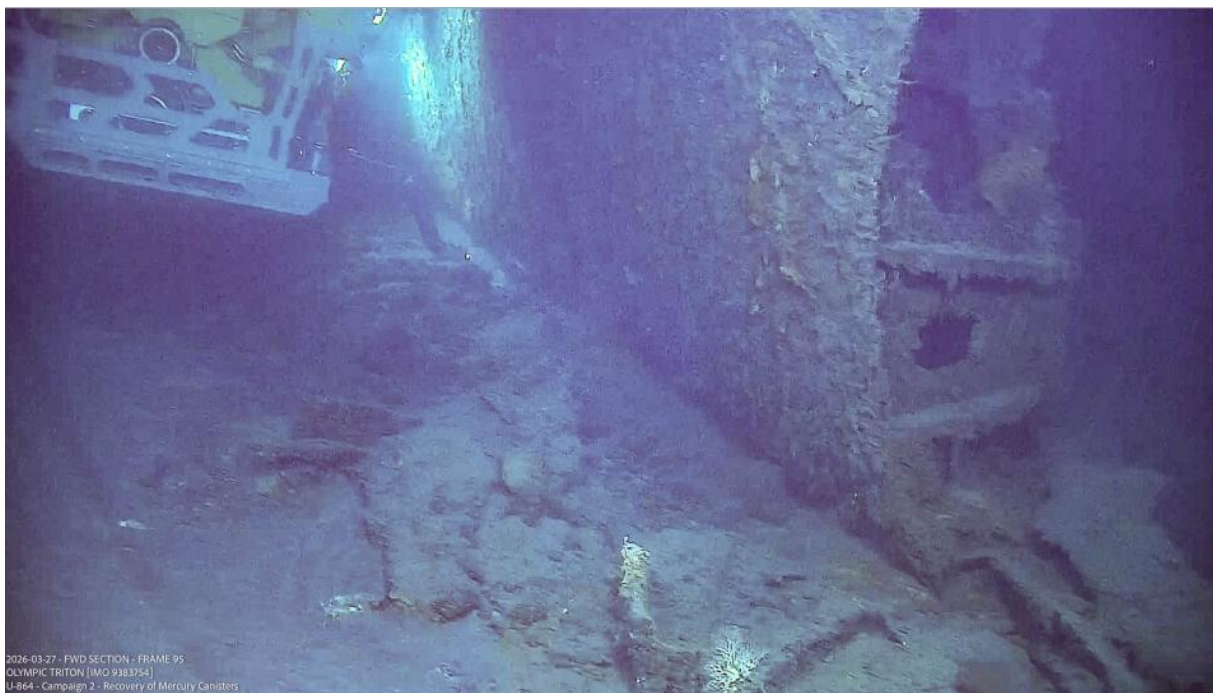
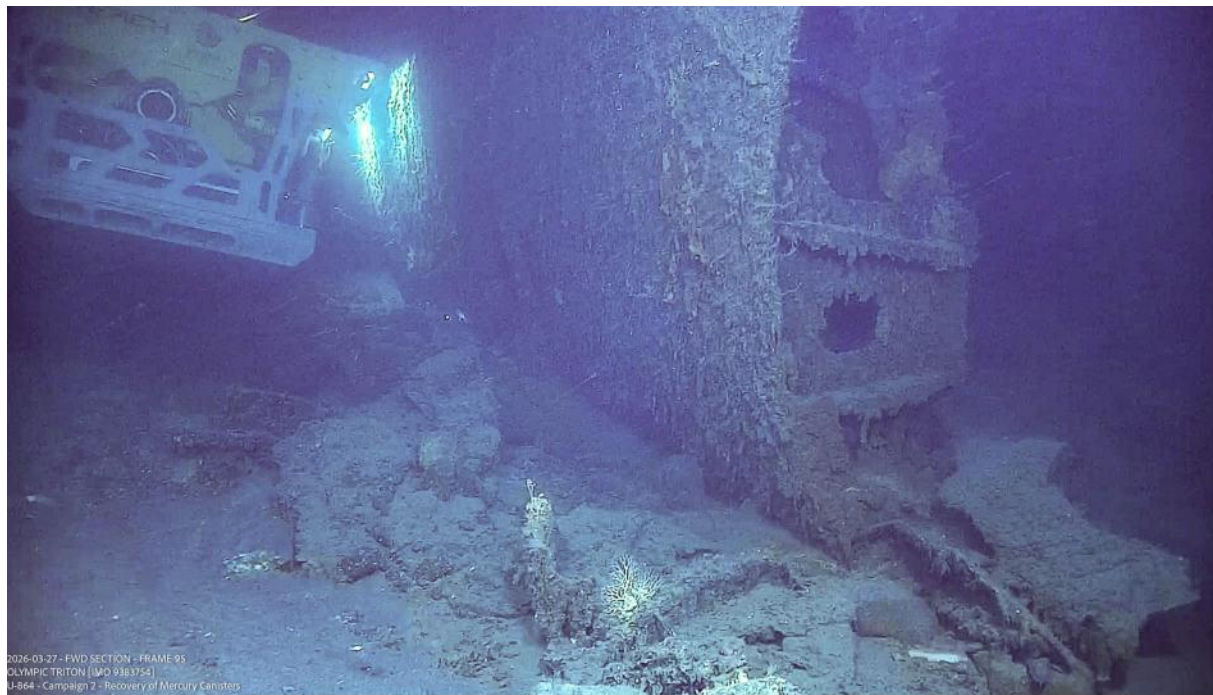
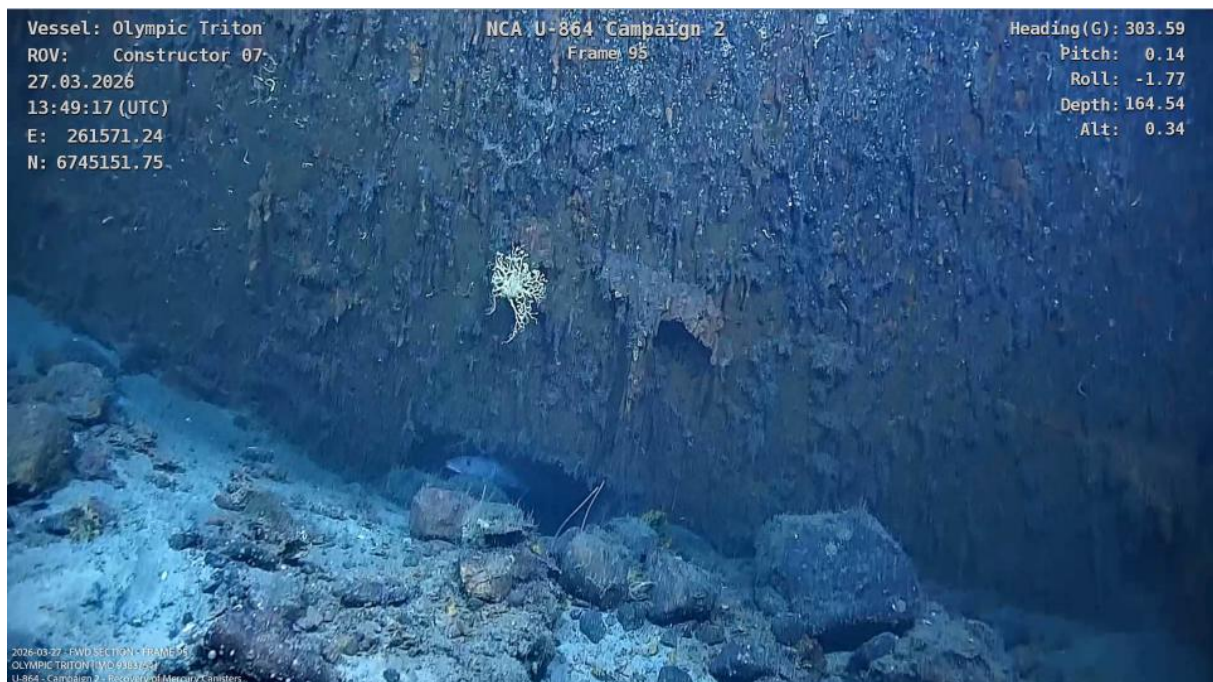
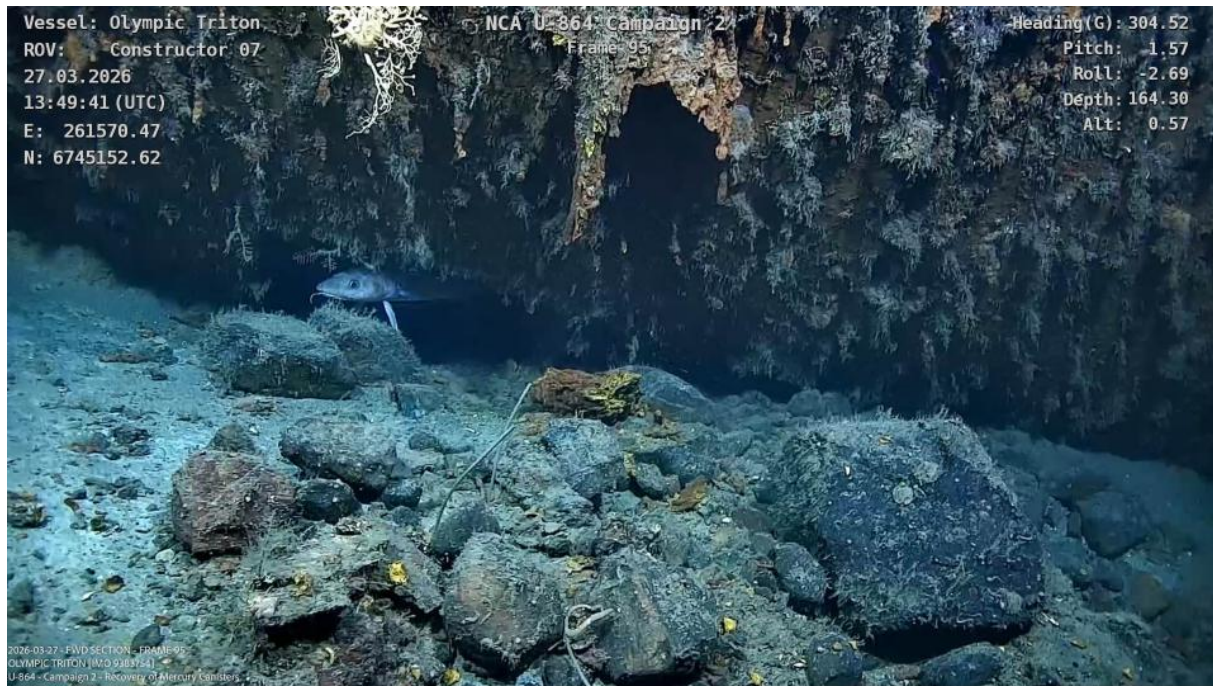
An observation during survey was the number and size of rock in area planned to be dredged for access to keel. By frame #95 (approximately pressure hull frame #55), on the port side forward section.

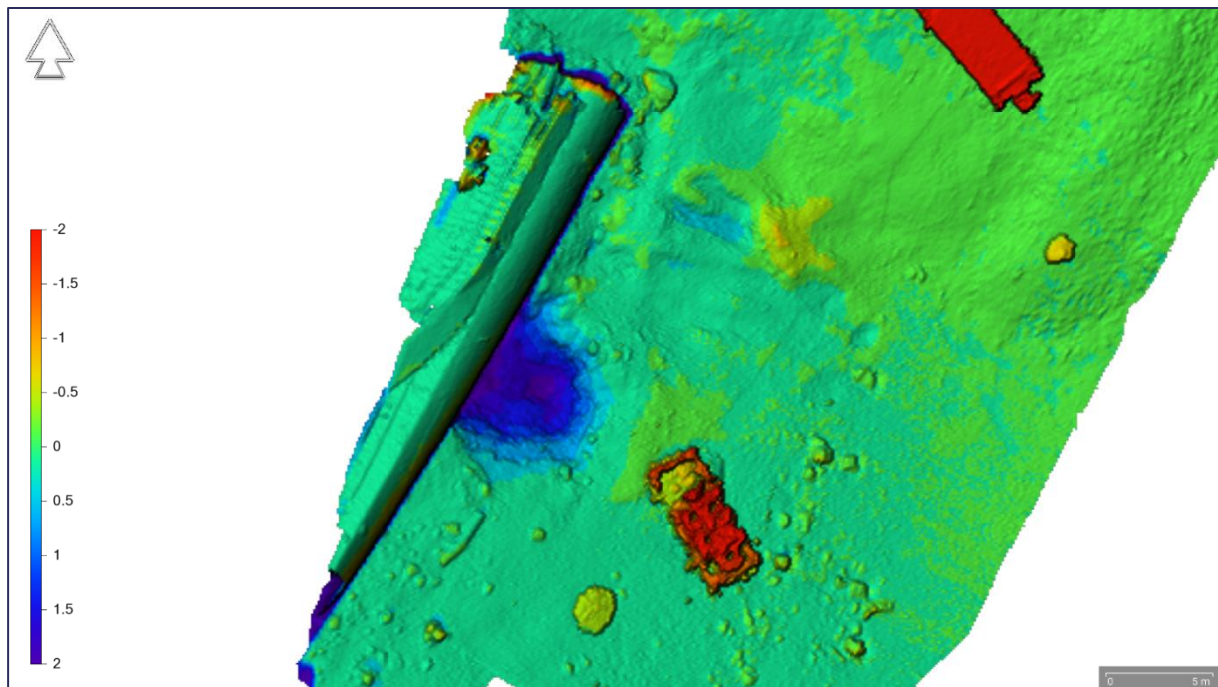
Using the same DTMs, a volume estimate was done, the results of which are shown in Table 3-10, which indicate that approximately 45 m<sup>3</sup> of sediment has been removed since the 2025 reference survey.

Figure 3-61 Dredged area before installation of rock bags, with difference in depth compared ref DTM
