THE LANCHESTER GUN COMPANY

SUPPLEMENTARY REPORT BY THE LANCHESTER GUN CO ON THE POSSIBILITY OF SHELL DAMAGE TO THE FISHING VESSEL WESTERN, (PORT SIDE)

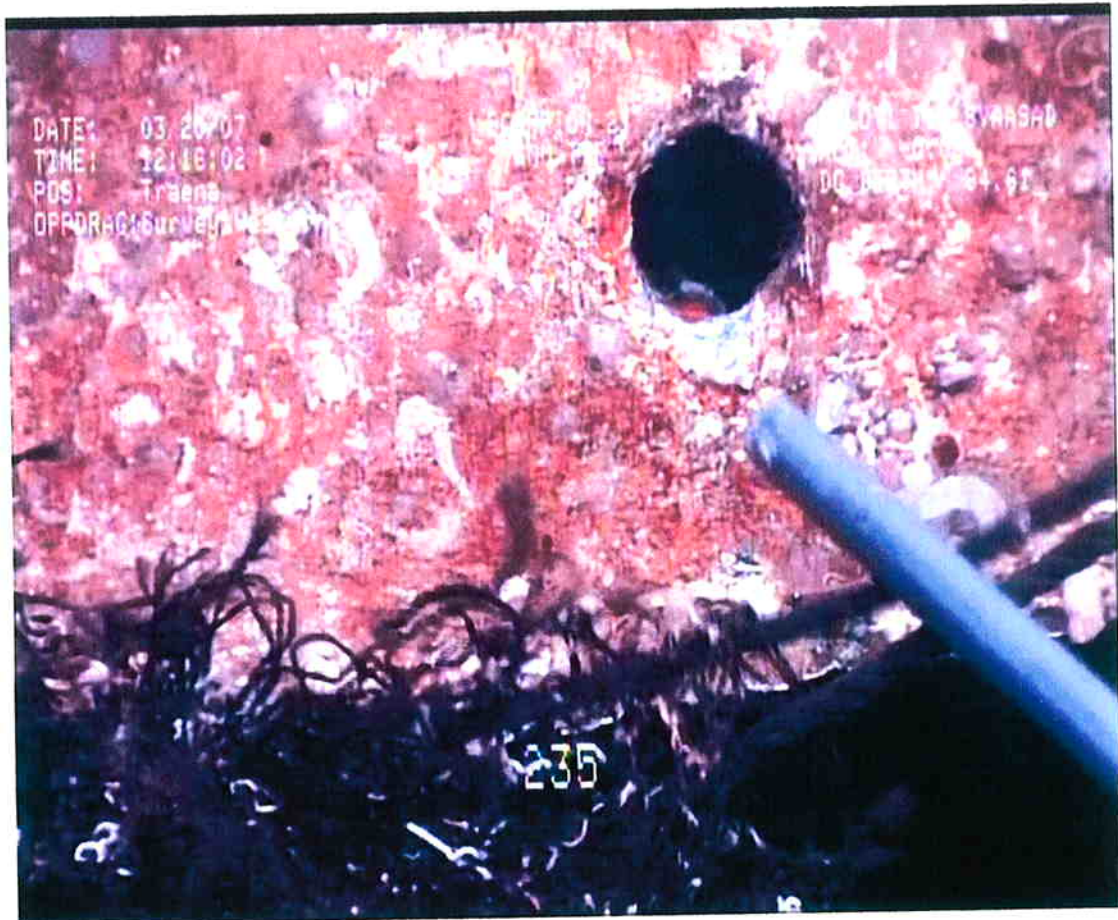
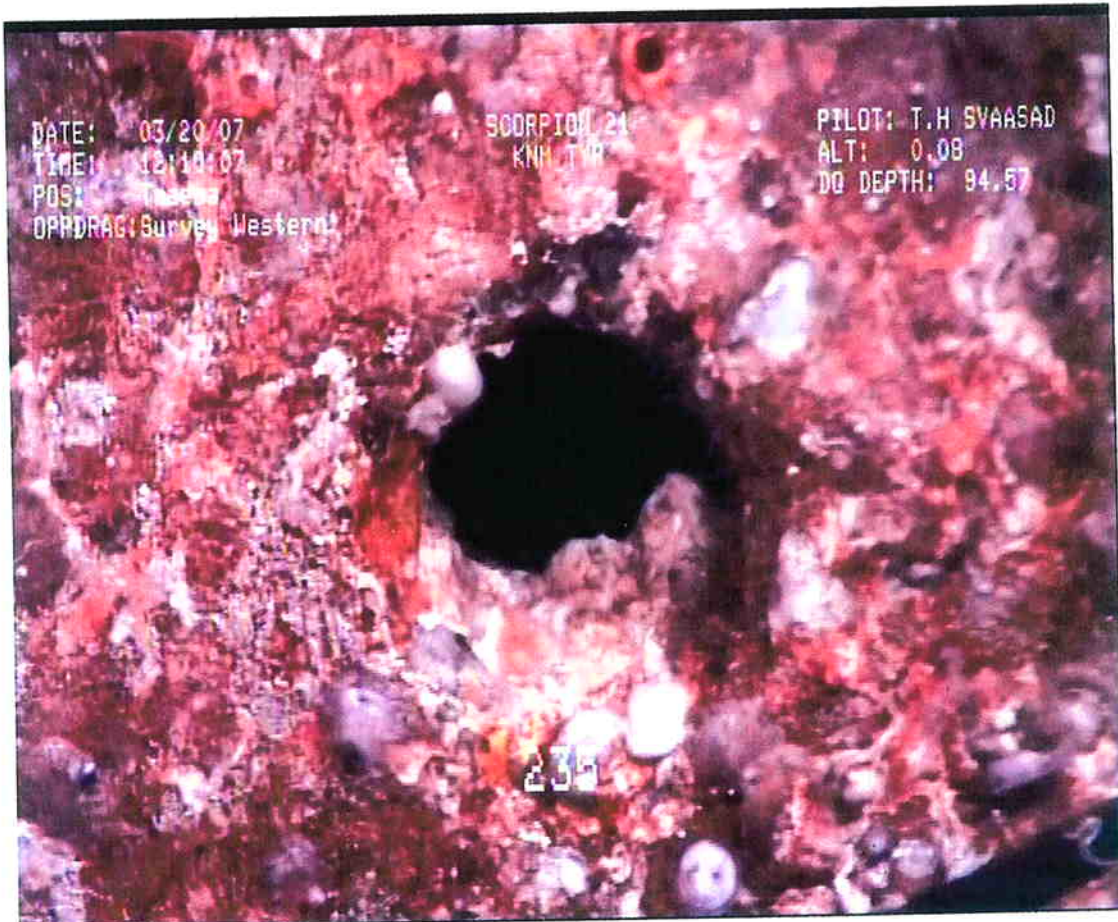
The attached photograph 1, (lower picture) shows the portside hole in its original state; this is taken from the 2007 video, since the 1981 black-and-white video is not sufficiently clearly focused to give much help (photograph 3). Photograph 1 shows an approximately circular hole, with a large half-moon-shaped whitish area below it. This area was gradually poked with a 16mm metal rod by the submersible, and the white parts fell away. I am not a marine archaeologist, and I do not know the effect that nearly thirty years under water will have on aluminium sheet, so it is not possible for me to say whether this white half-moon is corroded metal or barnacles.

I examined this hole with care, (from the outside only, of course) and I did not find any of the characteristic entry marks that shells make in this material. There was no sign of the extruded crown-shaped ring that surrounds a shell entry-hole, and there are no signs of rifling grooves on the edges of the hole (to show what I mean here, please see the lower hole in photograph 6 in my main report).

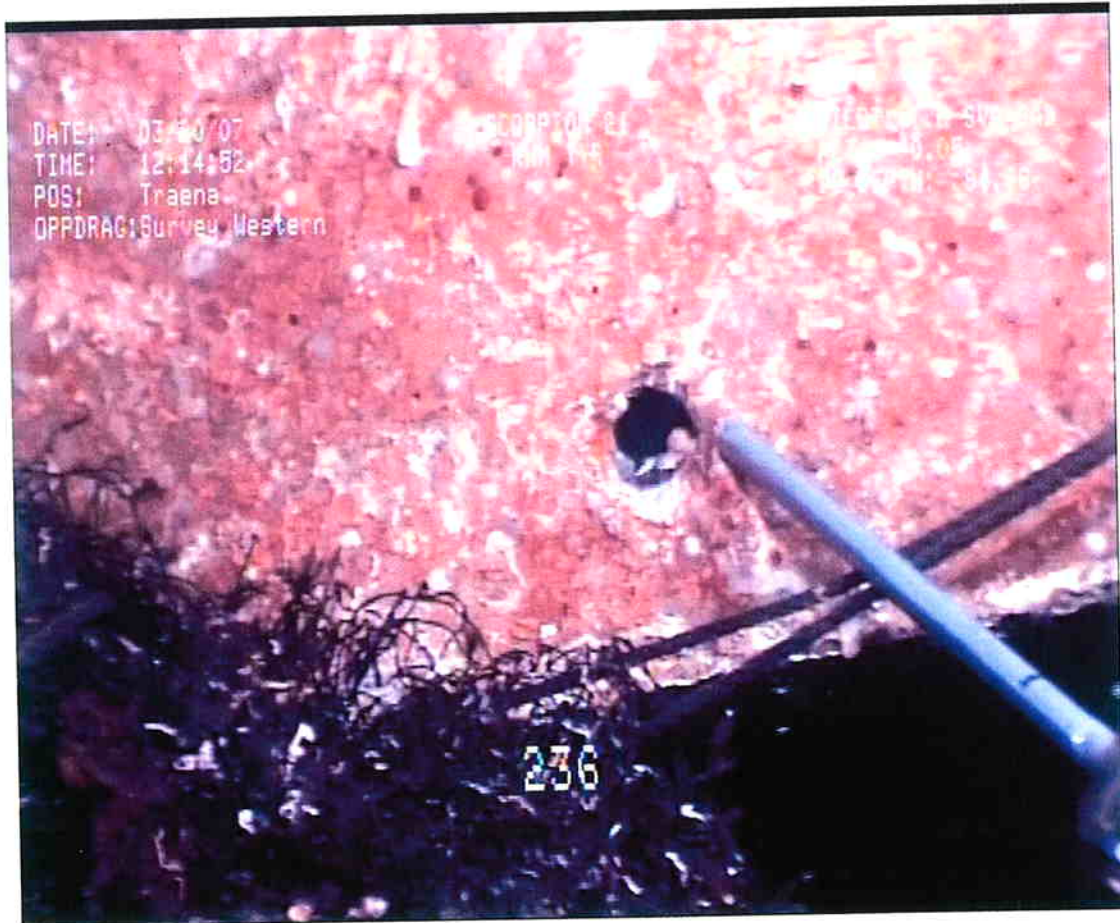
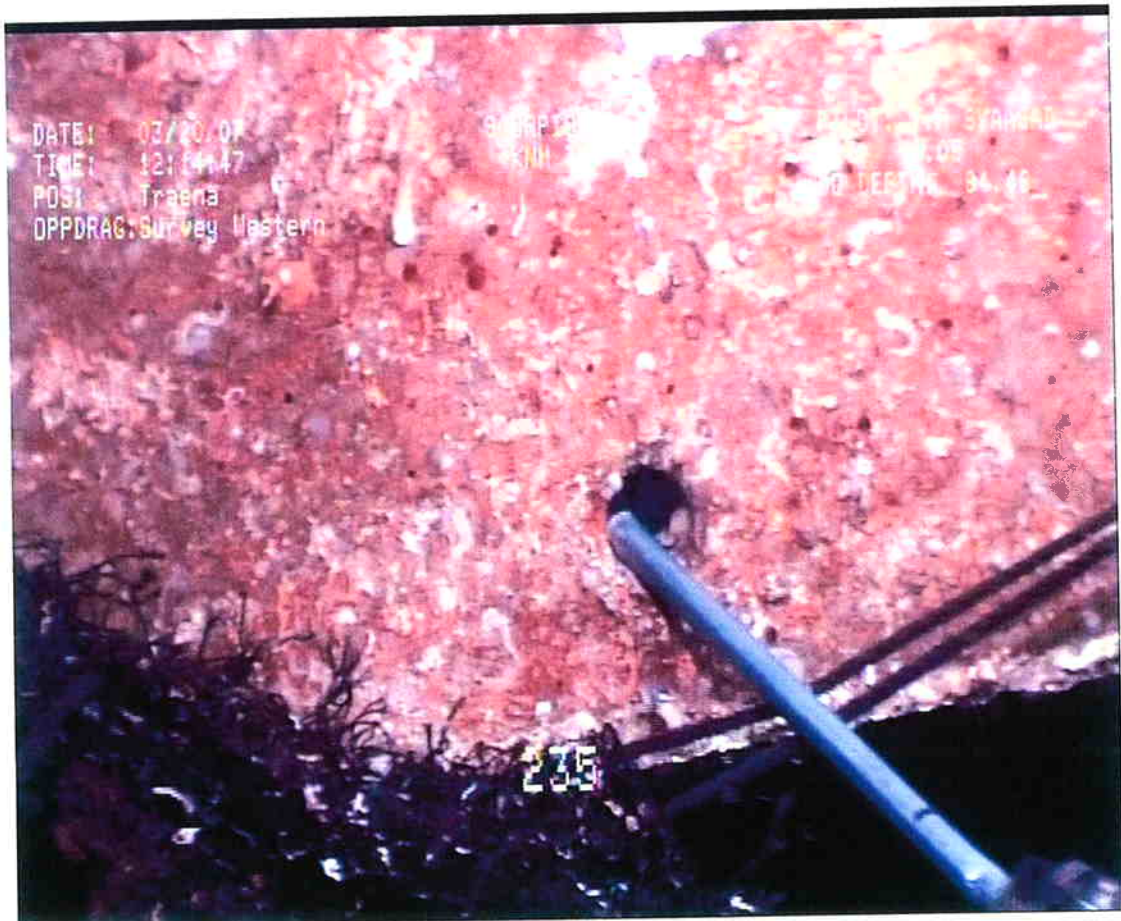
All the above is important because much can be learnt from the shape of the hole. Once the marine growth has been removed, it can be seen, as outlined in black ink on photograph 4 (lower picture) that the original hole was in fact elliptical in shape, and there is some evidence that the top side is protruding slightly and the bottom side pushed back. An elliptical hole is evidence that whatever caused the hole entered at an angle, and it appears that in this case the entry was made from below at an angle of approximately thirty degrees from the vertical; this is best shown by photograph 2. An entry from below would obviously rule out shell damage, and the fact that the hole was not originally perfectly circular would seem to rule out deliberate fabrication. I therefore conclude, from the evidence so far available to me, that this hole can only have been caused by static penetration by some object unknown.
