**The Scandinavian Star  
Disaster of 7 april 1990  
MAIN REPORT**

NOR 1991: 1E

**Report of the Committee Appointed by  
Royal Decrees of 20 April and 4 May 1990**

**Submitted to  
the Ministry of Justice and the Police in January 1991**

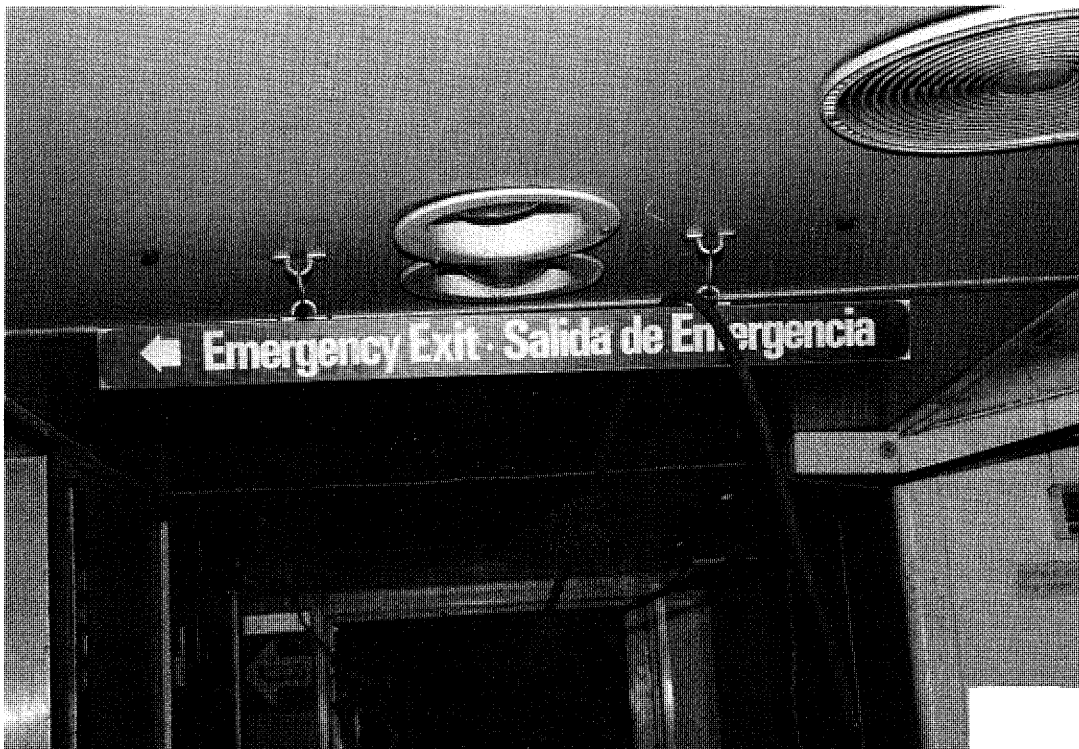
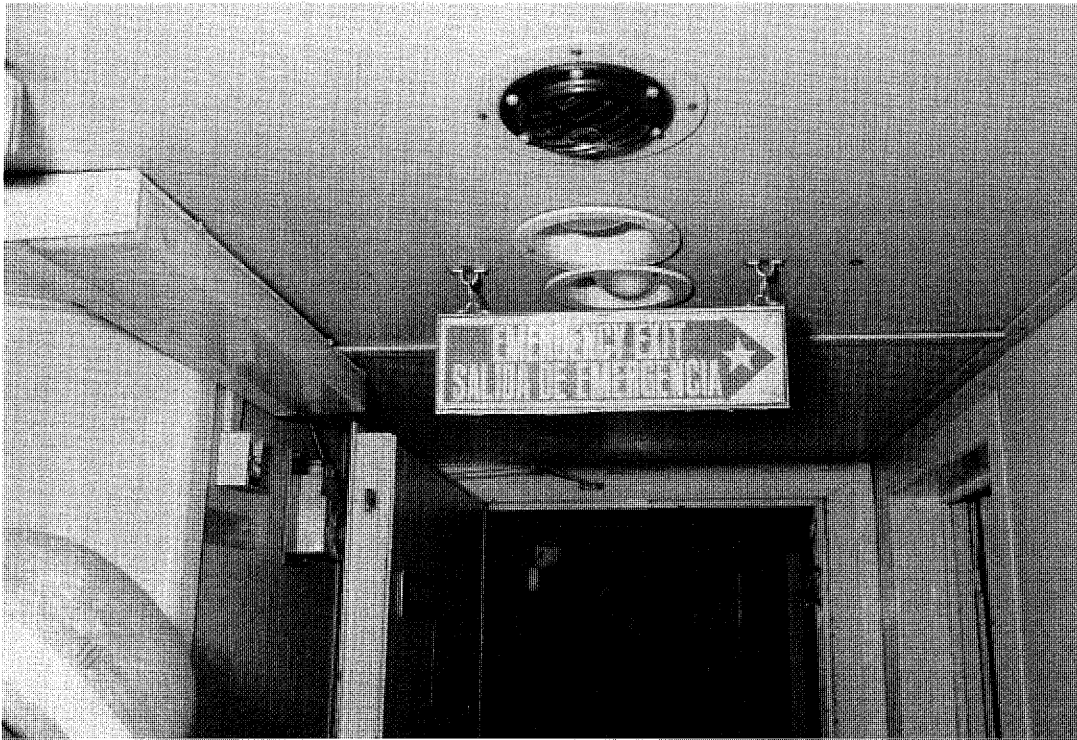
Photograph 8

*Photographs 7 and 8* show two types of notice at ceiling height, showing the position of an emergency exit in a longitudinal corridor. These emergency exits cannot be seen immediately, however, by a person standing in the same corridor. The fire doors that served as emergency exits were the same colour as the adjoining bulkheads, which meant that they were difficult to locate. Notices at ceiling

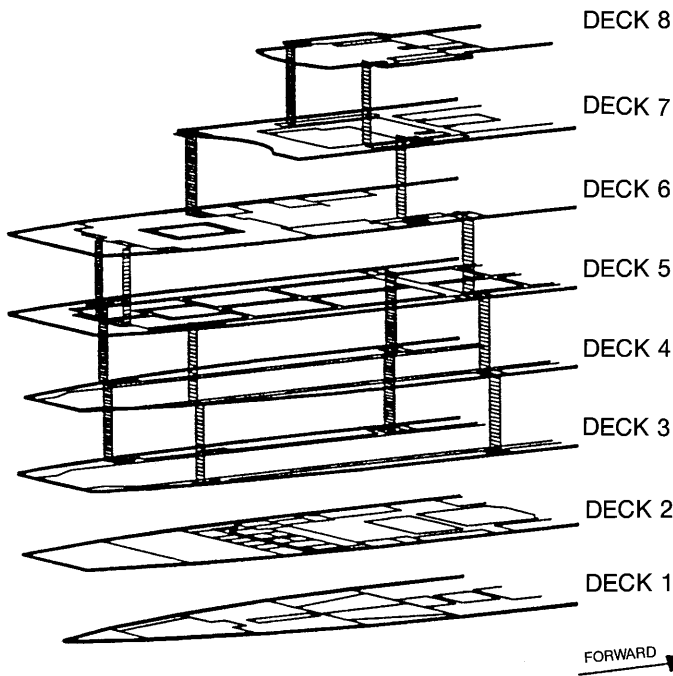
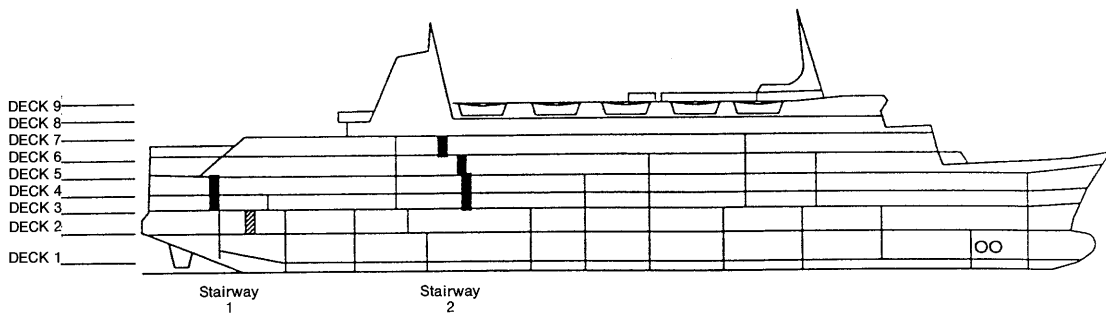
Fig. 4.7.2 Profile showing stairways used as escape routes in fire zone 1

The main escape routes in fire zone 1 may have been adequate for evacuation in a good light and with no smoke under organized conditions, but they were inadequate in darkness

and smoke and were not suitable for hurried evacuation under stress.

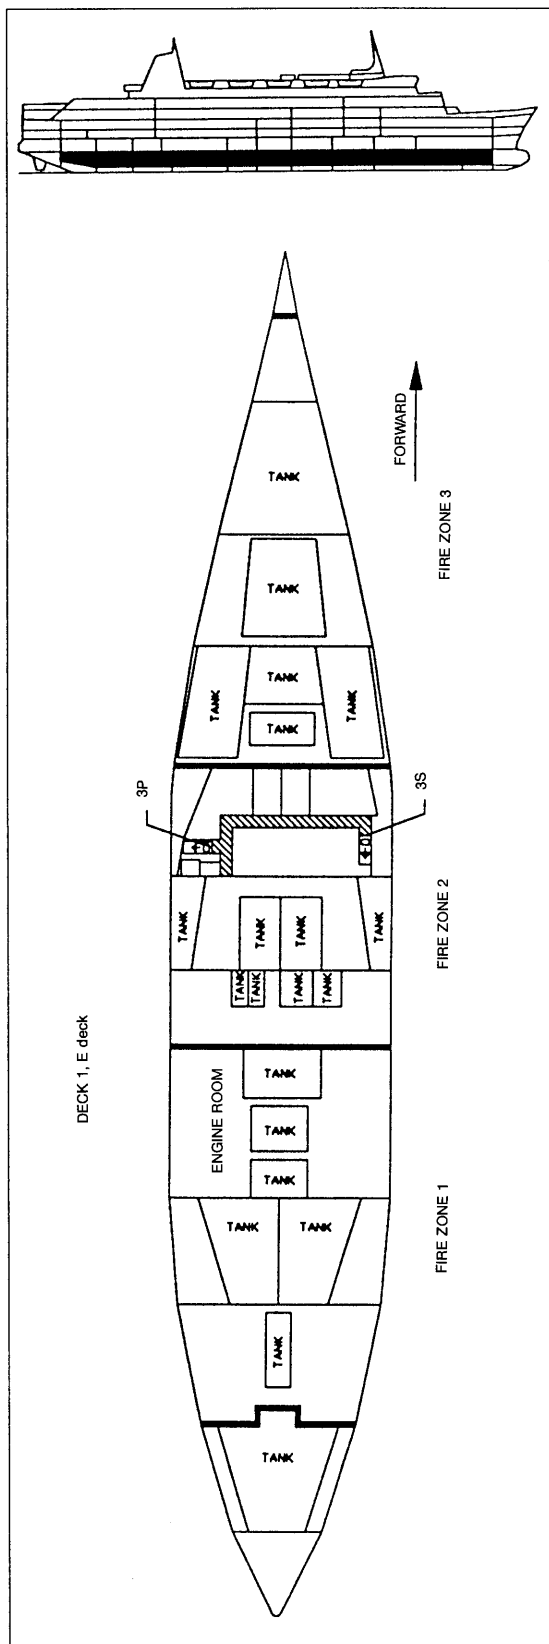
Fig. 4.7.5 Layout of deck 1 (E Deck), with hatched areas showing escape routes

The escape routes, on both sides up a ladder to a higher level, or out through watertight doors fore and aft, are reasonably good for crew members who are familiar with the ship. The forward escape route through a watertight door involves the use of one of two emergency exits in order to proceed further, which again requires a good knowledge of the ship. In case of a hurried exit through smoke it might be difficult to find.

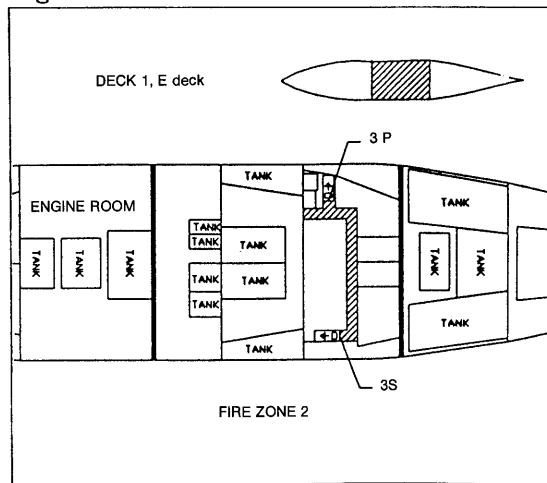
Fig. 4.7.5.2 Fire zone 2

The fact that this escape route does not lead directly to a muster station may be a shortcoming. (There are notices recommending passen-

gers when they hear an emergency signal to proceed directly to a muster station, where life jackets will be distributed by the crew.) However, as mentioned above, there are stores of life jackets at the embarkation stations for the lifeboats, so that it might not be necessary to proceed from here to the muster stations.

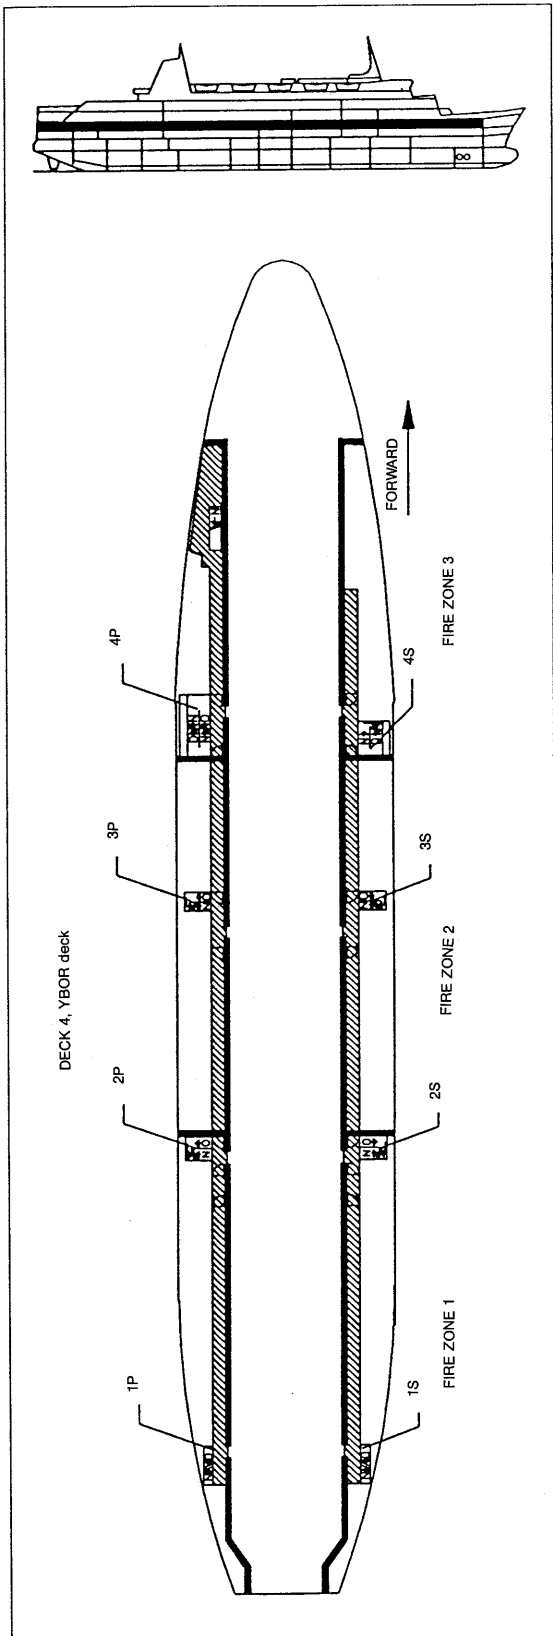
Fig. 4.7.8 Layout of deck 4 (Ybor Deck), with hatched areas showing escape routes

The cabin section at the forward end of the zone has stairs up to the deck above at both ends of the after transverse corridor. The starboard stairwell is in the same space as a shower and lavatory section. The whole section is separated from the cabin corridor by a door. Considering that the cabins are for crew, the escape routes are adequate, but smoke

might make it difficult to find the way out from the foremost transverse corridor.

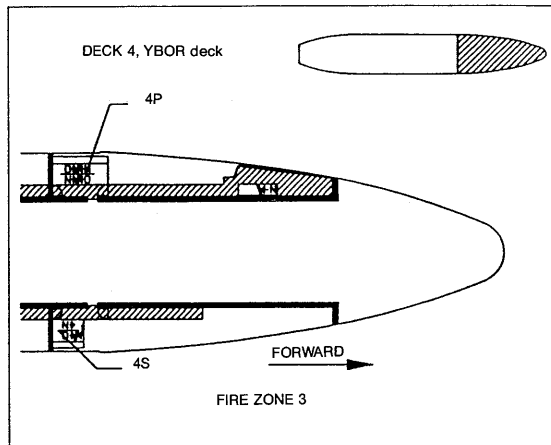
Fig. 4.7.8.3 Fire zone 3

Here, too, the cabins open off the longitudinal corridors without any changes of direction. The escape routes are up stairways about half-way along the corridors or out through fire doors fore and aft. For the limited number of persons with cabins in this zone the escape routes are adequate.

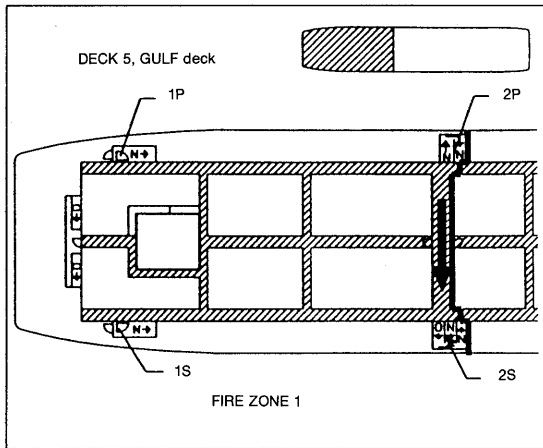
Fig. 4.7.9.1 Fire zone 1

The cabins, corridors, and escape routes follow the same pattern as on deck 3, but there is more cabin space than on the lower deck. Even though the number of persons is larger, the escape routes are in principle adequate. However, 19 bodies were found in the starboard cabins. This is probably because toxic smoke penetrated the corridor before the passengers became alarmed. Under the circumstances of this fire, therefore, the passengers in fact had no possibilities of escape.

Two bodies were found in the corridor.

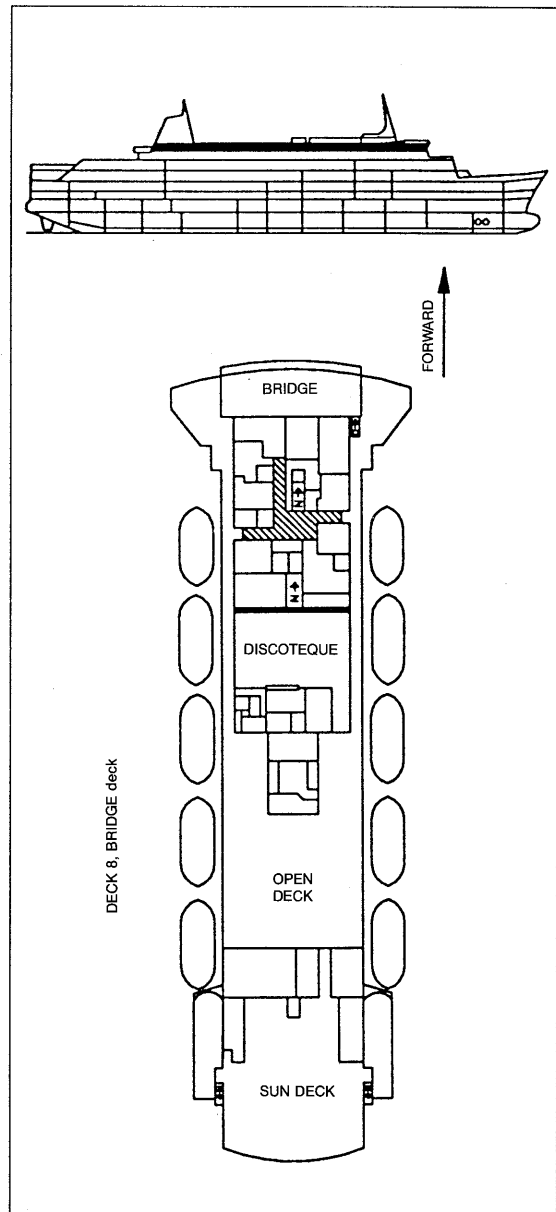
Fig. 4.7.12 Layout of deck 8 (Bridge Deck), with hatched areas showing escape routes

The escape possibilities are good.

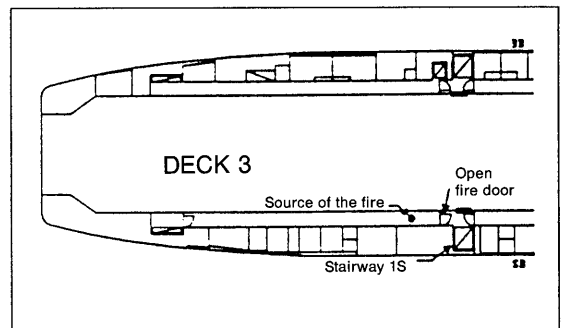
Fig. 8.3 Deck 3, starboard side.

The starting fire was lit here a little after 0200 hours. After 2 to 8 minutes this fire is thought to have attained an effect of 200 kW, enough to set fire to the corridor walls. Within 1 minute flashover had occurred over the whole cross-section of the corridor. The fire spread rapidly and emitted large amounts of toxic smoke. A critical temperature of 200°C was attained within 2 minutes, and fatal doses of carbon monoxide (CO) and hydrogen cyanide (HCN) were produced within 5 minutes. Within 10-15 minutes the fire in this part of the corridor was beginning to burn out. This section was empty during the disaster voyage, and no bodies were found here (see Fig. 8.3).
