## Kystverket - U-864 Wreck Investigation 2025 Campaign 1

28 August 2025

Issued for Review

Revision 2

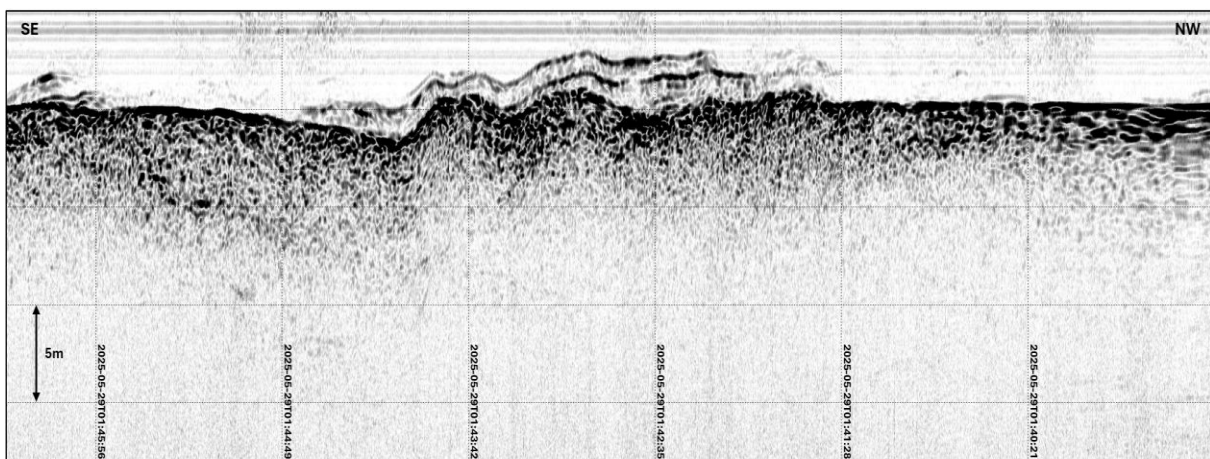
Figure 3-2 Line SBP\_Geo\_Stern\_M\_010 Data example with noise from the stern section of the wreck, in the middle of the profile

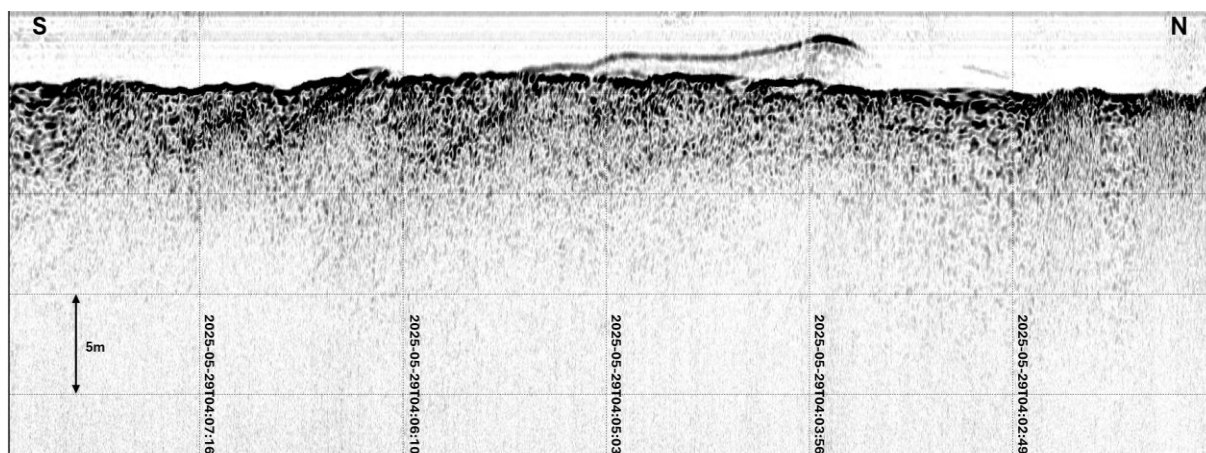
Figure 3-3 Line SBP\_Geo\_Bow\_M\_030 – Data example with noise from the bow section of the wreck, in the middle of the profile

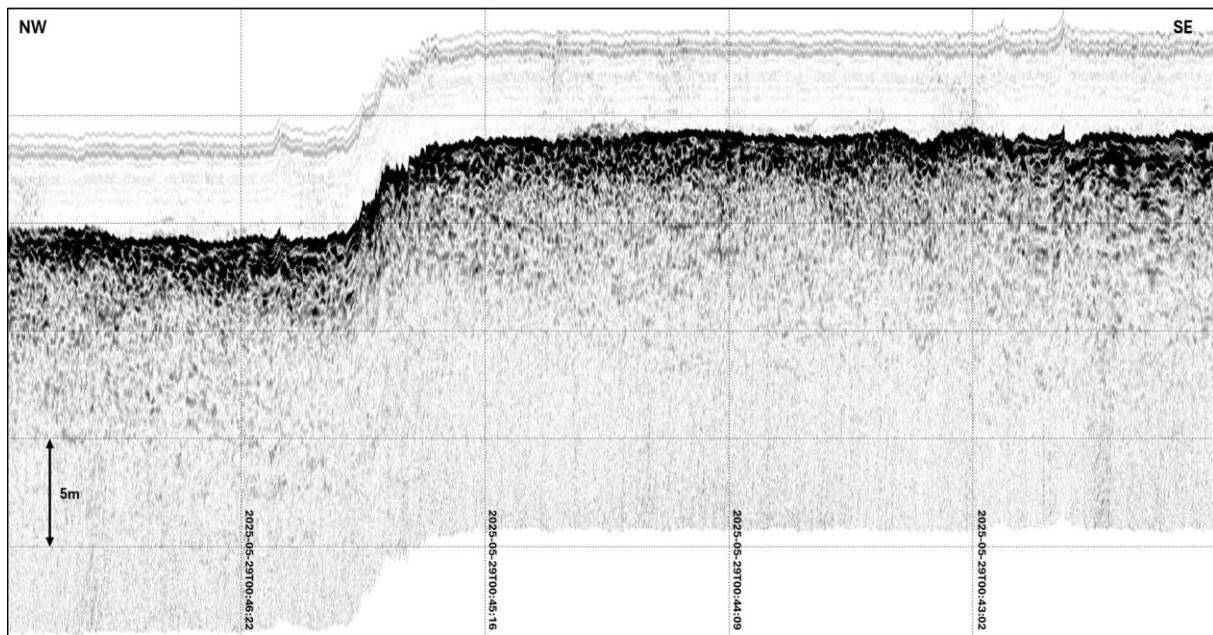
Sub-surface penetration was limited across much of the survey area due to the seabed characteristics, including bedrock areas, hard sediments on the seabed and previous work activity. Smearing effects and acoustic noise from the wreck and debris further compromised the data quality, making interpretation difficult. Penetration up to 5 m was occasionally achieved, however, it was usually less. Figure 3-2 - Figure 3-9 display data examples from the SBP profiler. The absence of distinct sub-seabed reflectors in the data examples illustrates the limited penetration achieved.

Figure 3-5 Line SBP\_Geo\_Stern\_M\_040 – Data example with no visible reflectors due to limited penetration

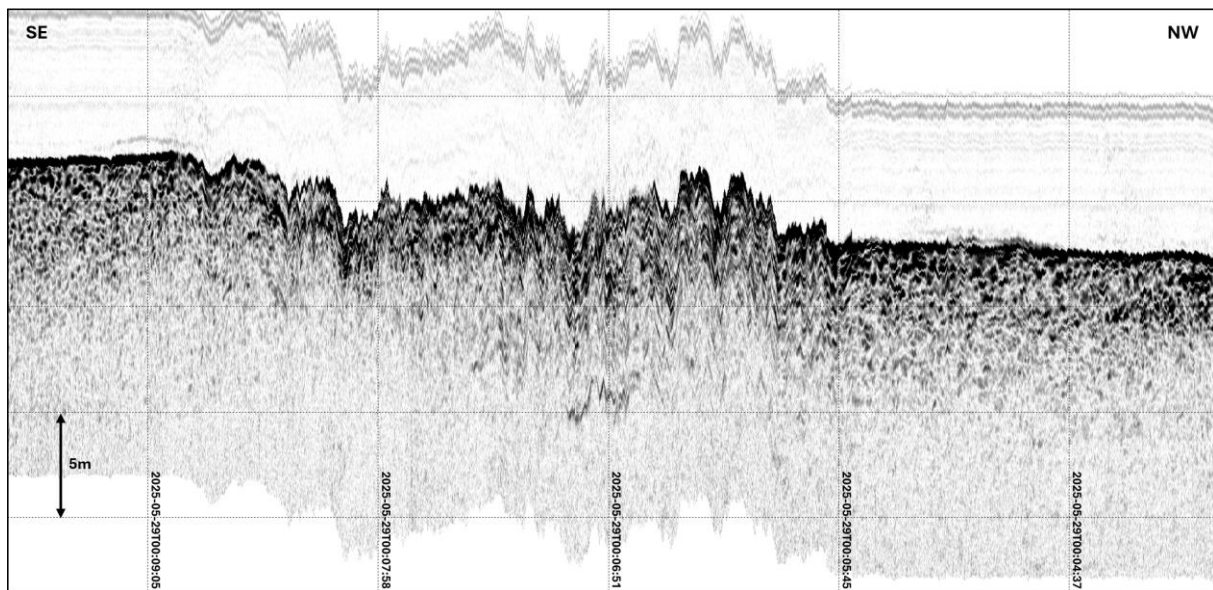
Figure 3-8 Line SBP\_Geo\_Stern\_M\_025 - Data example of noisy data

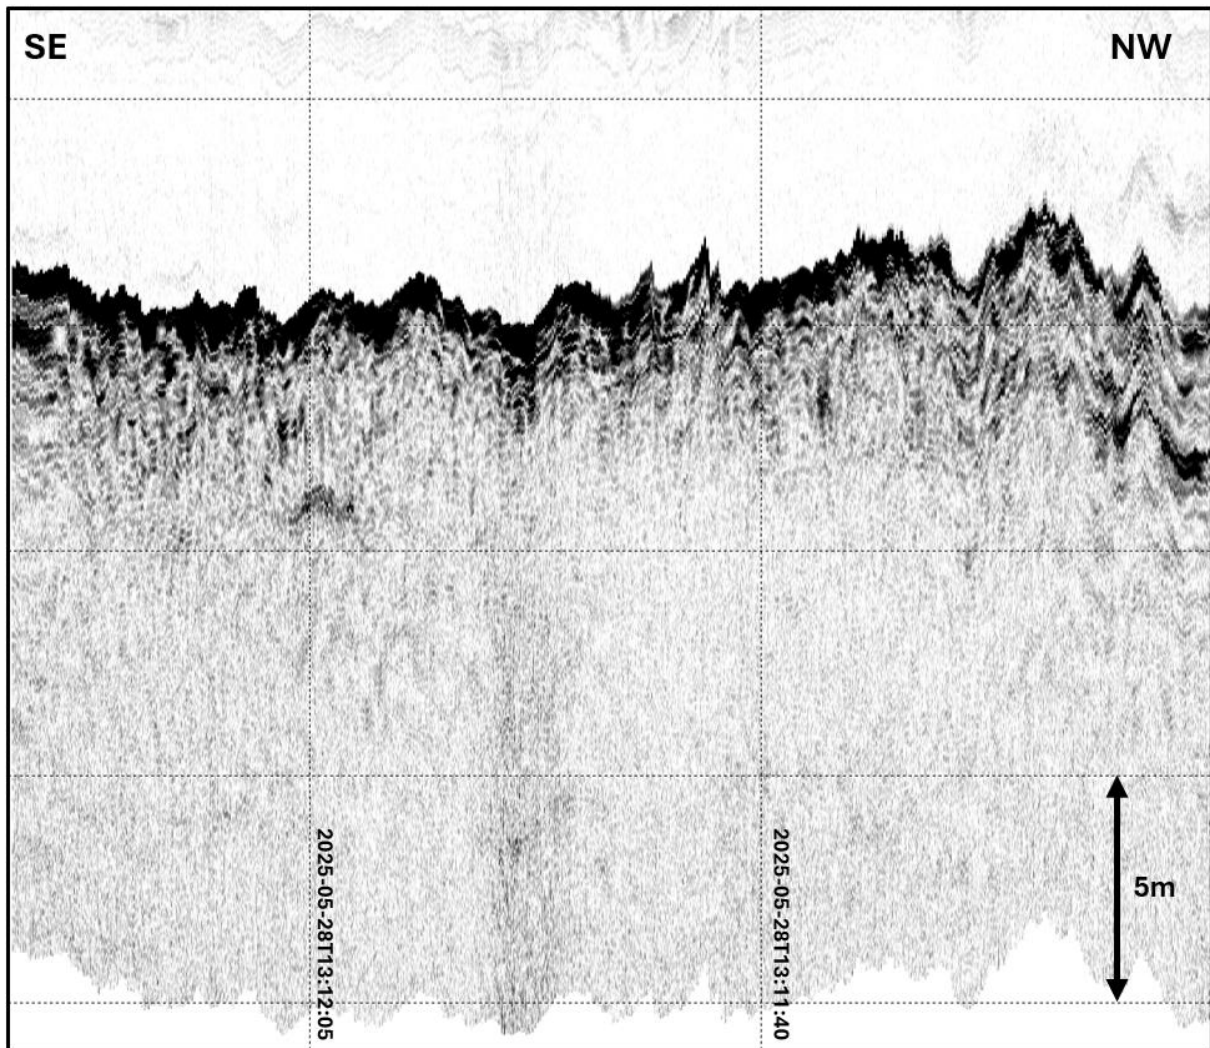
Figure 3-9 Line SBP\_Geo\_Stern\_X\_035b – Data example of noisy data

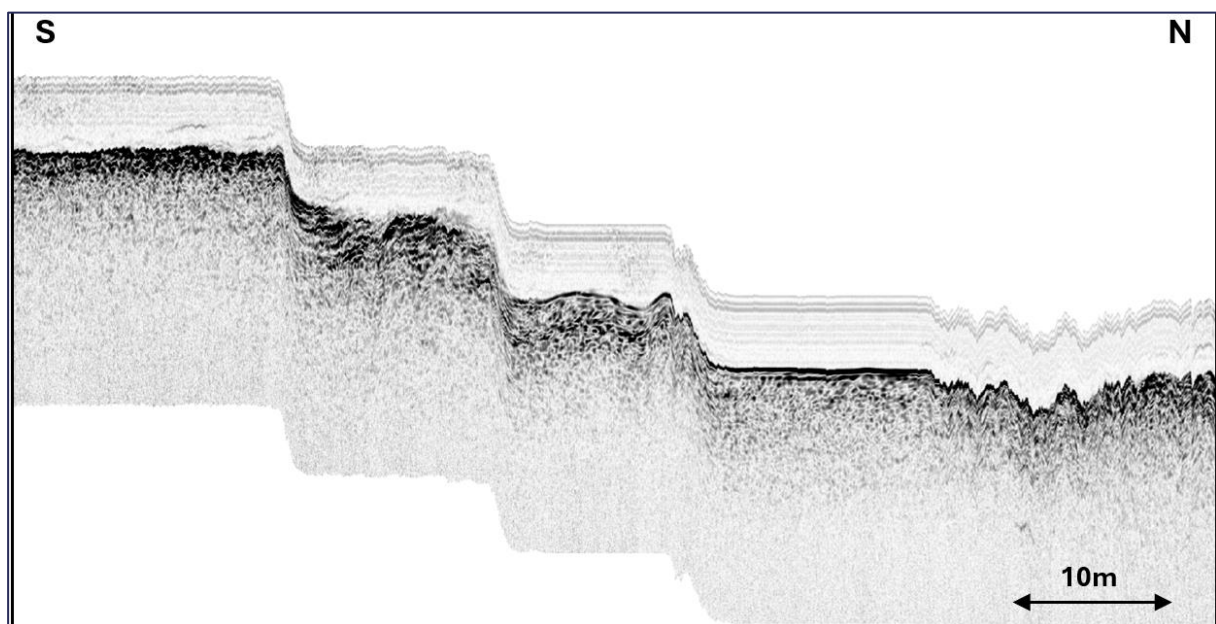
Profiles across areas with inclined seabed, particularly to the east and west of the stern section, show apparent vertical drops in the seabed (Figure 3-10). These are motion-induced artifacts caused by ROV heave and attitude movements. The actual seabed morphology in these areas is generally smooth and gradually sloping.

Figure 3-10 Line SBP\_Geo\_Bow\_M\_055 – Data example of motion-induced artifacts caused by ROV movements

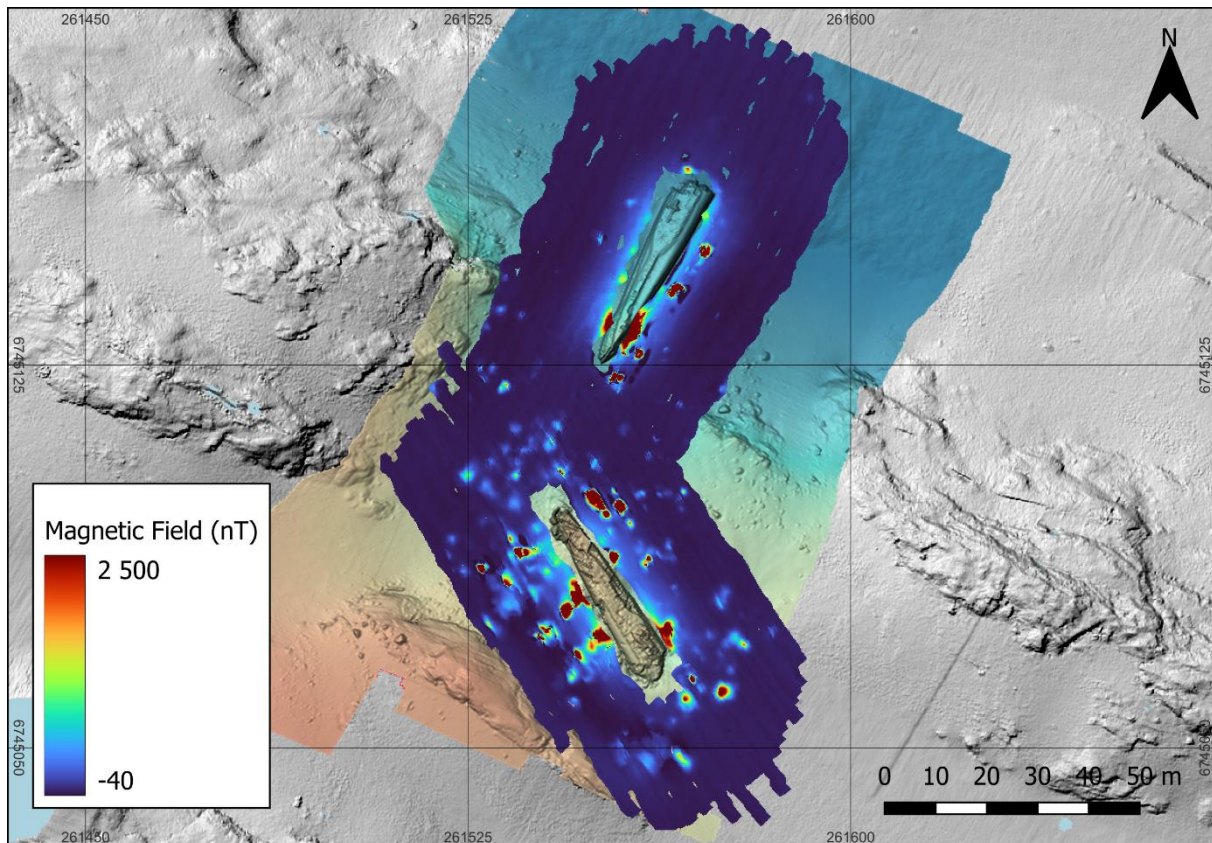
Figure 3-11 TSS 440 heatmap showing increase in the magnetic field (nT) where metallic debris is located

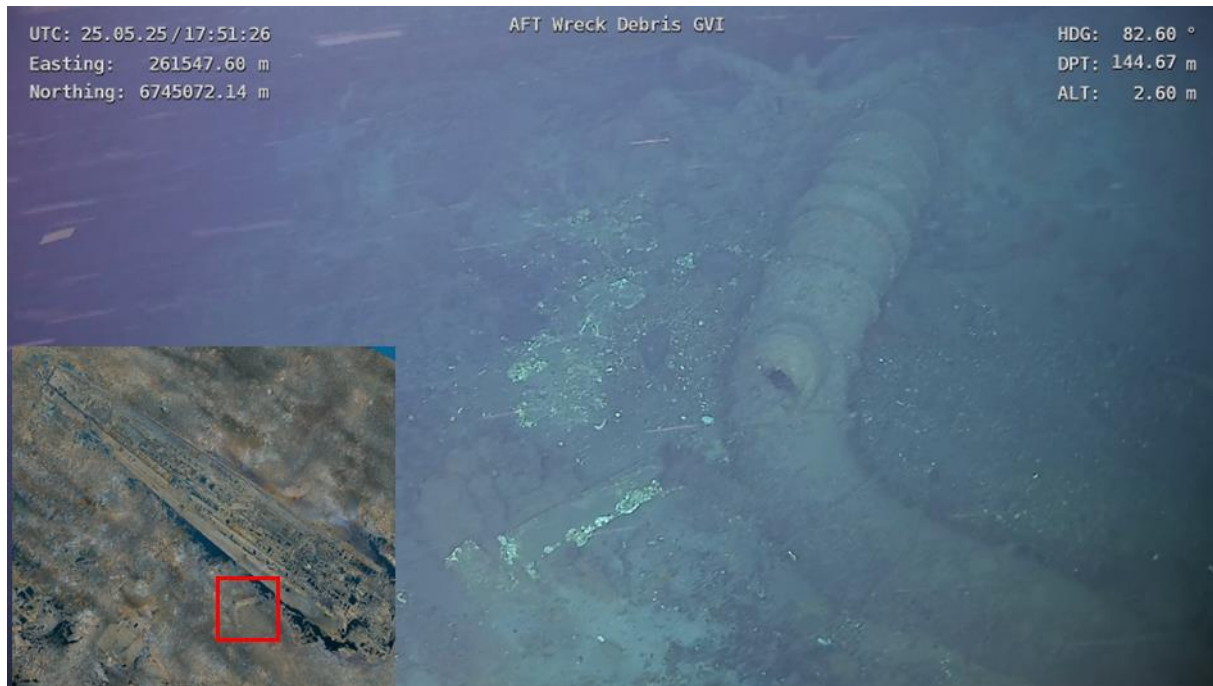
Figure 3-18 HD video example from the stern section showing debris

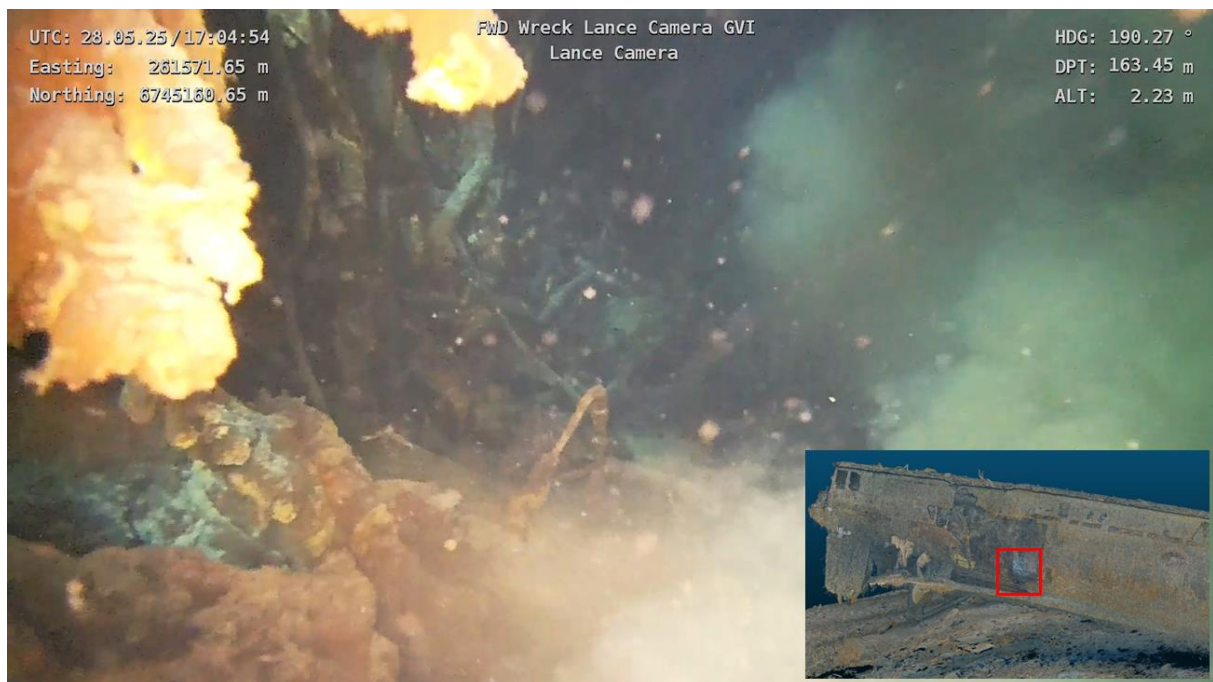
For the lance camera survey, the overall quality of the video was good; however, insufficient lighting and suspended material limited the visibility within the wreck. Examples of poor visual conditions are presented in Figure 3-19 and Figure 3-20. Figure 3-21 and Figure 3-22 show examples from both the ROV and the lance camera, displaying high video quality before entering the wreck.

Figure 3-19 Lance camera example showing suspended material obstructing the view

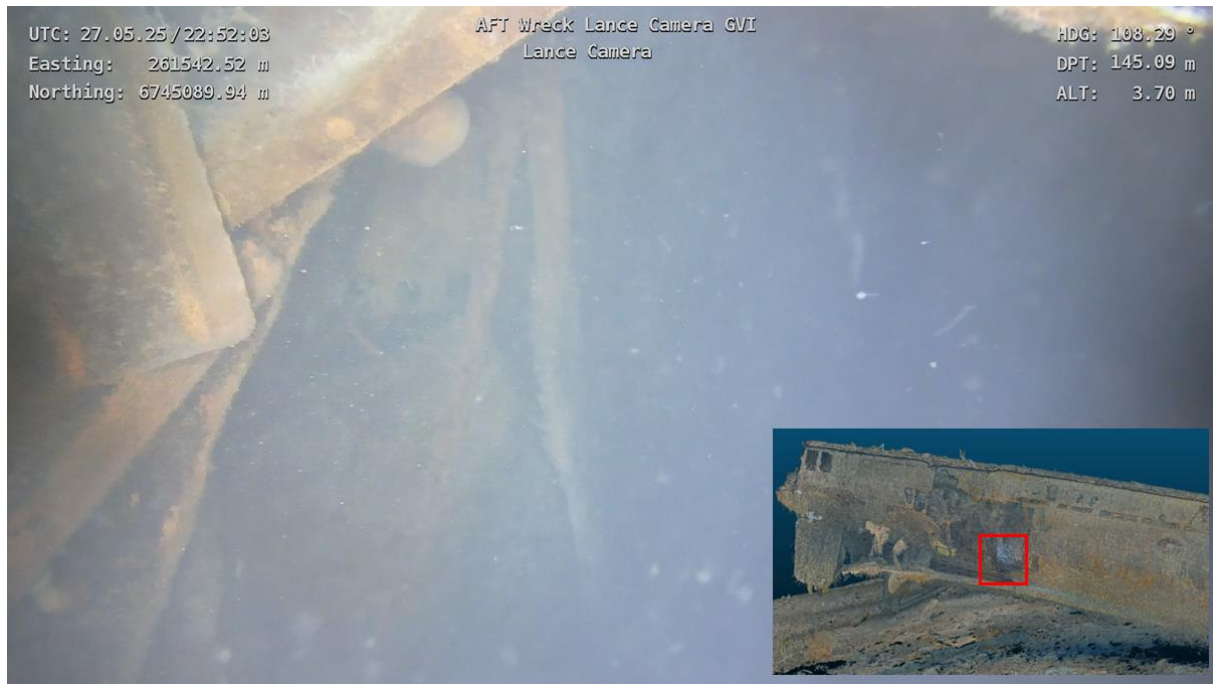
Figure 3-20 Lance camera example inside the wreck. Low visibility due to poor lighting

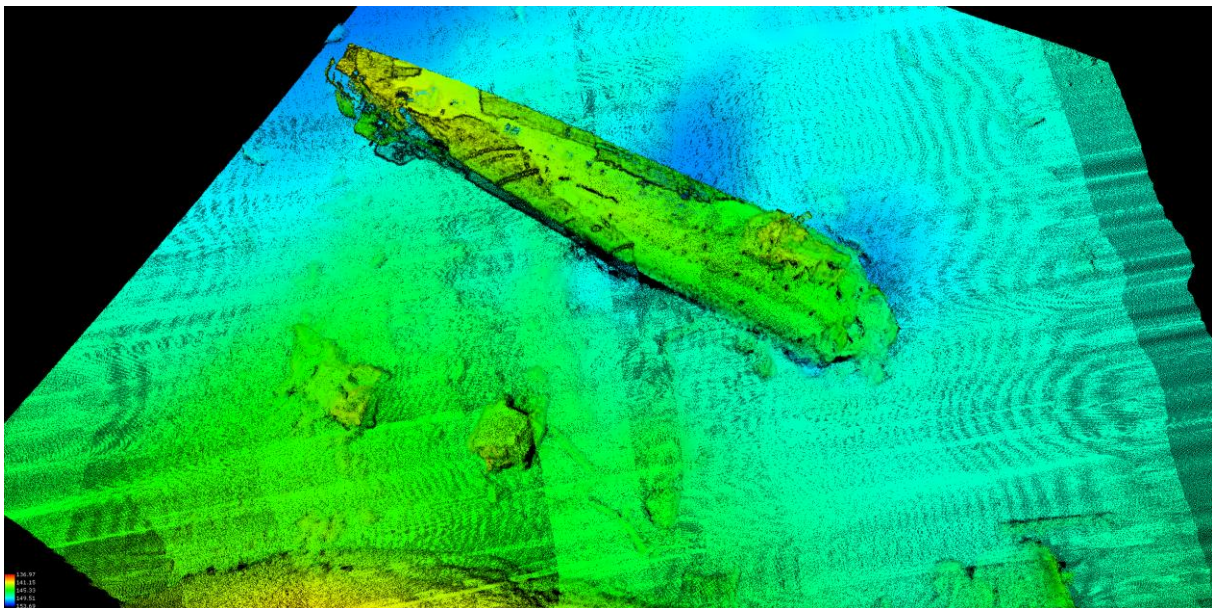
Figure 4-6 Point cloud data example showing the stern section of U-864

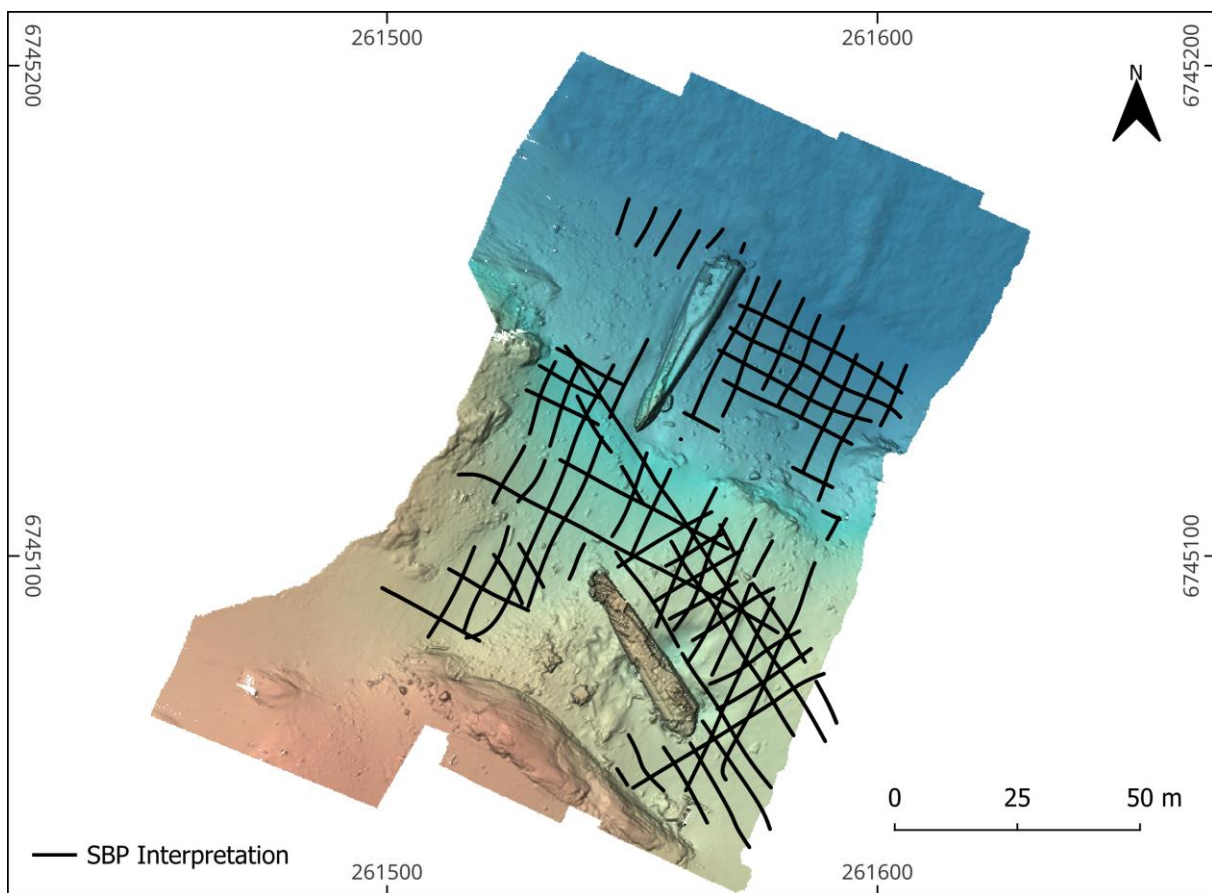
The signal penetration was generally limited across the survey area. A few irregular and weak reflectors were visible, but no continuous reflectors were observed. Consequently, identification of clear sedimentary units was not possible, and only the top of bedrock partially interpreted (Figure 4-7). This interpretation was based on several data sources and could not have been completed by sub-bottom profiler data alone. The digital terrain model (DTM) derived from multibeam data shows multiple exposed outcrops, while cone penetration test (CPT) data, collected by NGI in 2006, provide point measurements of sediment thickness (Figure 4-8). In some areas where no reflectors were visible, the CPT results were used to interpret the position of the top of the bedrock. The top of bedrock was primarily found in the area between the two wreck sections and on the eastern side of the bow section.

Figure 4-7 Overview of where the top of bedrock has been interpreted

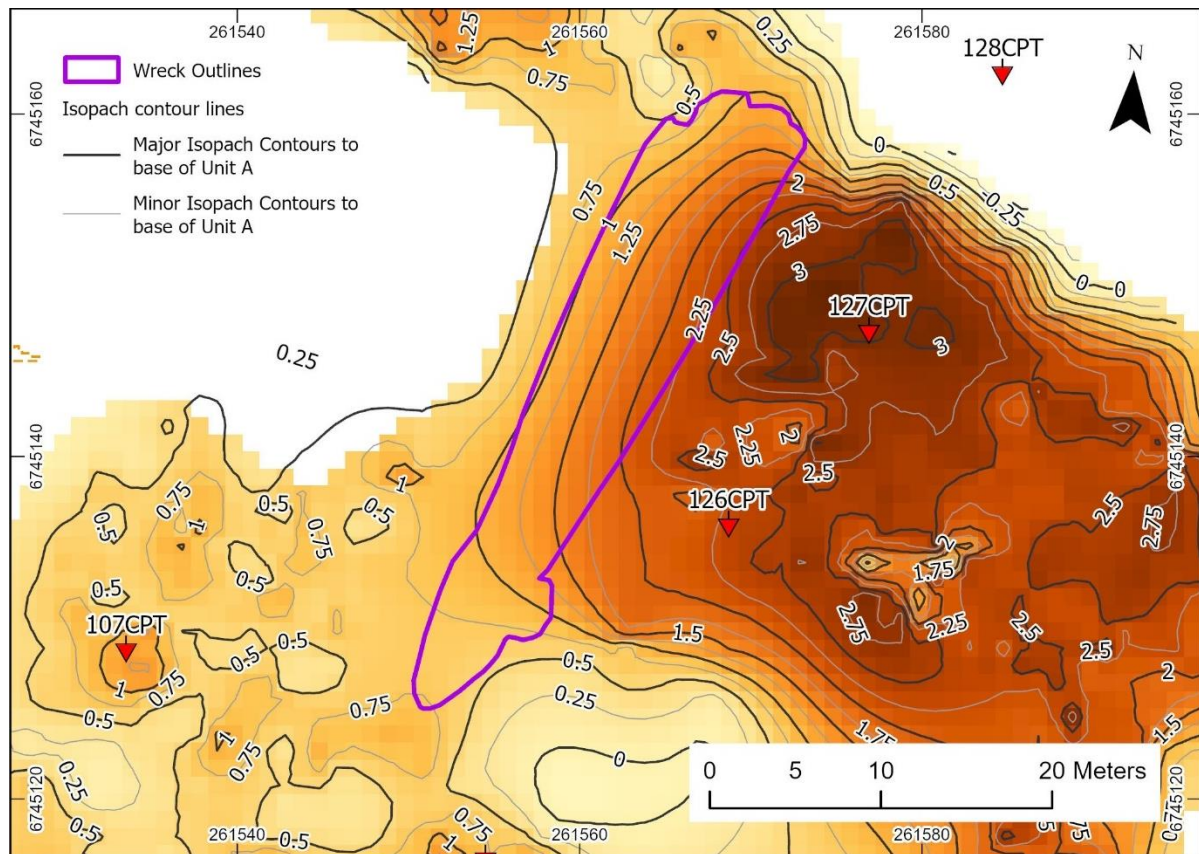
Figure 4-9 and Figure 4-10 display depth below surface for the bedrock horizon derived from the CPT and SBP data. Note that the generation of isopach relies on interpolation and due to the limited interpretation in the area, the map may not be 100% accurate.

Figure 4-9 Isopach showing bedrock depth below surface at the bow section

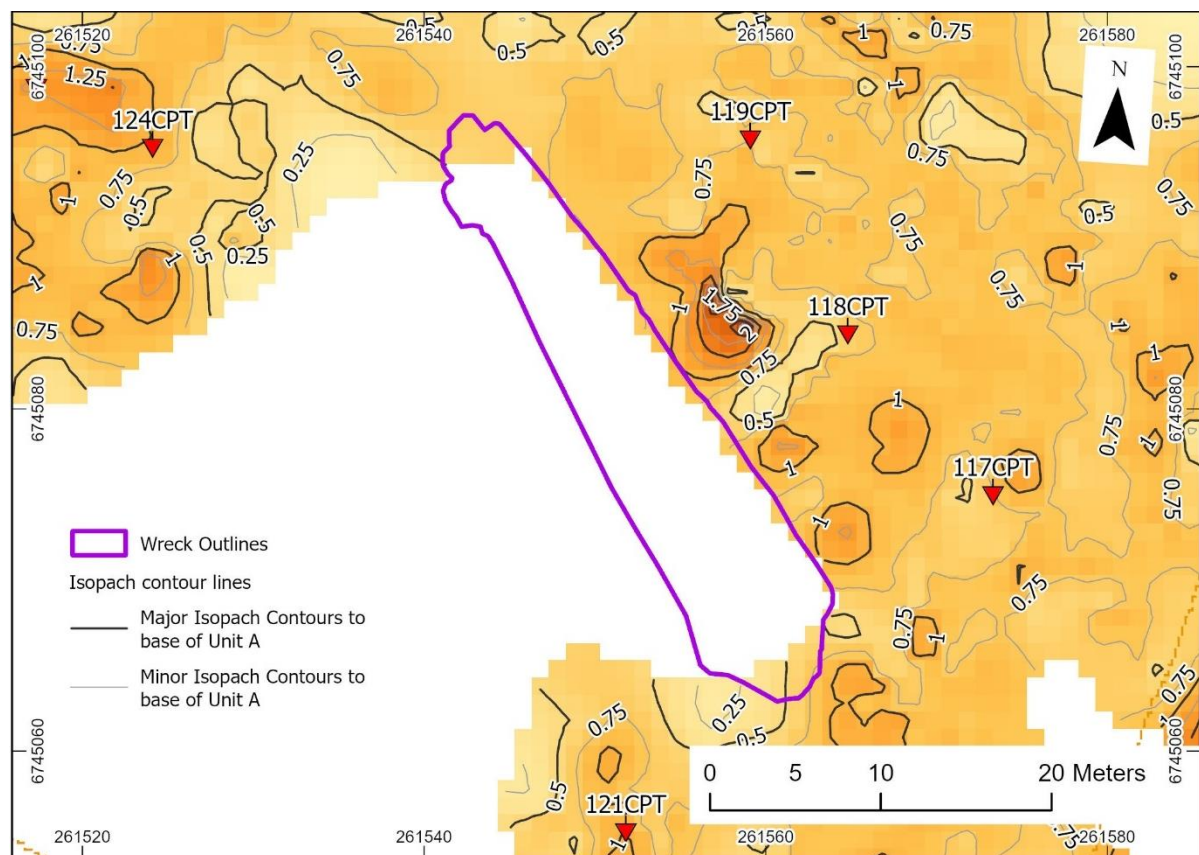
Figure 4-10 Isopach showing bedrock depth below surface at the stern section

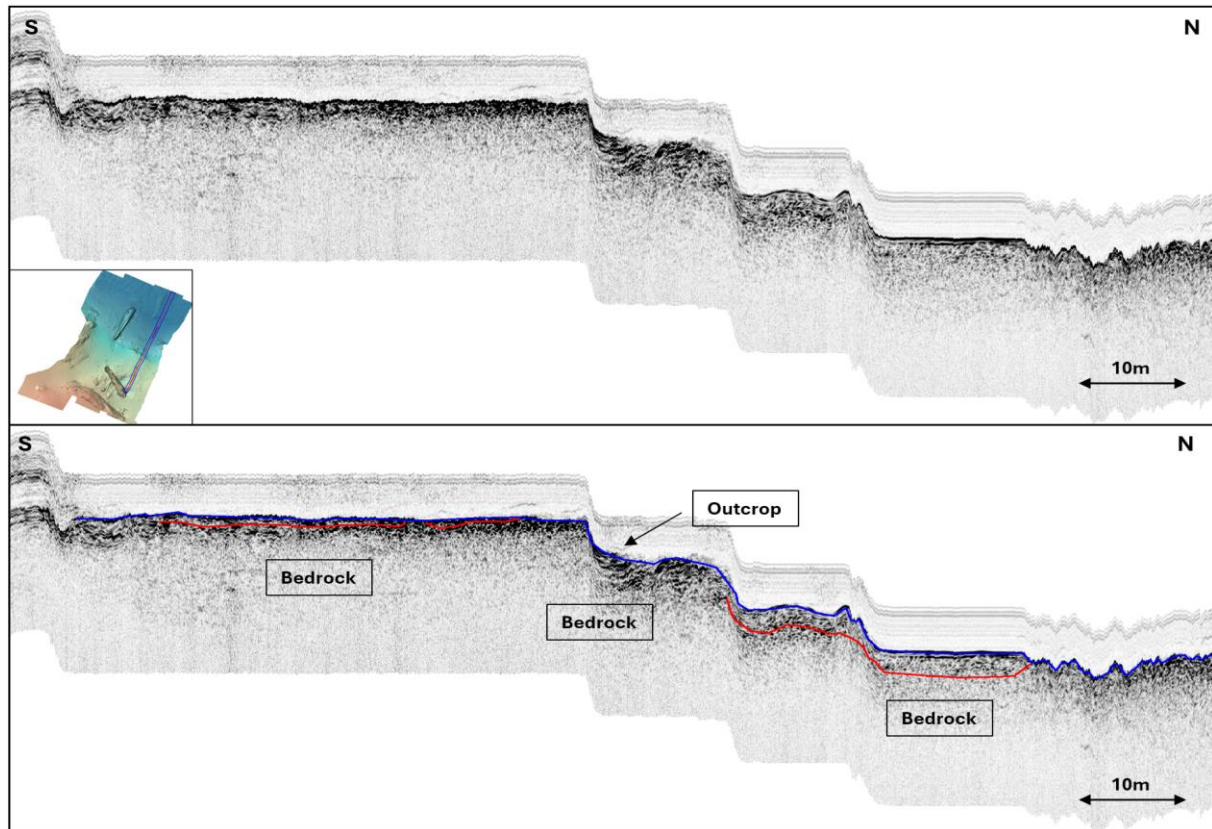
On the eastern side of the bow section, acoustically transparent sediments were visible below the seabed. A weak irregular reflector underneath has been interpreted to be top of the bedrock. Sediment thickness in this area varies from less than 3 m up to 5 m (Figure 4-11 and Figure 4-12). To the west of the bow section, no sediments or bedrock reflectors were identified, and no CPT data was available in that area. Noisy data, in some of the survey lines, complicated the interpretation and may have affected the results.

Figure 4-11 Sub-bottom profiler data example from Line SBP\_Geo\_Bow\_M\_055. The vertical drops in the seabed are motion-induced artifacts from ROV movements

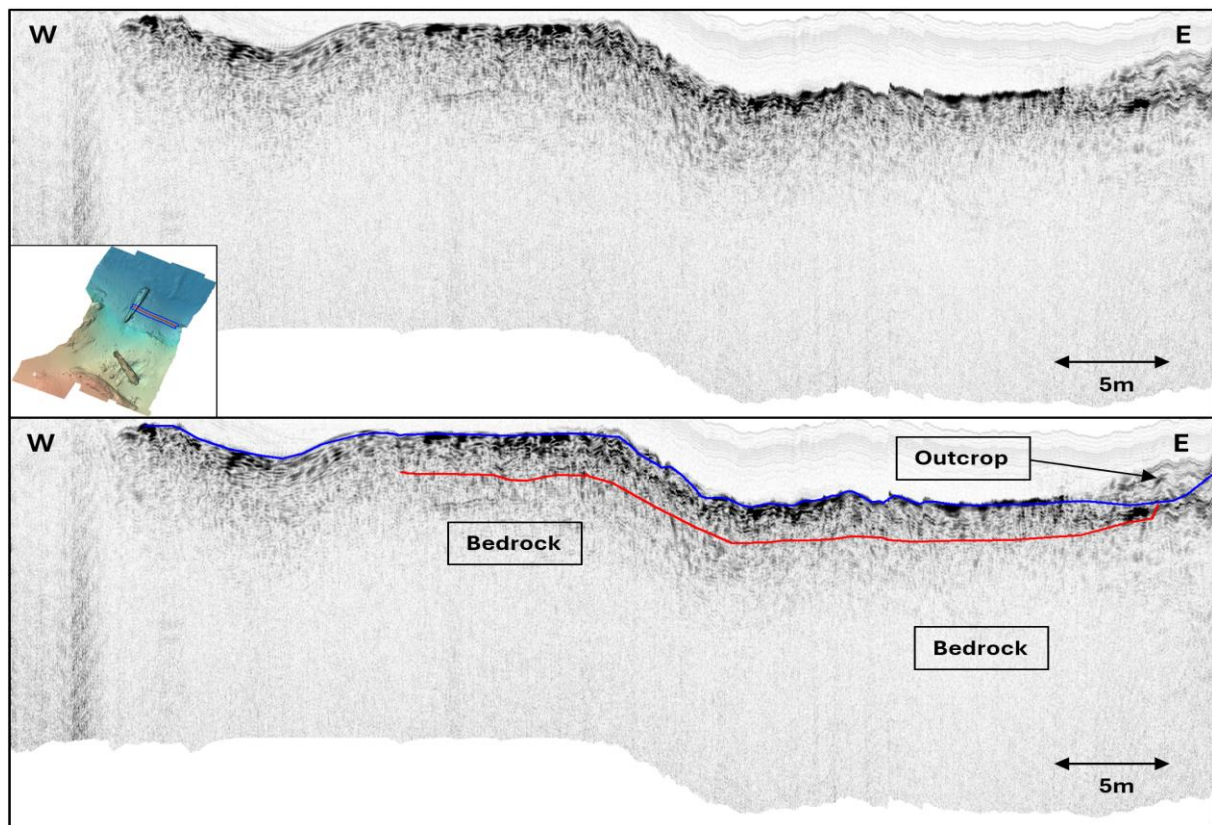
Figure 4-12 Sub-bottom profiler data example from Line SBP\_Geo\_Bow\_X\_045b

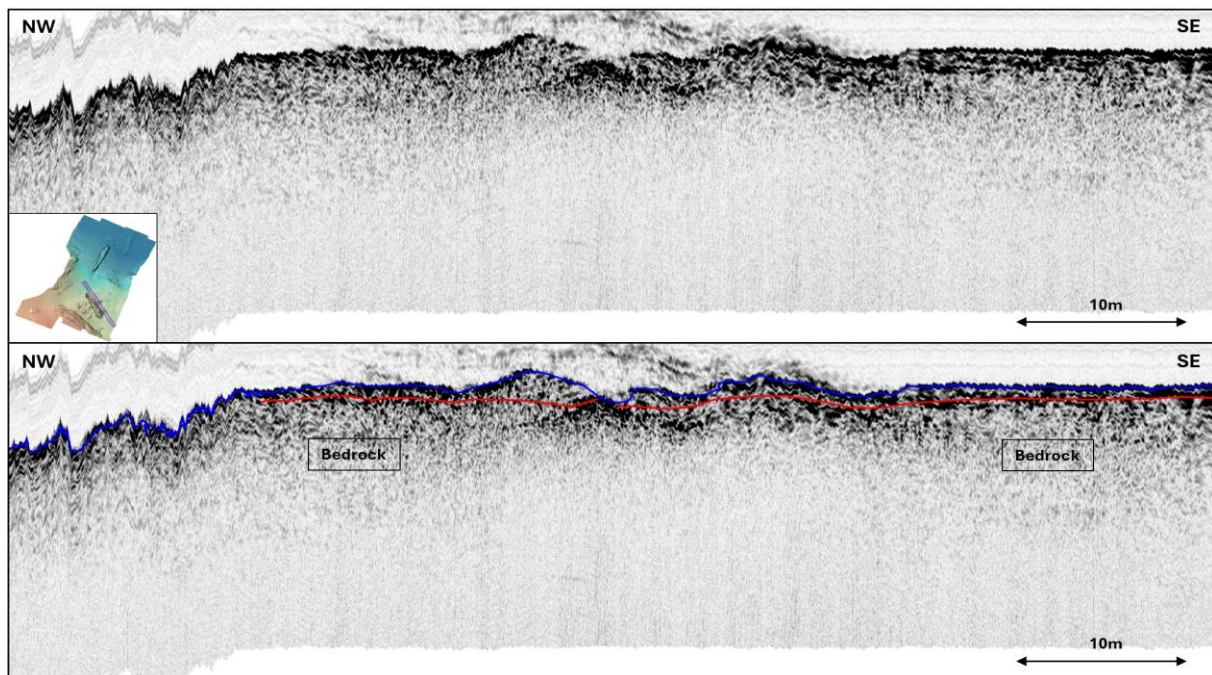
Several CPTs were taken in the area northeast of the stern wreck. Combined with irregular reflectors, the sediment thickness in this area was estimated between 1 m and 2 m (Figure 4-13 and Figure 4-14). A prominent bedrock slope is located 15 m southwest of the stern wreck. Acoustic interference from the wreck and debris between the outcrop and the wreck prevented any interpretation in this area.

Figure 4-13 Sub-bottom profiler data example from Line SBP\_Geo\_Stern\_M\_021

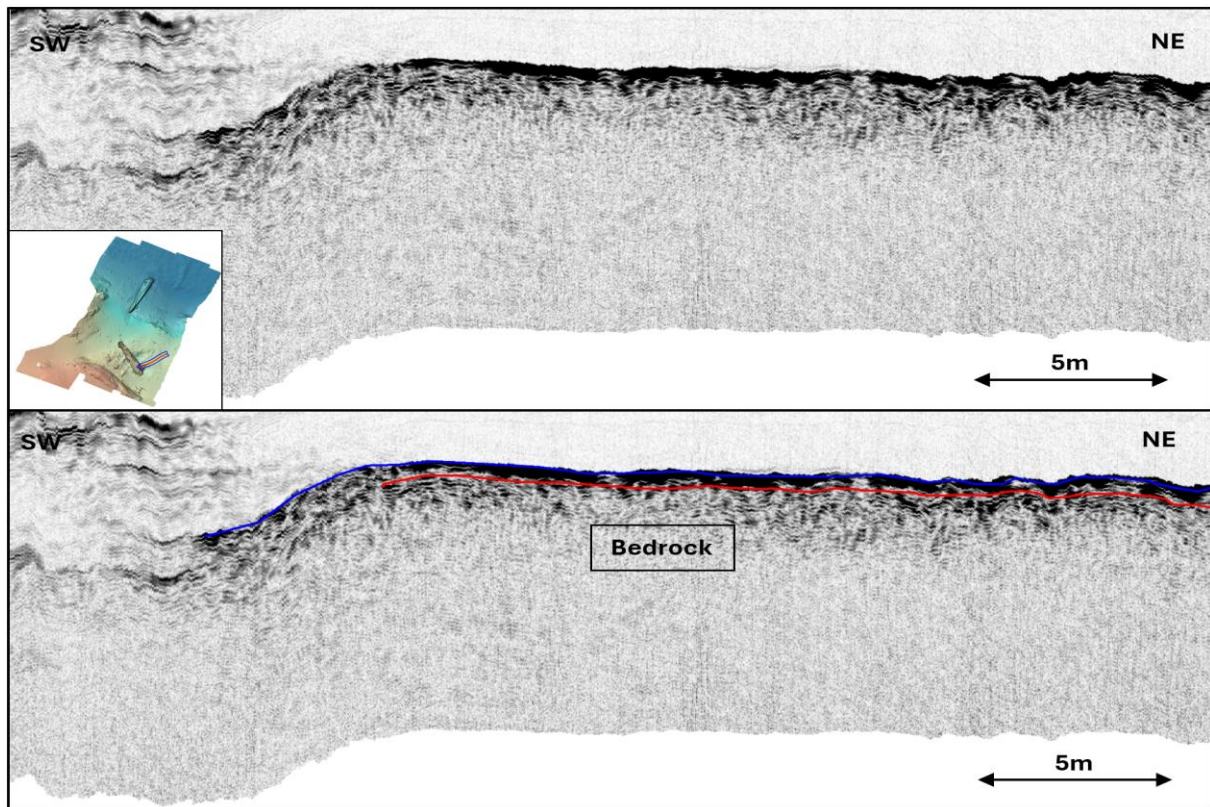
Figure 4-14 Sub-bottom profiler data example from Line SBP\_Geo\_Stern\_X\_040b

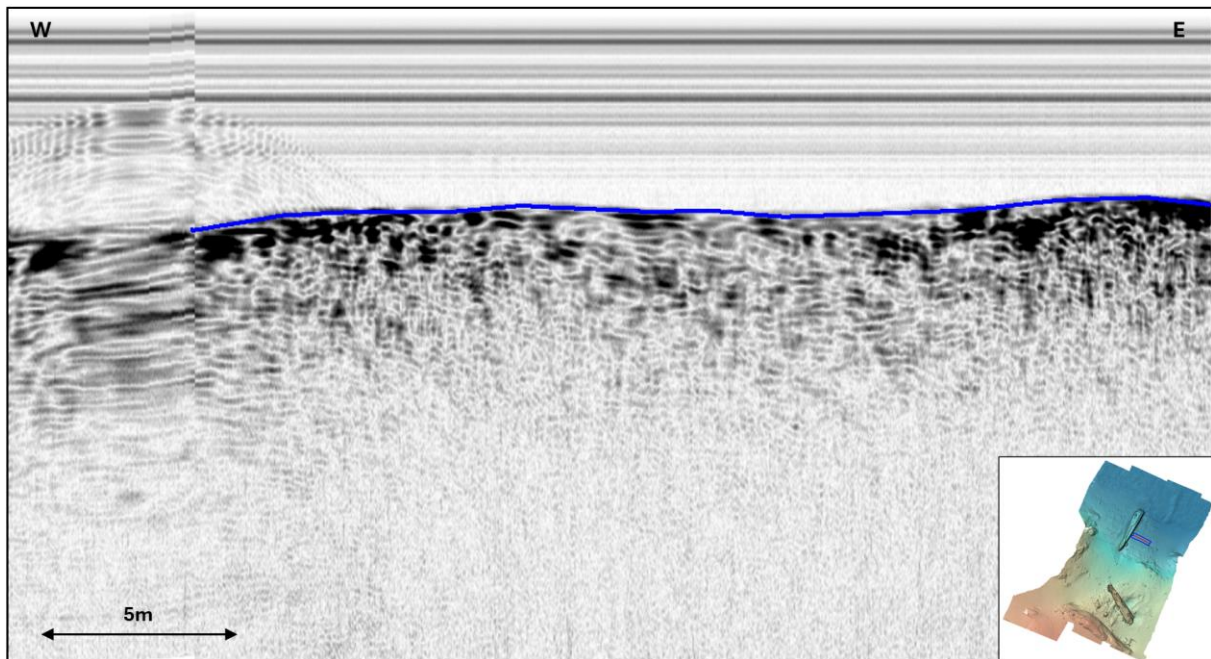
A tilted sub-bottom profiler survey was conducted to estimate the burial depth of the keel and the distance to bedrock directly under the wreck pieces. The tilted transducer increased the already wide opening angle, resulting in increased interference from surrounding objects. This was particularly noticeable close to the wreck, where interference from the hull distorted the data. The data acquired during the tilted SBP survey did not provide any results that could be further used to interpret the seabed nor the position of the keel. Figure 4-15 and Figure 4-16 display examples from the tilted SBP survey. Note how the images become more distorted on the western and northeastern sides due to the wreck.

Figure 4-15 Sub-bottom profiler data example from Line SBP\_Tilt\_Bow\_P\_04 Note the hyperbolic shape on the western side, masking the seabed below

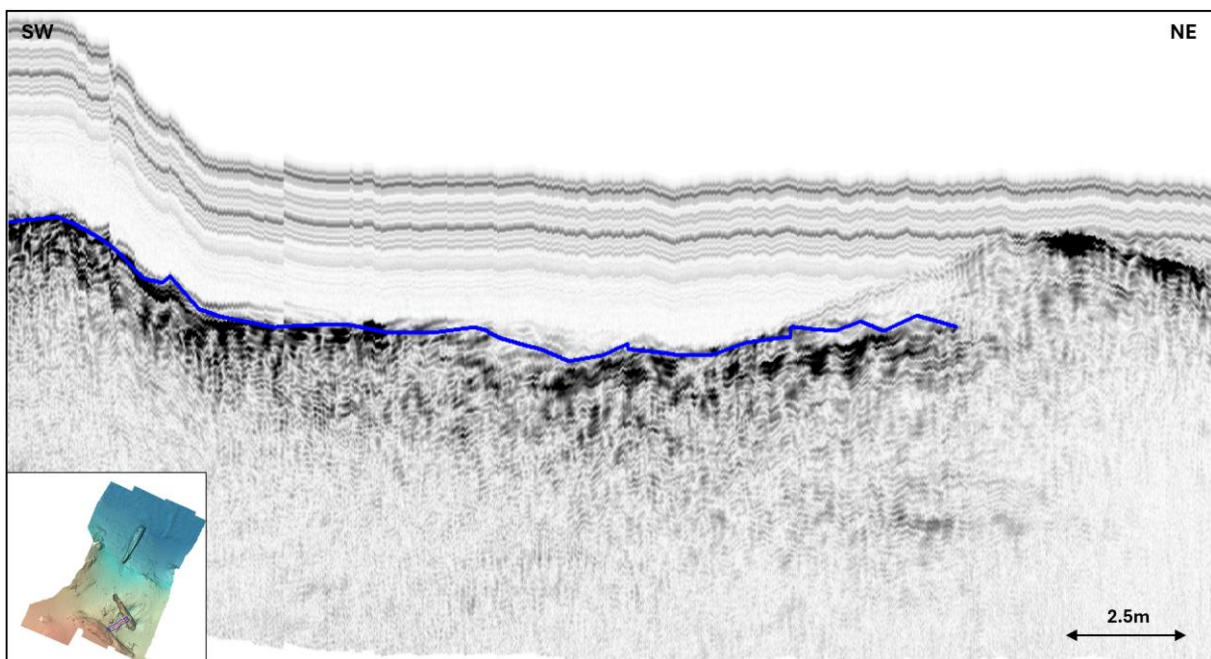
Figure 4-16 Sub-bottom profiler data example from Line SBP\_Tilt\_Stern\_P\_06

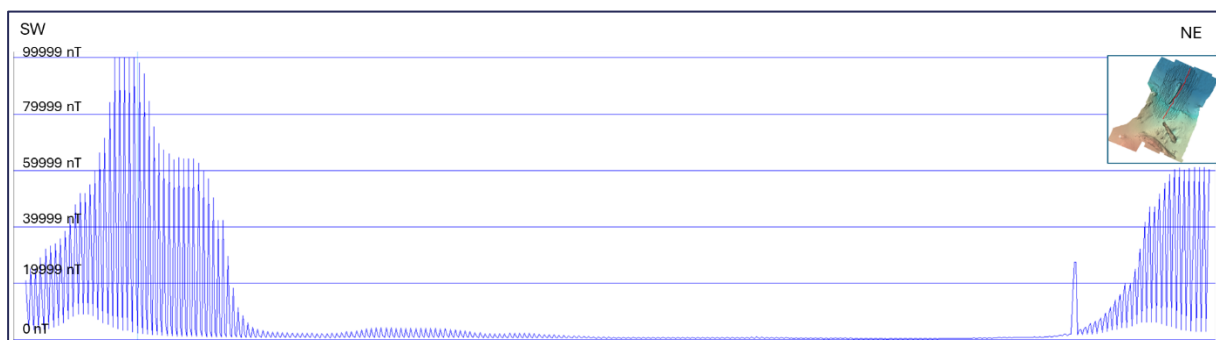
Another challenge during the TSS 440 survey was the high magnetic interference from the wreck itself and its masking effects on the survey lines closest to the wreck. The magnetic signature from the wreck primarily impacted survey lines closest to the wreck (within 3 m) before being reduced further away. Readings up to 99999 nT were recorded during the survey, caused by the outer hull of the wreck. Examples from line TSS 440\_EM\_Bow\_030 (Figure 4-17) and line TSS 440\_EM\_Stern\_014 (Figure 4-18), display profile view of the magnetic field where the signal is responding to the wreck itself. It should be noted that the maximum recorded magnetic field may represent the upper limit of the system and not the actual reading from the hull.

Figure 4-17 TSS 440 data example from line TSS 440\_EM\_Bow\_030\_20250226\_0220 highlighting the maximum value recorded

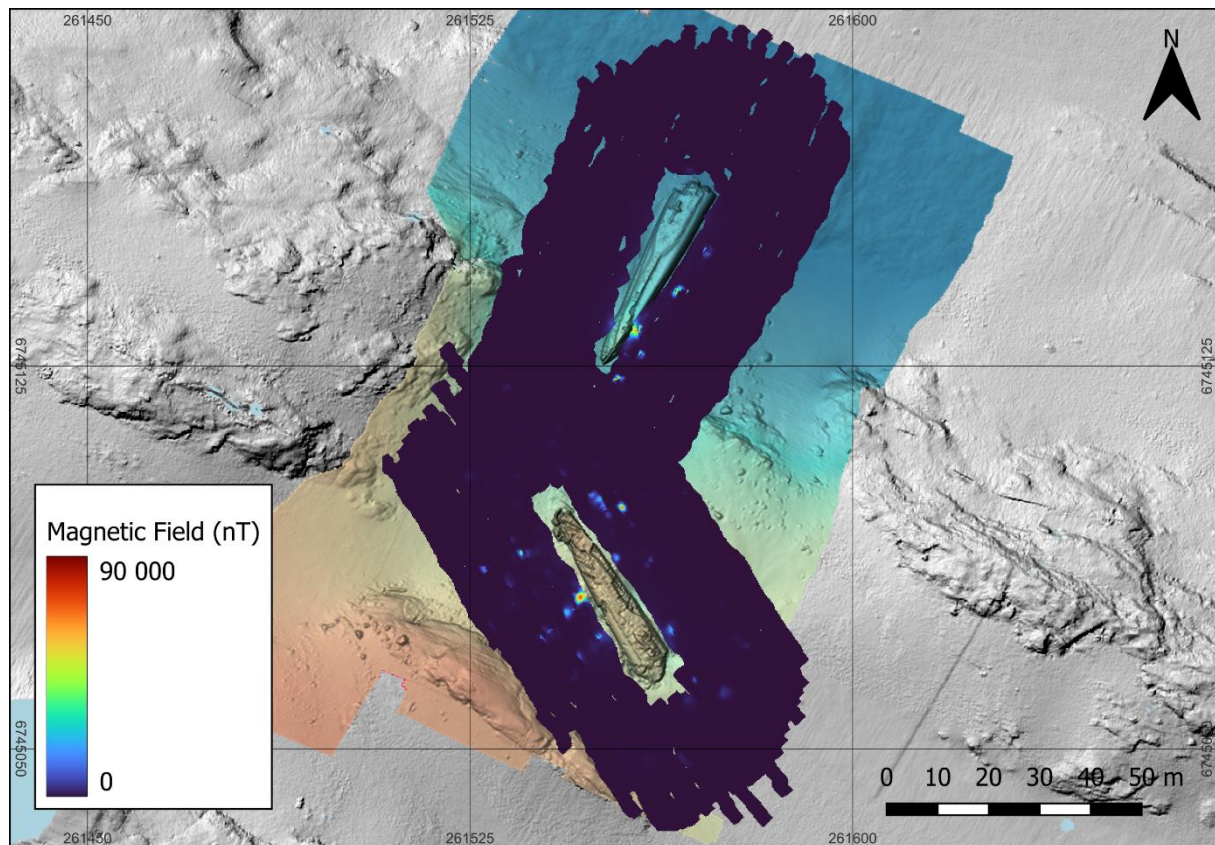
Figure 4-19 displays the magnetic field grid with approximate maximum and minimum values. Within this range, only a few anomalies are seen, and all can be correlated to large pieces of debris on the surface. In order to get a more realistic representation from the magnetic field grid, the data was limited to only include results between -40 nT and 2500 nT (Figure 4-20).

Figure 4-19 TSS 440 magnetic field grid showing approximate max and min values

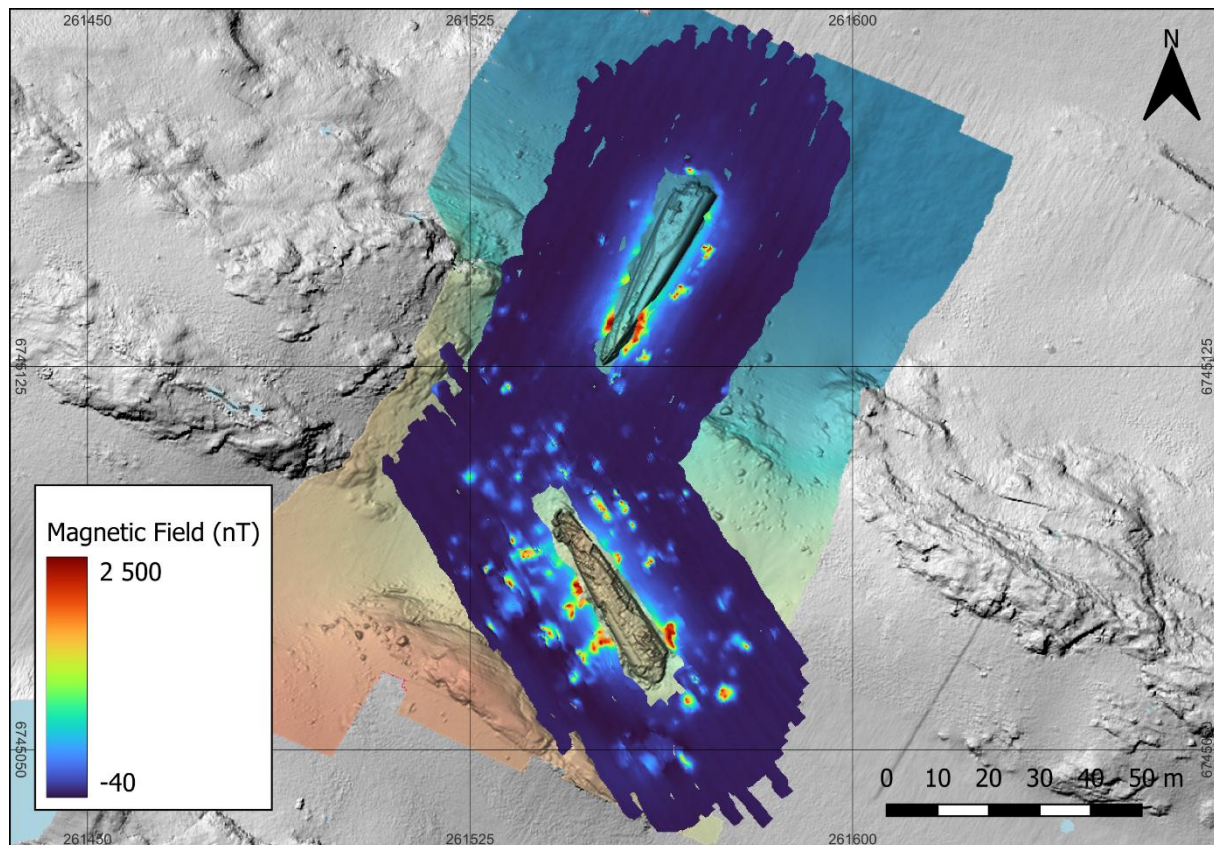
Figure 4-20 TSS 440 data clipped to only incorporate magnetic field signal between -40 nT and 2500 nT

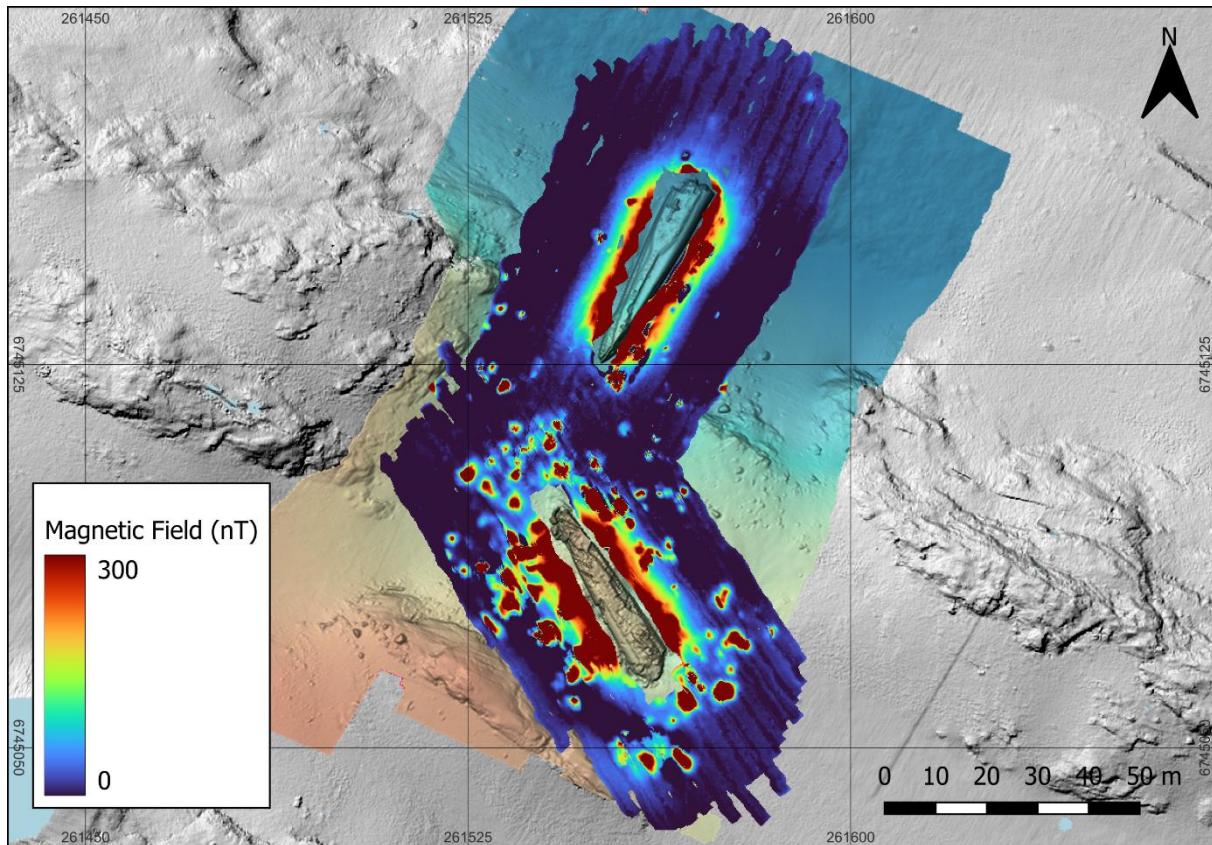
However, even with the reduced signal range, magnetic masking caused by the larger pieces of debris and the hull of the wreck, still affected the data. Figure 4-21 shows an example where the range of the magnetic field interval is set between 0 nT and 300 nT. More anomalies are enhanced, however, the magnetic field surrounding the wreck masks any potential targets up to 4 m away from the hull.

Figure 4-21 TSS 440 heatmap with reduced magnetic range showing large masking area from the bow wreck
