## Kystverket - U-864 Wreck Investigation 2025 Campaign 1

28 August 2025

Issued for Review

Revision 2

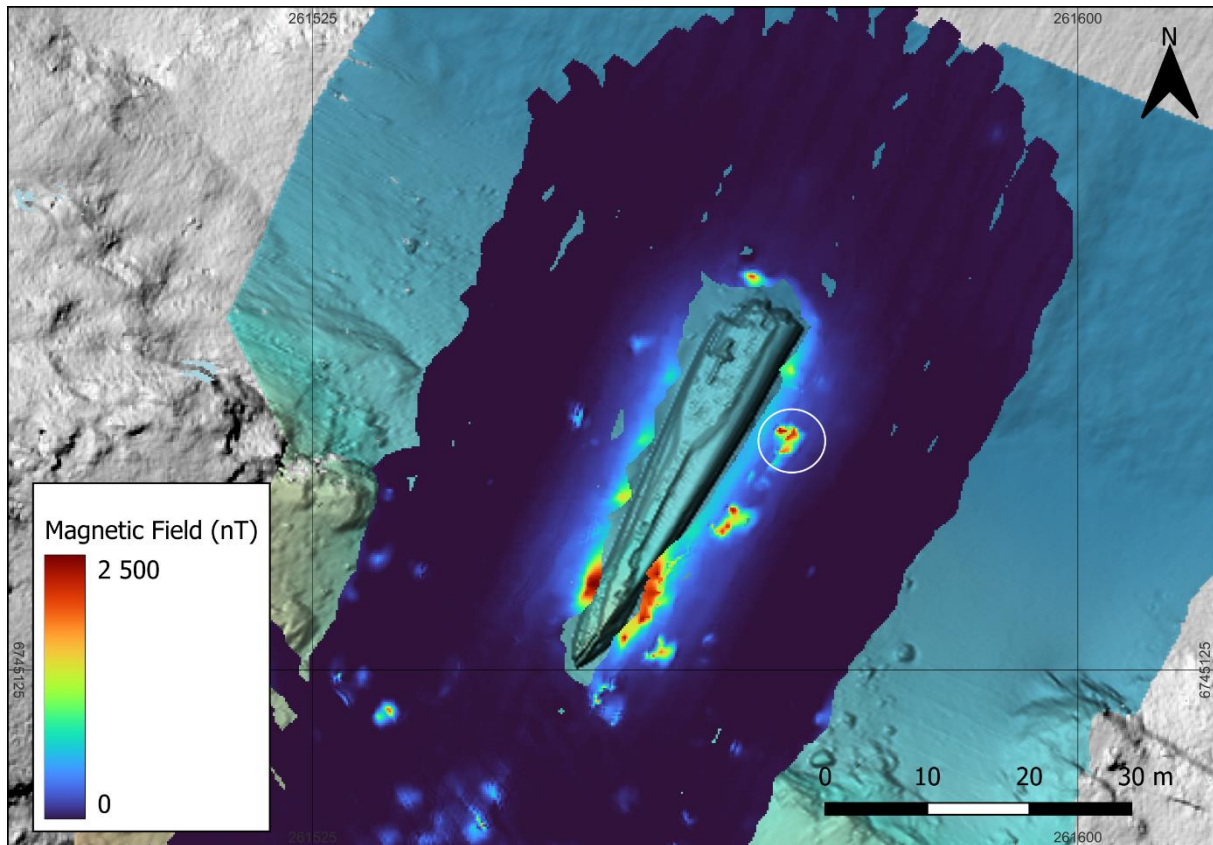
Due to the high frequency of debris and the large magnetic range detected by the TSS, the resulting data could not identify any new targets with certainty. Almost all the anomalies detected by the TSS 440 could be correlated to previously identified targets and new anomalies could be identified as surface debris. Figure 4-22 displays an example where a magnetic anomaly was observed away from any previously identified targets. The magnetic signal was within the range of a mercury canister, however, the video confirmed that the target did not match the expected shape of a mercury canister (Figure 4-23).

Figure 4-22 Possible new magnetic anomaly

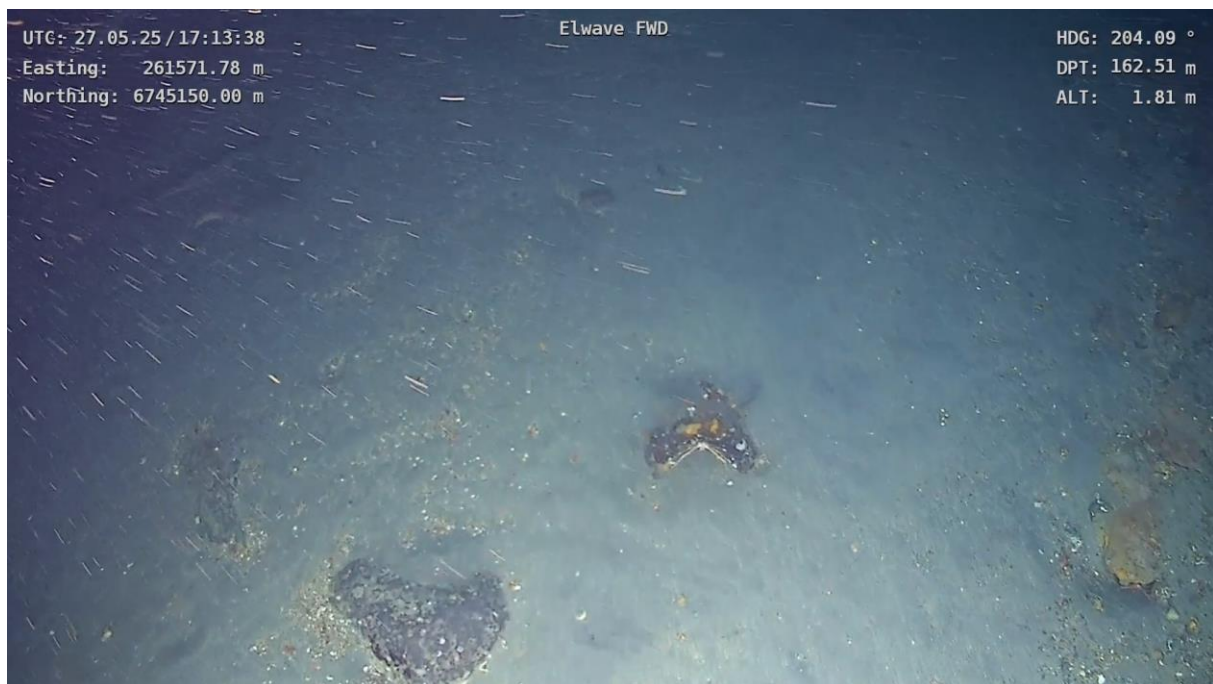
Figure 4-23 Video image of the magnetic anomaly. It is most likely some debris

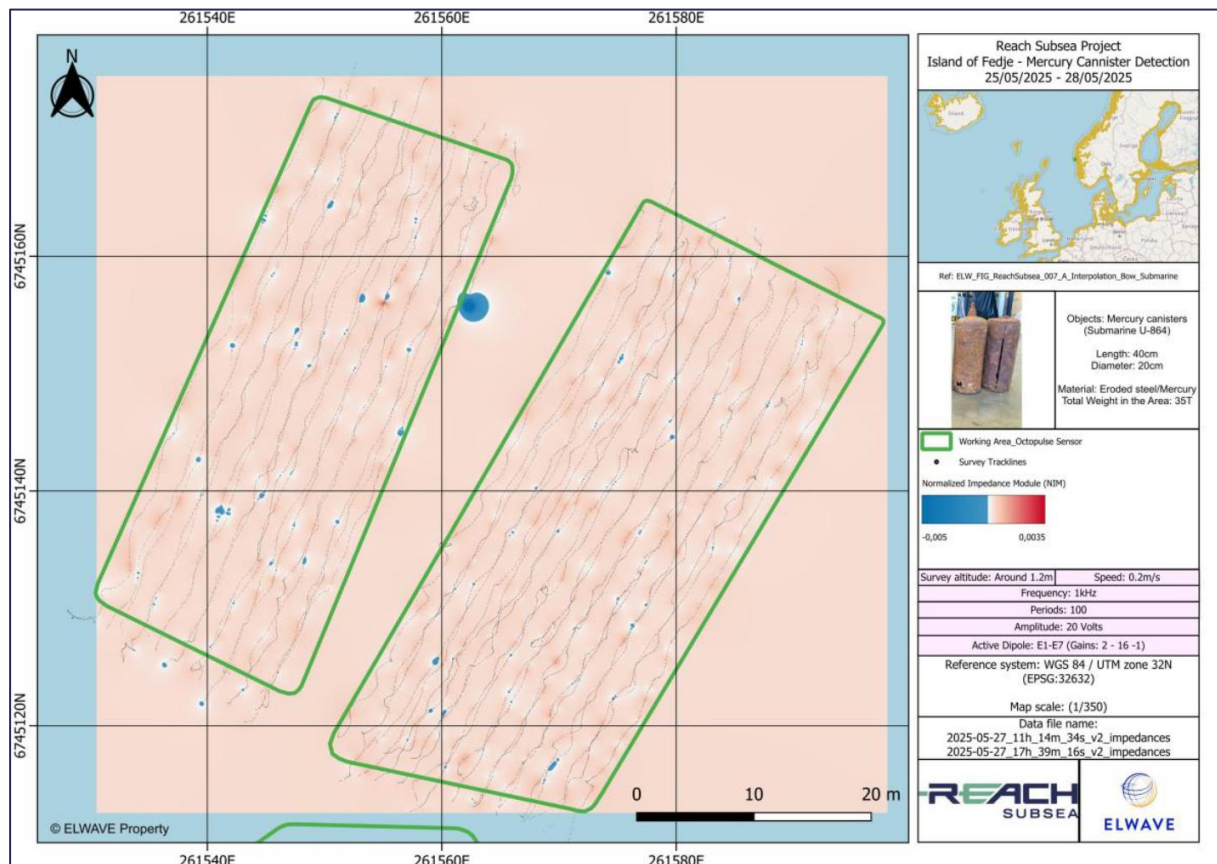
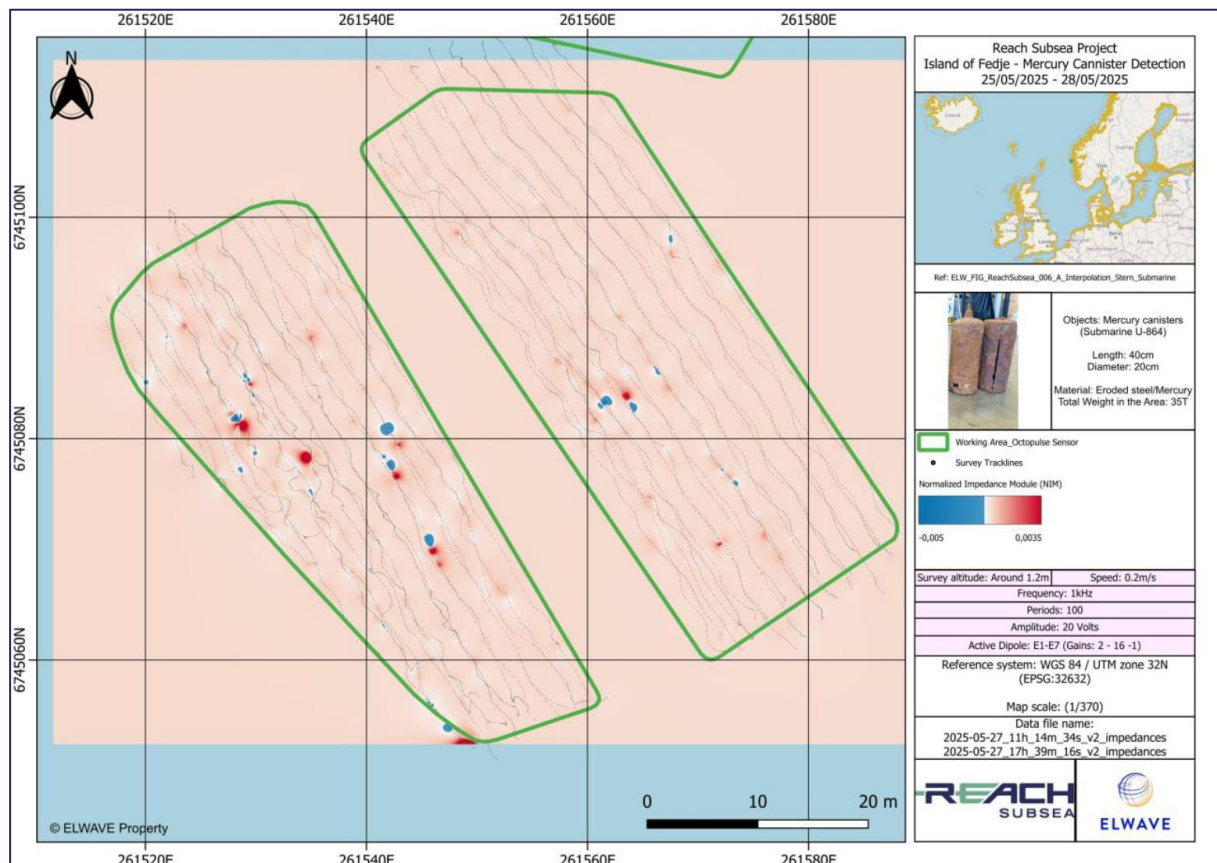
Based on the derived detection levels and the calculated impedance grids (Figure 4-24 and Figure 4-25), a total of 149 electrical anomalies were revealed (Figure 4-26). 103 of the targets were also classified as conductive anomalies. 15 of these fall within A01 or A02, indicating that they have a similar signature as a mercury canister.

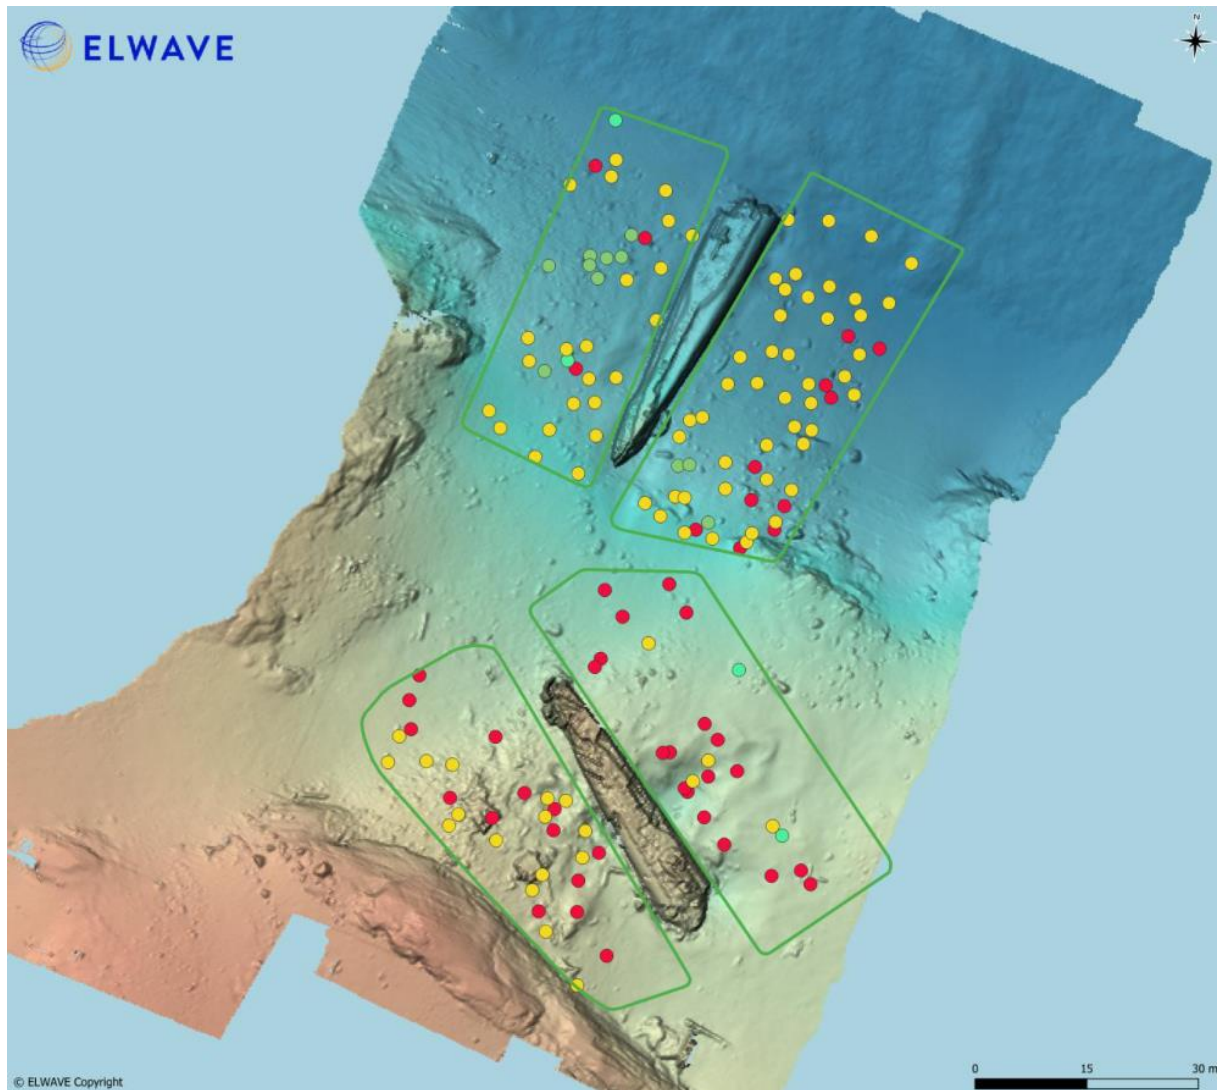
For the stern section, the targets found by the Octopulse system match relatively well with the results from the TSS 440 survey. The results are consistent with the significant number of debris that is found around the wreck. However, potential targets are more likely a result of a piece of metal debris rather than a canister.

For the bow section, there is a bigger deviation from the TSS 400 survey. The Octopulse system was able to detect multiple individual targets, whereas the TSS could only differentiate a few from the magnetic signal of the wreck. It should be noted that most of the targets identified around the bow section of the wreck fell within the A03 category. Additionally, the area, particularly the starboard side, is characterized by large boulders, which may have impacted the performance of the Octopulse system.

Figure 4-26 All targets detected by the Octopulse system. Bright green represents A01, green represents A02, yellow represents A03, and red represents A04 (not conductive)

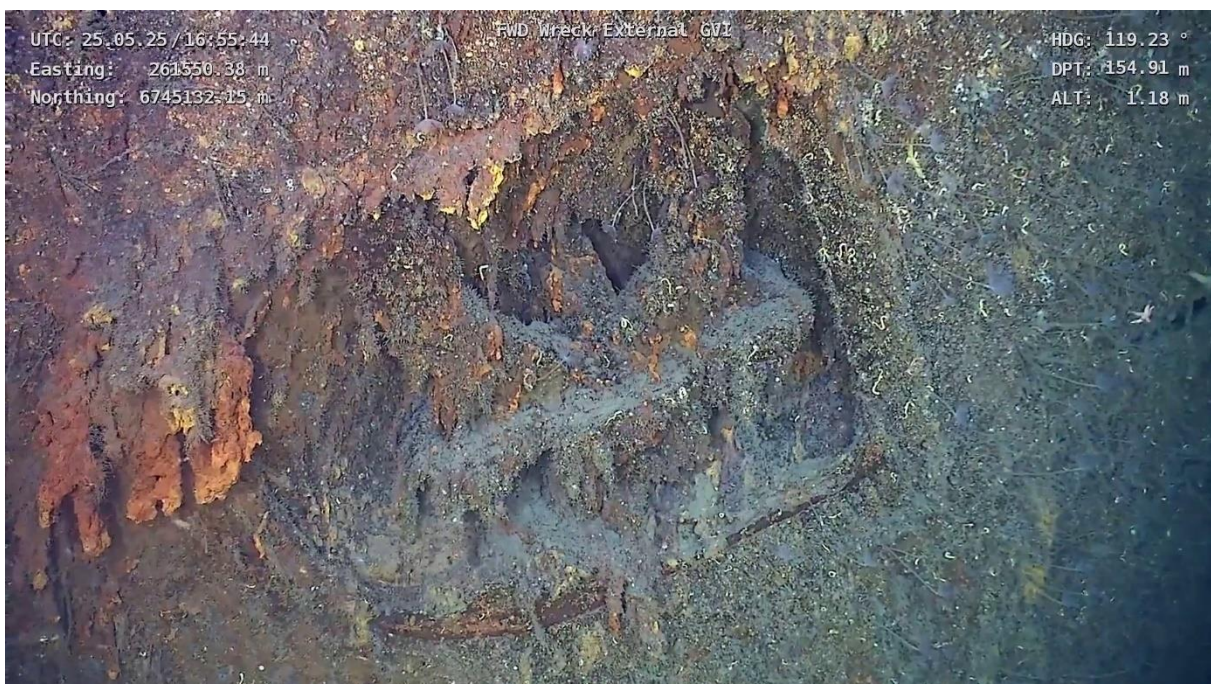
The visual inspection of the bow section revealed that the wreck has undergone significant corrosion. Several panels were missing from the hull on the port side, exposing compartments on the hull (Figure 4-29 and Figure 4-30). The starboard side was more or less intact with a few minor panels missing at the front of the wreck (Figure 4-31). The anchor can still be seen on the starboard front side (Figure 4-32).

Figure 4-32 Starboard side anchor still intact

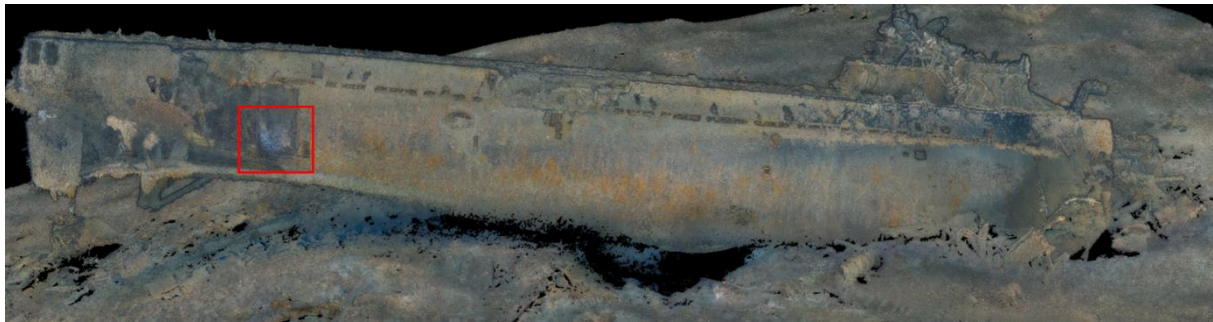
Similar to the bow section, the stern was found to be heavily corroded and multiple steel panels from the outer hull were missing (Figure 4-34 and Figure 4-35). The most notable area was found on the starboard side, close to the propellers, where a large piece of the hull had detached. The cut-out location to the stern torpedo bay is located within that area (Figure 4-36).

Figure 4-35 Starboard side view of the stern section. Note the small light-coloured area, within the red square, where the cut-out opening to the torpedo bay is located

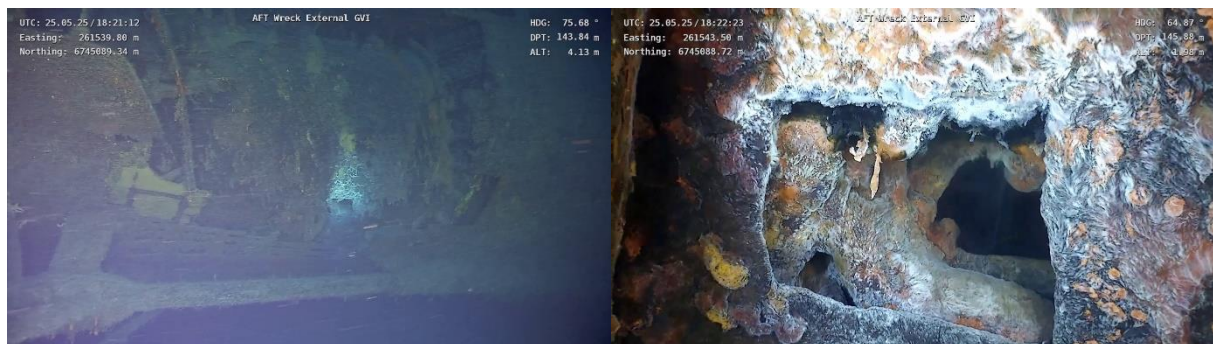
Figure 4-36 Location of the cut-out to the torpedo bay

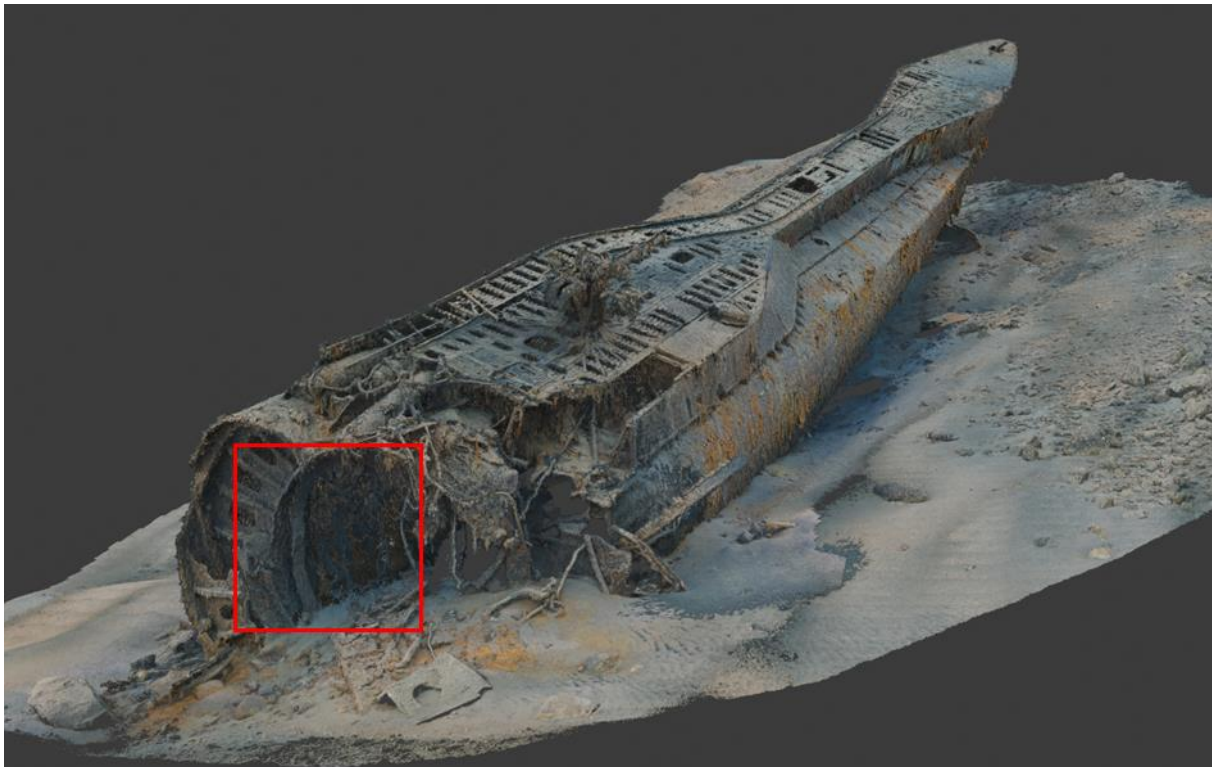
At the bow section, only the fracture point was selected for internal inspection, as no other points of interest were possible to investigate with the lance camera. The main purpose of the internal inspection of the fracture point was to determine if the hatch to the torpedo bay was open and potentially inspect any torpedoes remaining inside. Figure 4-58 displays the opening at the fracture point where the internal inspection took place.

Figure 4-58 Photogrammetry data example showing the bow fracture point. The red square shows where the internal inspection was conducted

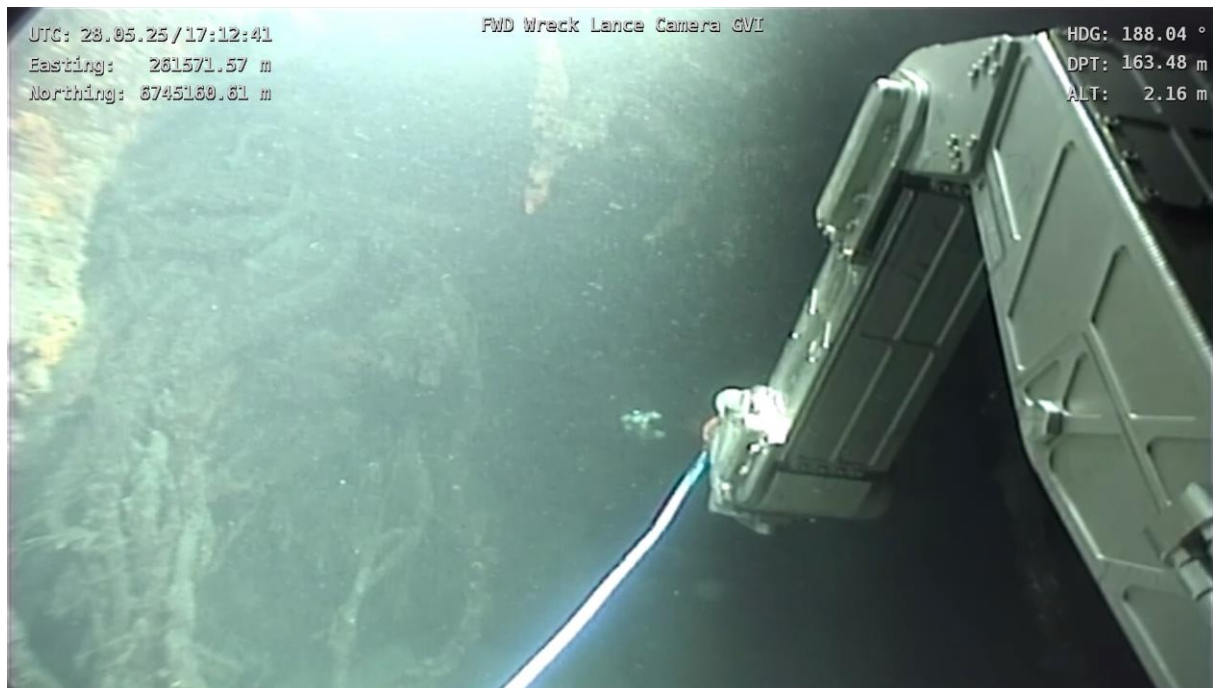
Internal access to perform the internal inspection was limited due to debris blocking the opening (Figure 4-59). This made it difficult for the ROV to get close enough to the opening to get a good view of the inside. The lance camera was extended 2 m into the fracture point from where the ROV stopped. Figure 4-60 shows how the lance camera is held by the ROV manipulator and then extended into the wreck.

Figure 4-60 Video image showing the lance camera extended into the bow fracture point

In order to get a better view of the insides of the fracture point a much smaller ROV would be required. However, debris blocking the path would make safe navigation difficult, with a high risk of damage or loss; therefore, it is not recommended.

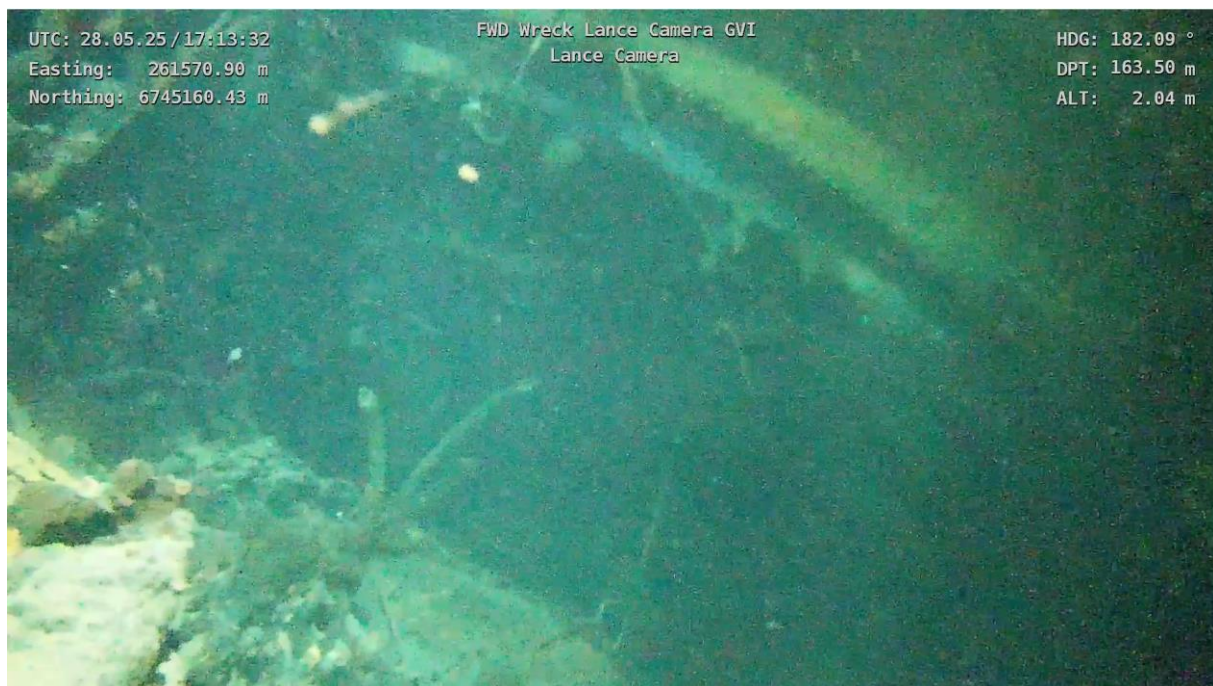
The inside of the wreck showed significant damage and was covered by sediments. The sediments reduced the ability to identify any key points (Figure 4-61). The lack of proper lighting, in combination with the internal damage, made it difficult to get a clear image from the lance camera (Figure 4-62). Consequently, the inspection could not confirm if the hatch to the torpedo bay was open, nor was it possible to investigate the potential for torpedoes inside.

Figure 4-62 Lance camera example showing the inside of the fracture point

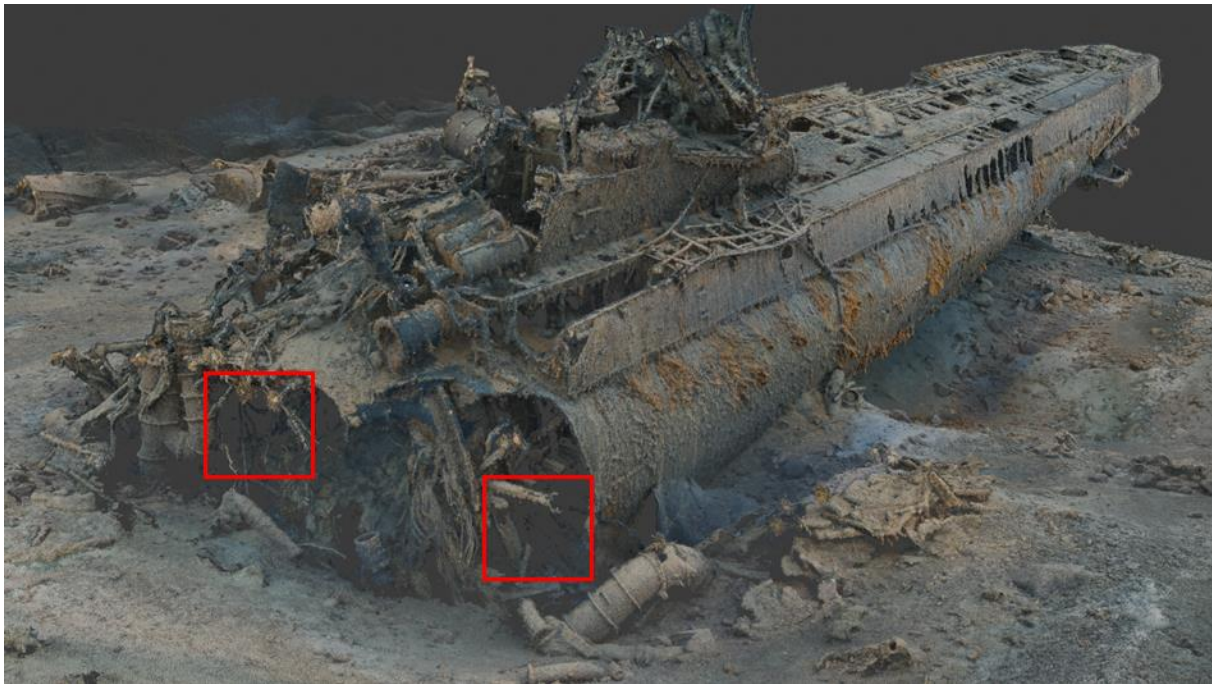
Similar to the bow section, the fracture point at the stern was difficult to access due to debris blocking the entrance. The angle of the wreck also made it difficult to access the fracture point, as it was tilted down into the seabed surface. Consequently, the ROV was positioned slightly above the fracture point with no visibility into the wreck (Figure 4-65). The inside of the wreck showed significant damage, with debris and cables exposed (Figure 4-66 and Figure 4-67).

Figure 4-63 Photogrammetry data example showing the stern fracture point. The red squares show where the internal inspection was conducted

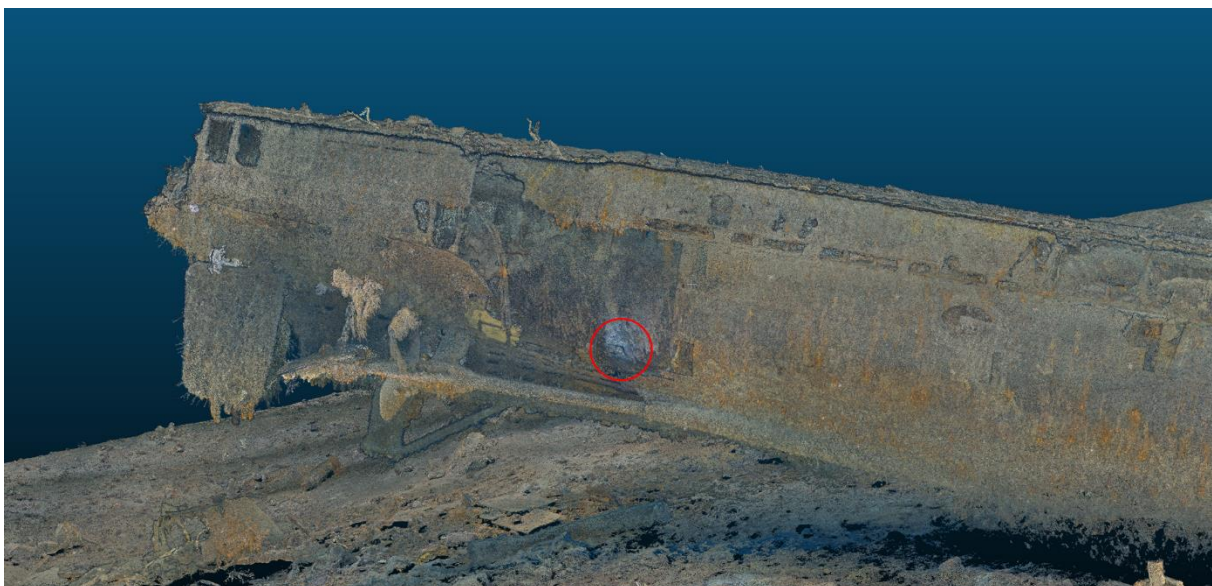
At the stern section, two locations were picked for the internal inspection. The two locations were the stern fracture point and the previously cut-out close to the stern torpedo bay. Figure 4-63 and Figure 4-64 display the locations where the lance camera was inserted into the wreck. The cut-out is located on the starboard side of the stern section.

Figure 4-64 Photogrammetry model showing the location of the cut-out where the lance was inserted

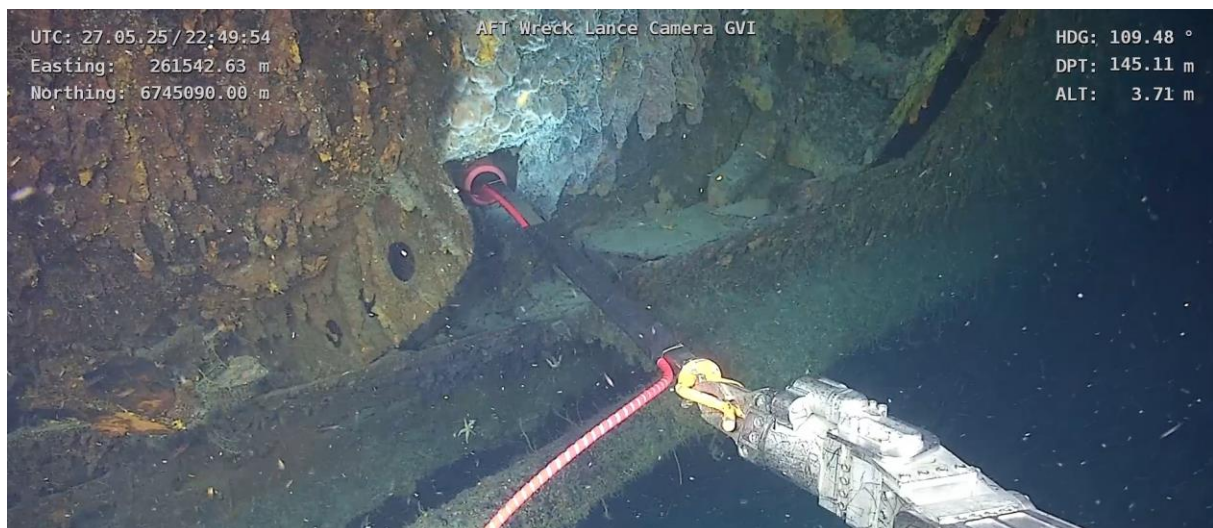
The second location was a small cut-out from a previous survey where the lance camera was inserted (Figure 4-68). The camera was inserted approximately 1 m into the torpedo bay; however, due to the extent of debris, it could not be advanced further, and no torpedoes were identified. The deterioration of the materials within the wreck made it very difficult to assess any significant details from the video. An example of this is displayed in Figure 4-69, where a damaged case seems to be containing an unidentified object or objects.

Figure 4-68 Video image example showing the lance camera inserted into the cut-out location

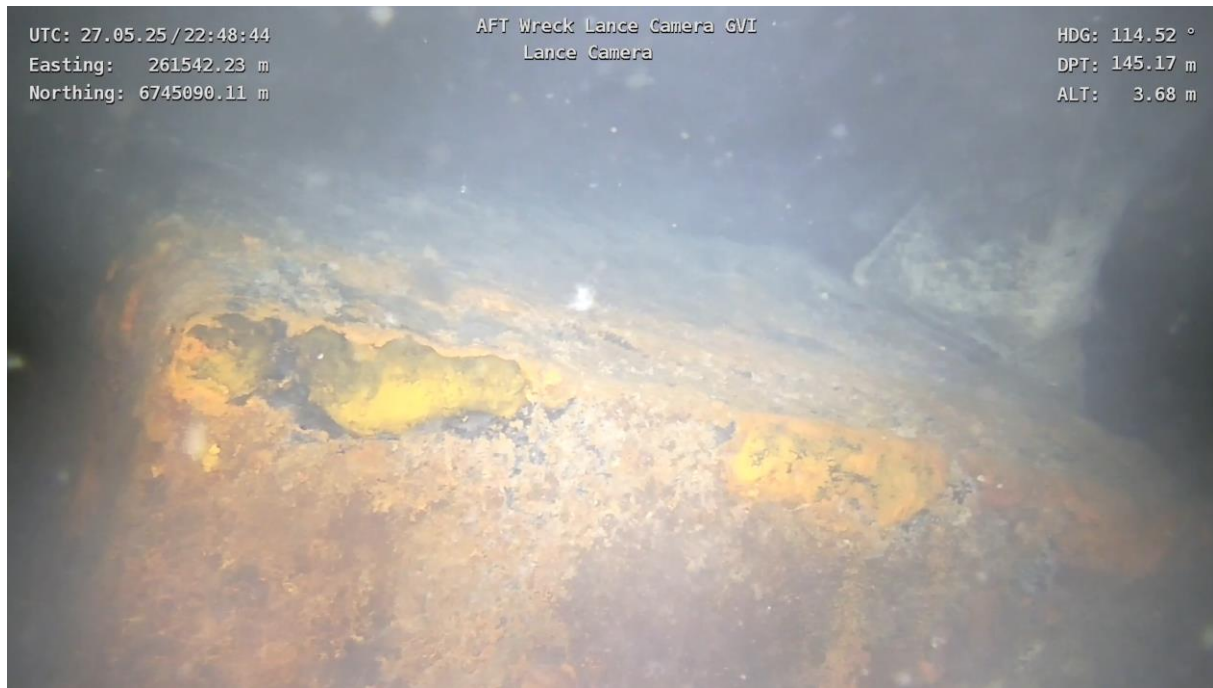
Figure 4-69 Lance camera example showing a possible container inside of the torpedo bay

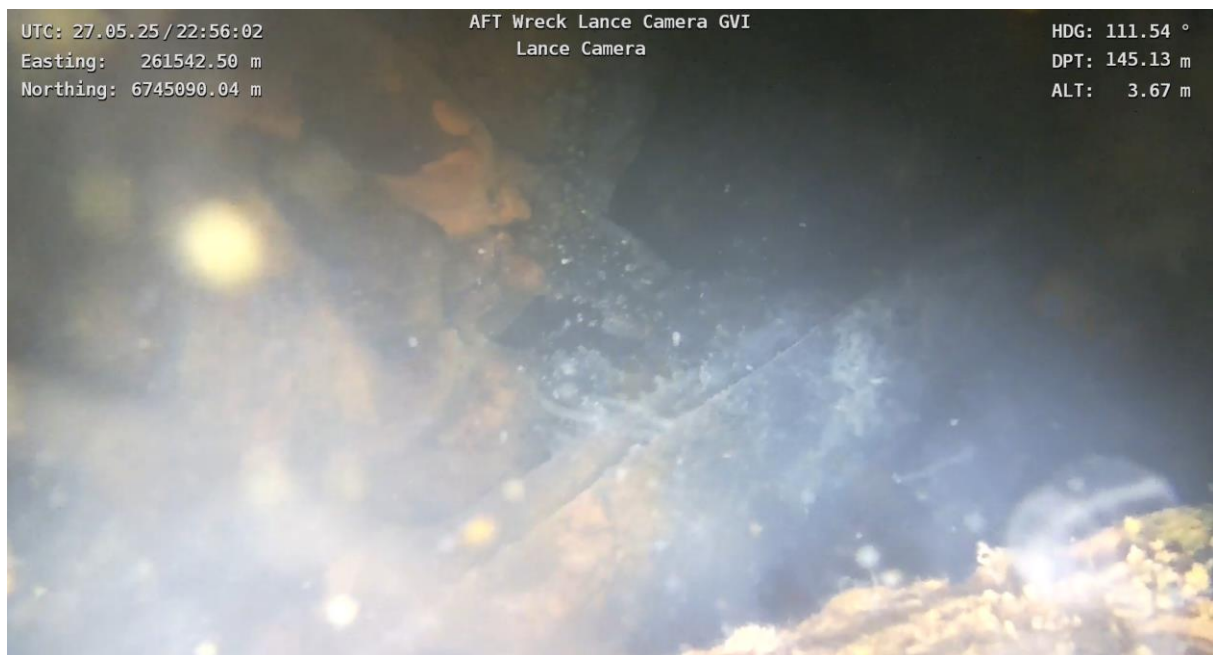
In addition, the lighting source for the lance camera was not powerful enough to illuminate the open space, resulting in less-than-optimal visibility. Suspended organic material also reduced the visibility of the camera (Figure 4-70). For future surveys, a more powerful light source could possibly illuminate the open space more effectively, and provide more details of its contents.

Figure 4-70 Lance camera example highlighting the poor visibility and suspended organic material

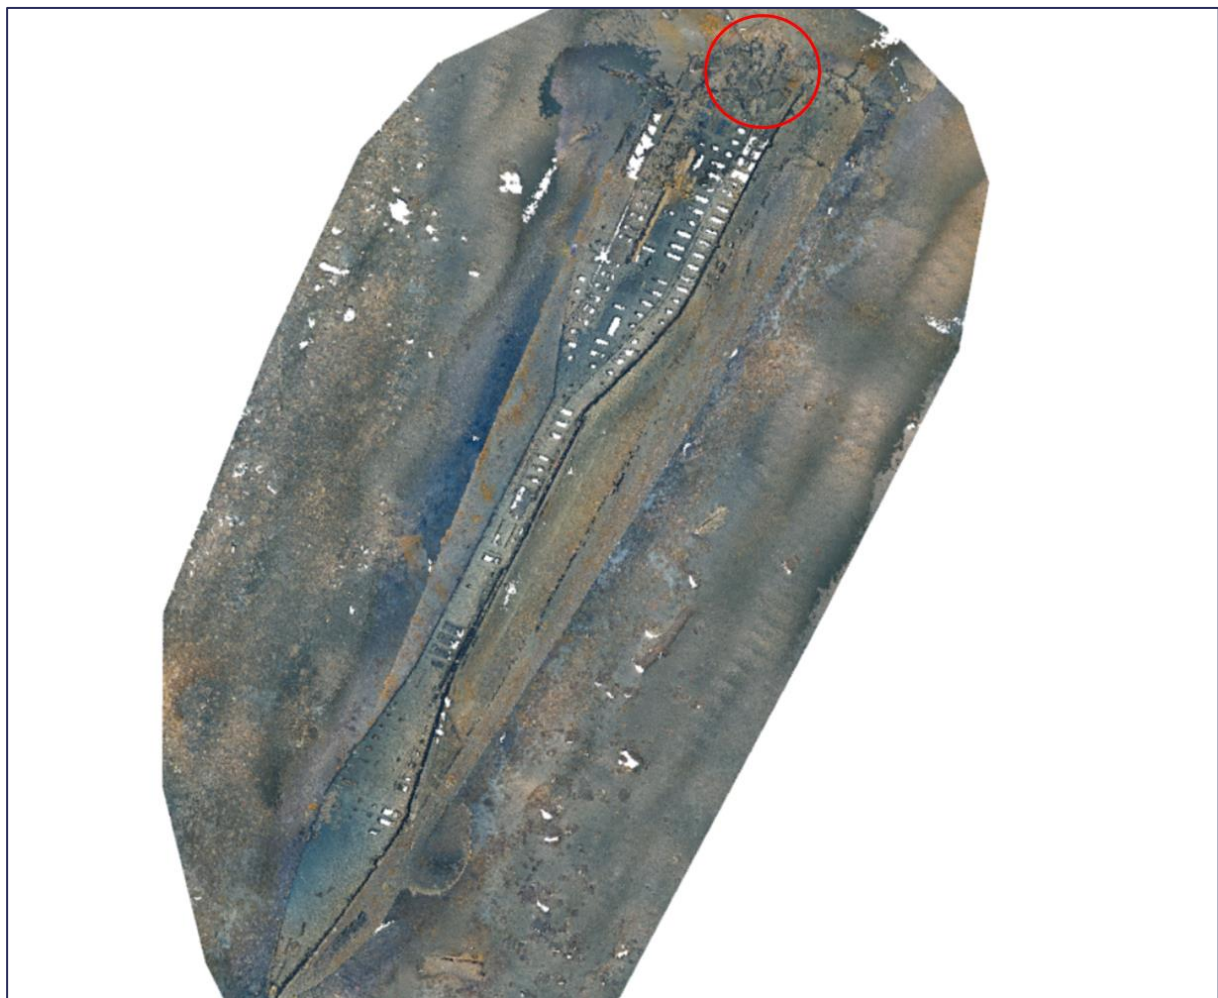
The inspection of the bow wreck showed that the deck was mainly intact up to the fracture point, with occasional missing panels (Figure 4-71 and Figure 4-72). Even though some parts of the deck were open, none of the external storage containers were open and their contents could not be observed. At the fracture point, a gas container was protruding out of the wreck (Figure 4-73). The location of the protruding gas container is highlighted in Figure 4-74.

Figure 4-74 Location of the gas container

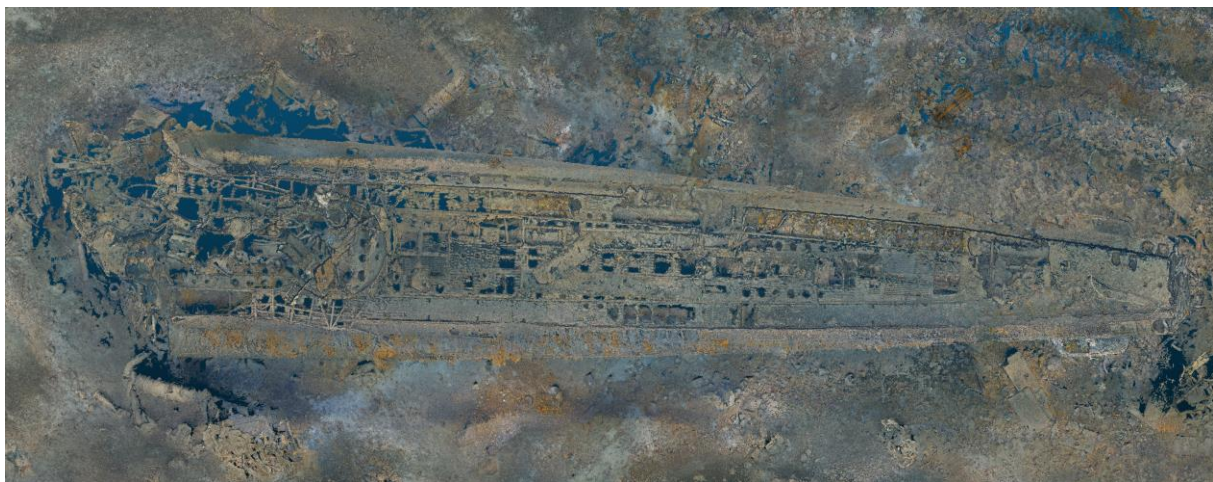
The deck on the stern section was found to be in various stages of degradation (Figure 4-75 and Figure 4-76). At multiple locations, marine life was observed moving along and between the various storage rooms below the deck, indicating significant degradation of the walls.

Figure 4-76 Photogrammetry model, from above, showing the state of the stern deck

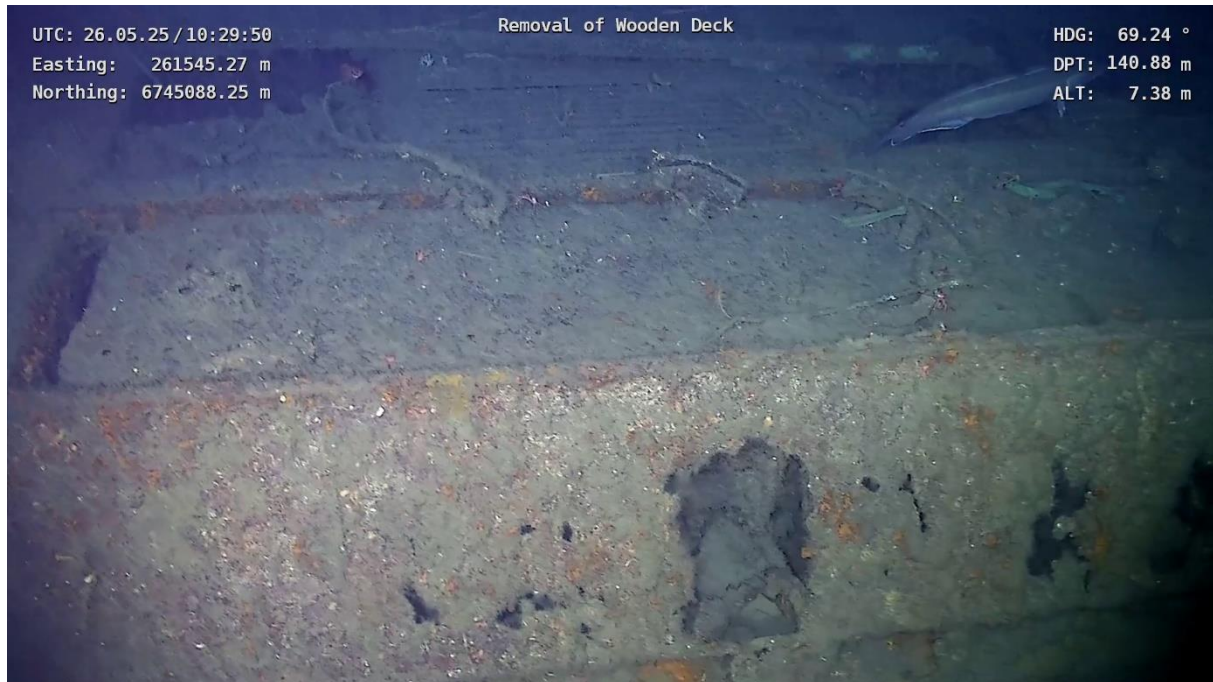
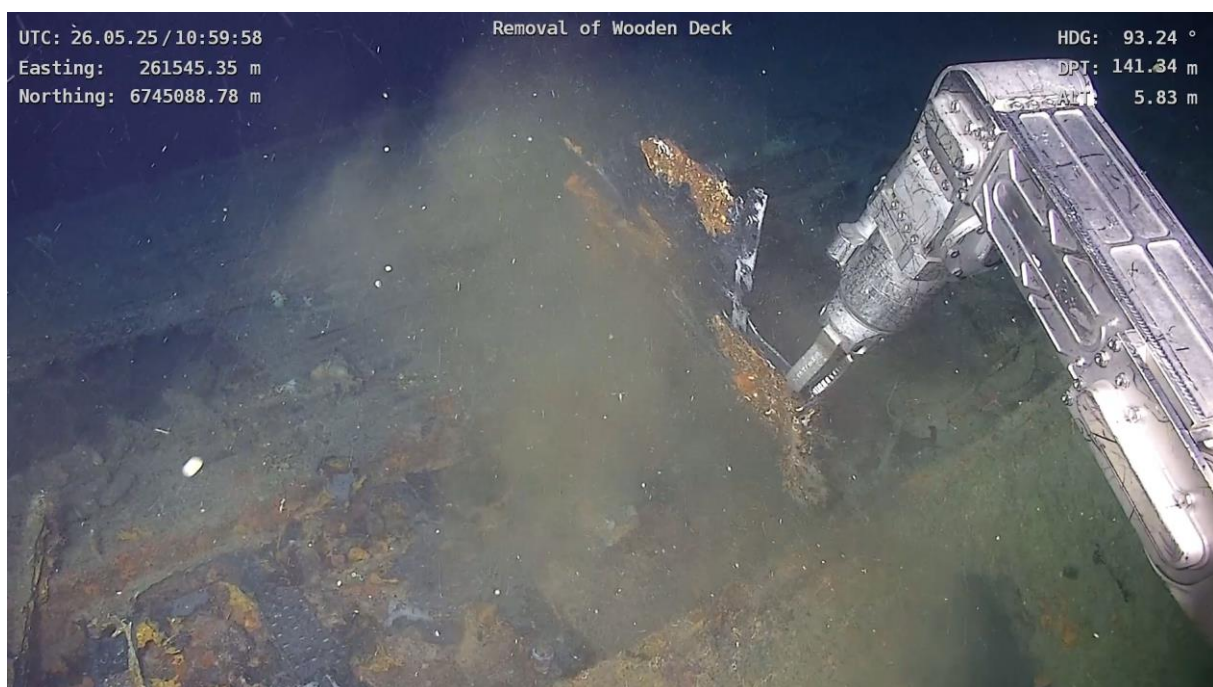
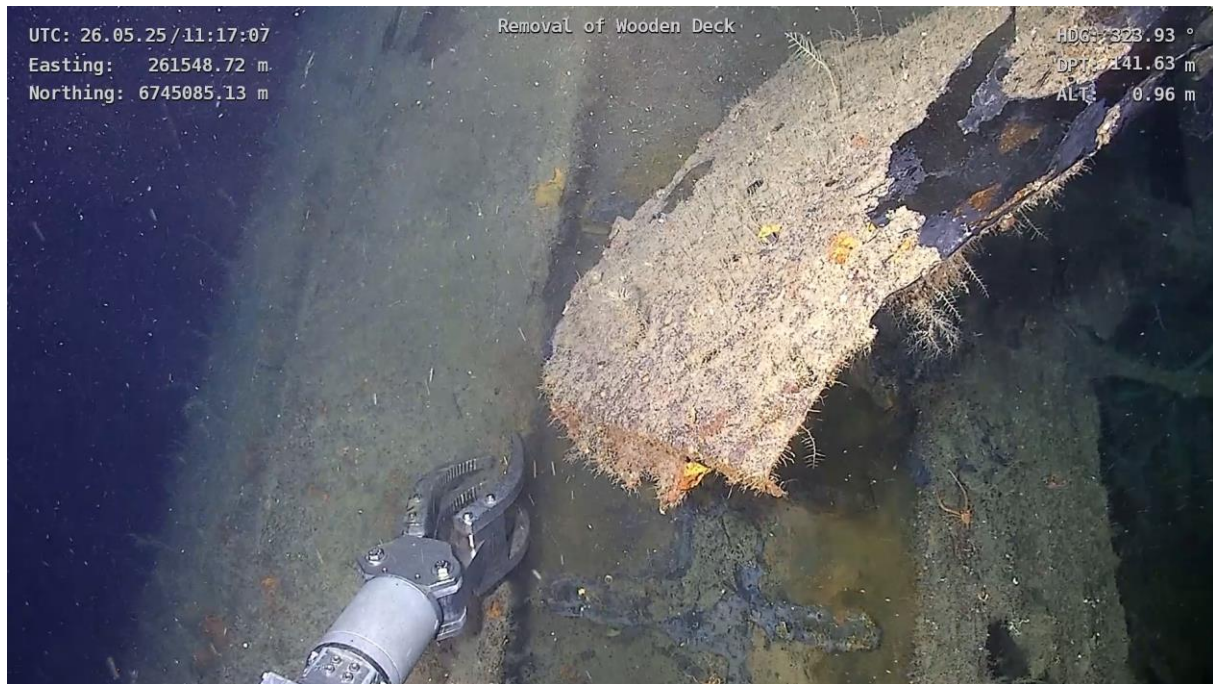
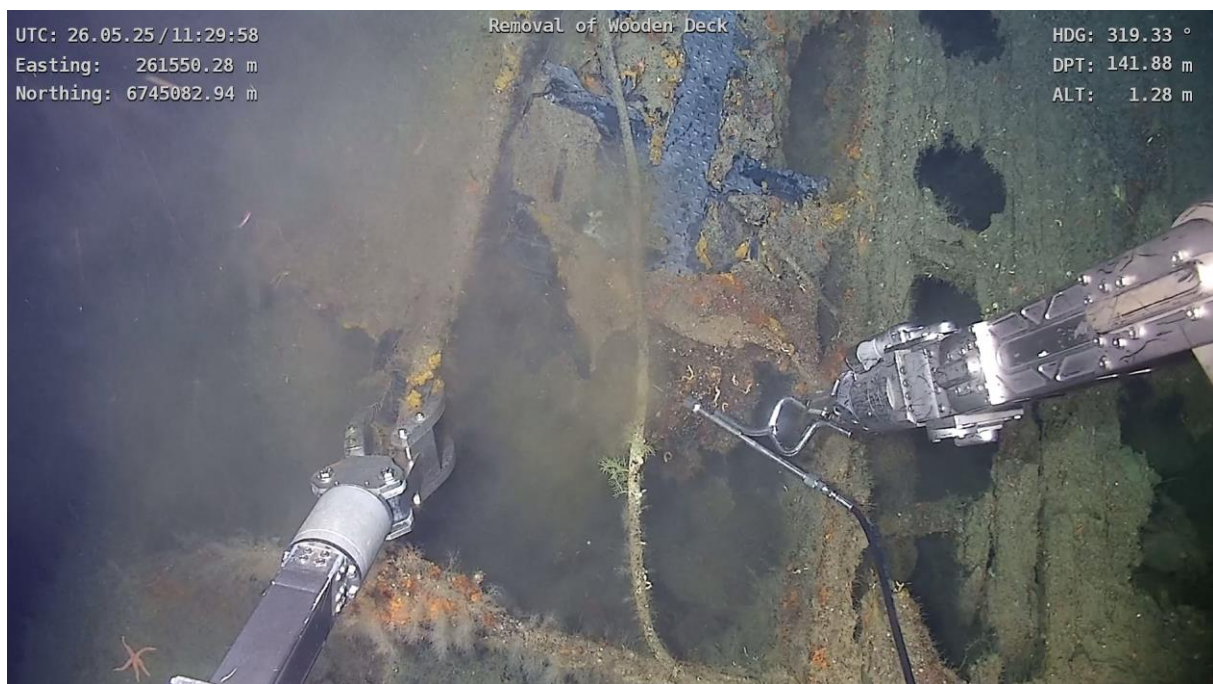
At location 1, a large section of the container roof was removed, revealing a cylinder approximately 8 m long and approximately 0.7 m in diameter. A hex nut could be seen at the exposed end of the cylinder as well as a grab handle. The cylinder was not found to have any serious defects nor were any signs of leakages observed. The cylinder is believed to be containing some kind of fuel.

Figure 4-79 External storage container at location 1 before removal

Figure 4-80 Container roof at location 1 being removed

Figure 4-81 More container roof removed at location 1

Figure 4-82 Water jet being used to clean debris from the opening at location 1
