## Kystverket - U-864 Wreck Investigation 2025 Campaign 1

28 August 2025

Issued for Review

Revision 2

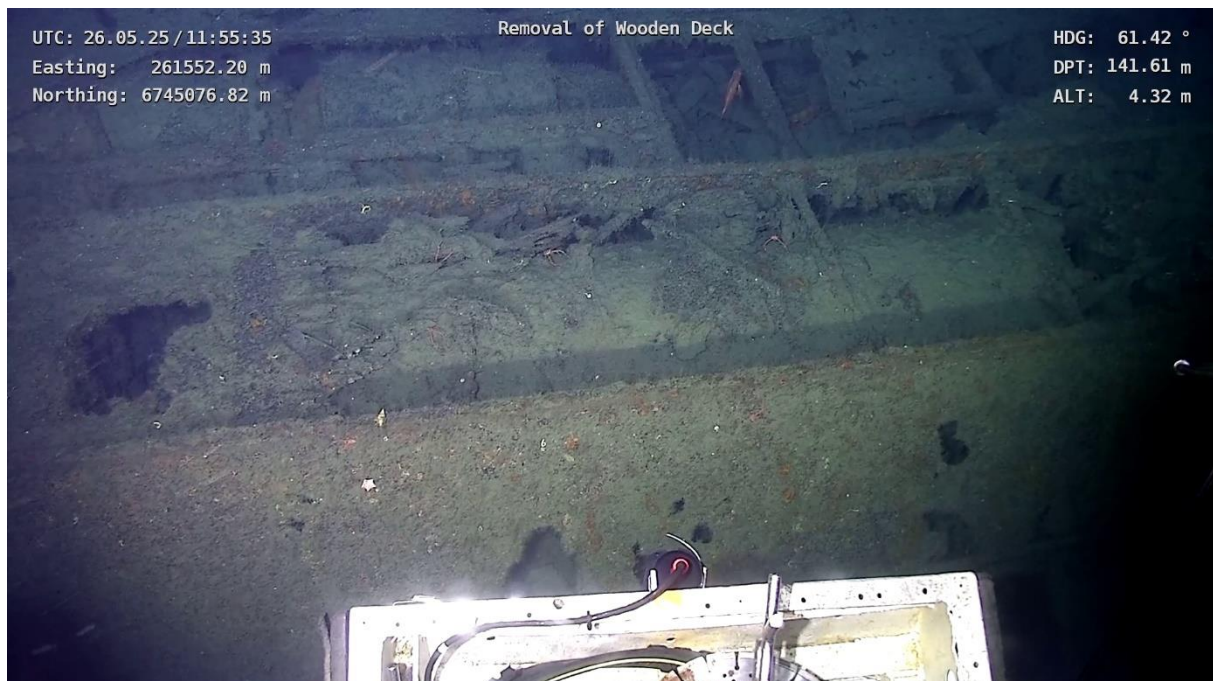
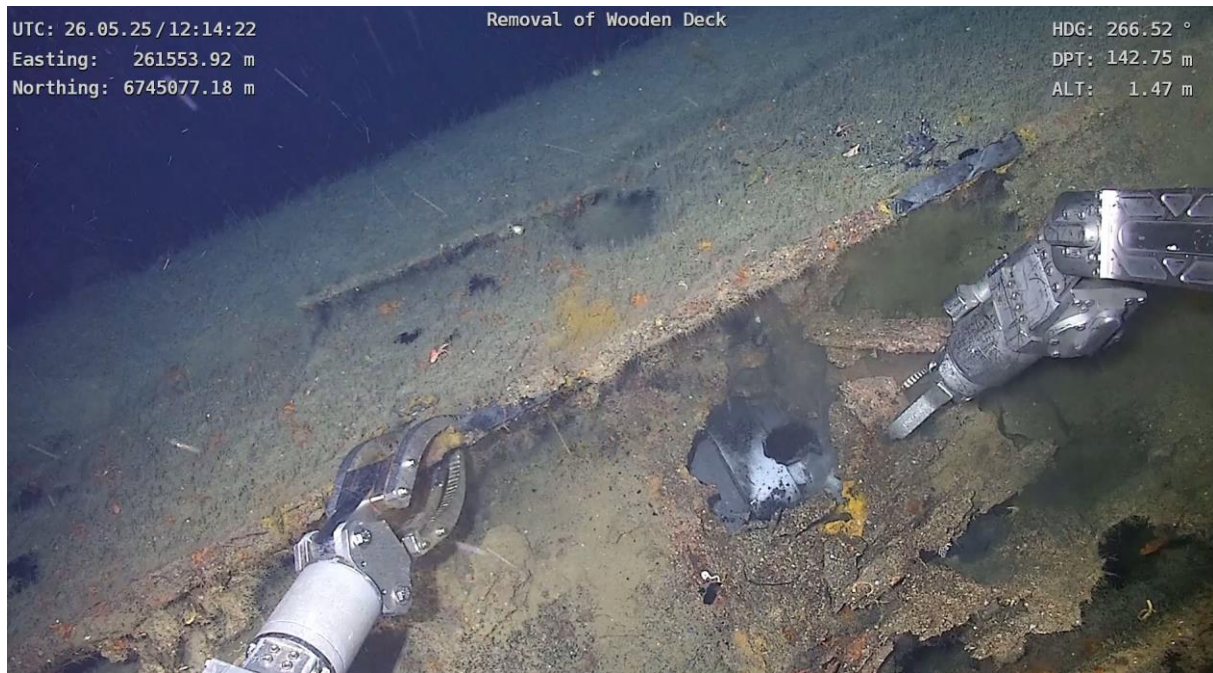
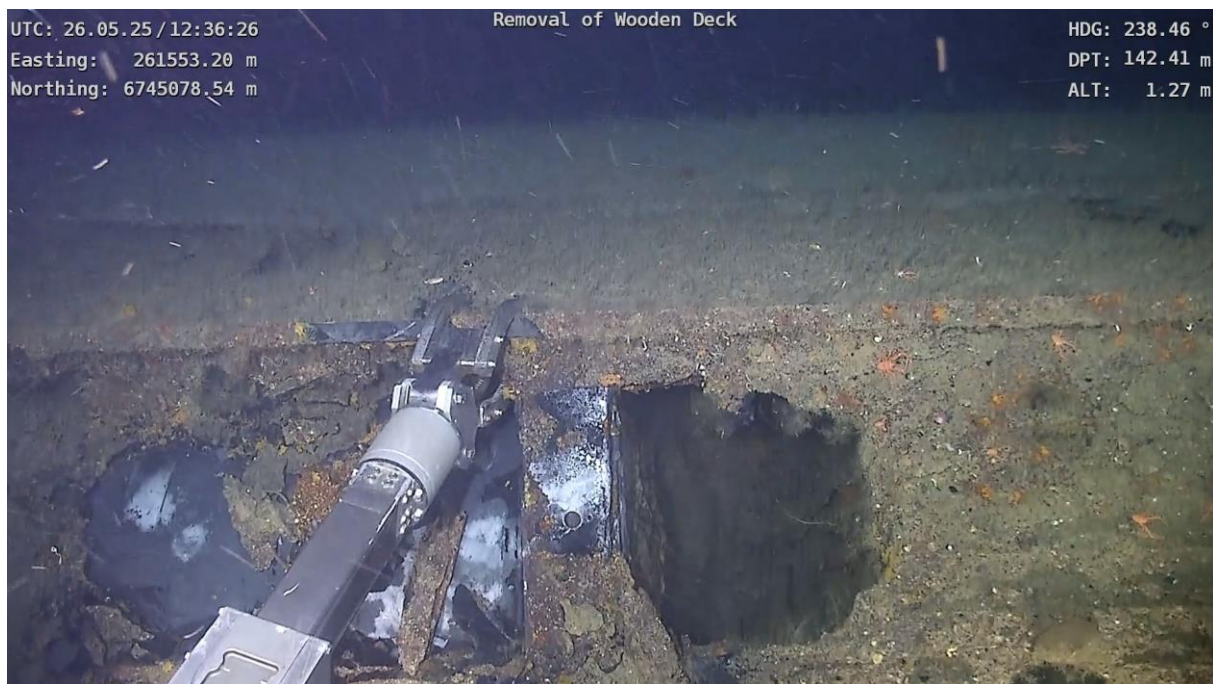
At location 2, the container roof was removed revealing a cylindric container approximately 3m long and approximately 0.6m in diameter. The cylinder had protruding grooves around the radius of the body. During the jetting of the container, bubbles were seen emanating from the container. Figure 4-84 - Figure 4-88 display the conditions of the external storage container before, during and after removal of the deck.

Figure 4-84 External storage container at location 2 before removal

Figure 4-85 Container roof at location 2 being removed

Figure 4-88 External storage container at location 2 after removal

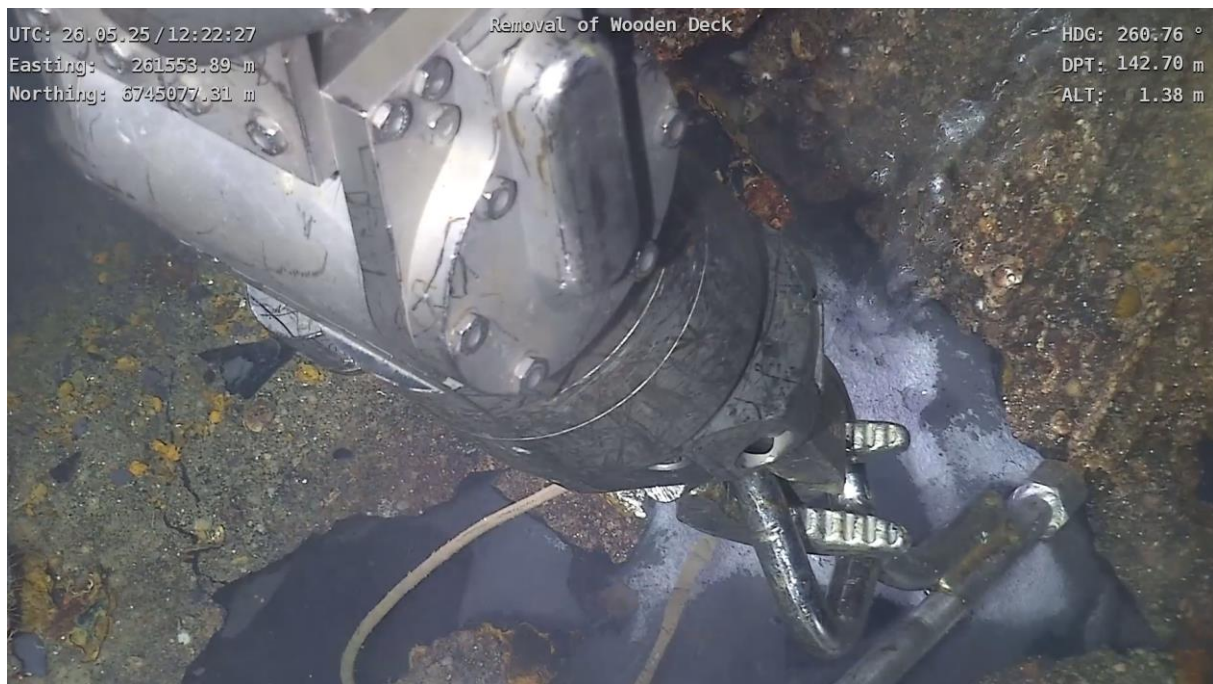
Figure 4-86 Bubbles emanating from the cylinder just above the manipulator

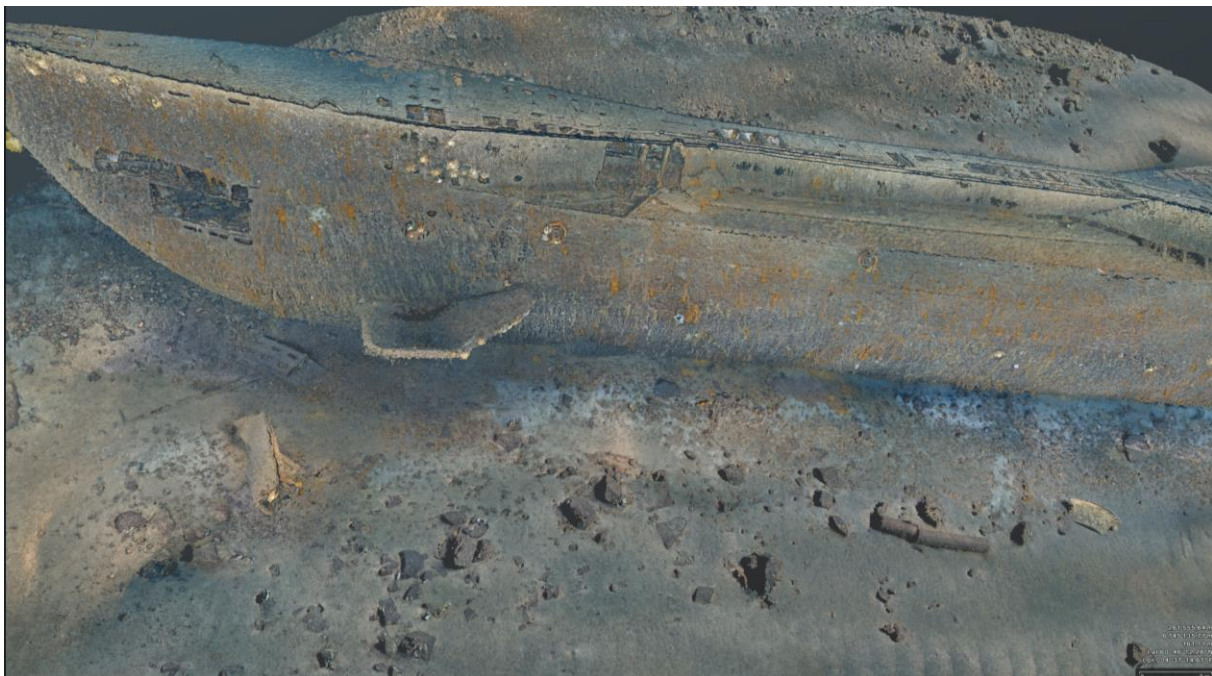
The level of details obtained from the photogrammetry did not only reveal the conditions of the outer hull but were also able to give a much more detailed view of the seabed surrounding the wreck. Based on the photogrammetry models, in combination with the video and CPTs, it was discovered that the seabed around the bow wreck was much firmer than originally believed. The seabed was originally believed to be very soft, and that debris and possible mercury canisters would sink into the seabed. However, the photogrammetry model showed that debris and small boulders have not subsided below the surface, indicating a coarser and denser surface sediment than originally believed (Figure 4-93). This is further supported by core samples (CPT125-127) taken by NGI in 2006 (Reference 3). The samples show a thin top layer of denser sand on top of softer clay.

Figure 4-93 Photogrammetry model of the bow section showing coarse sediment and debris

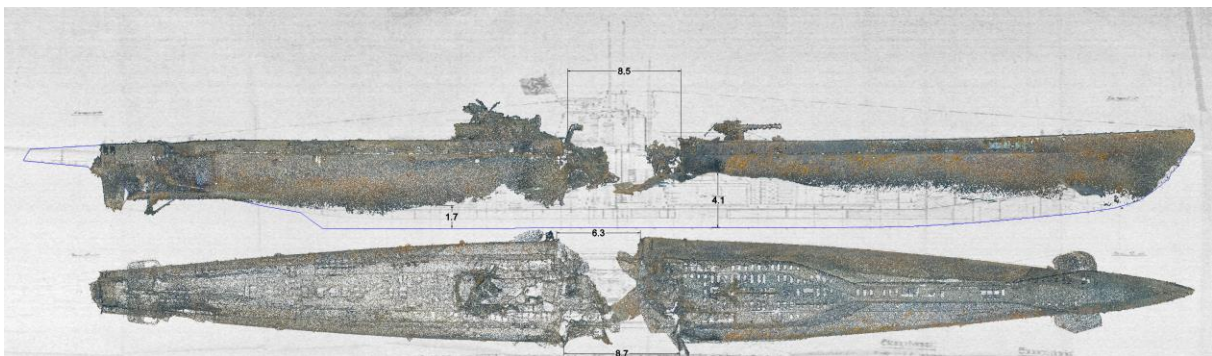
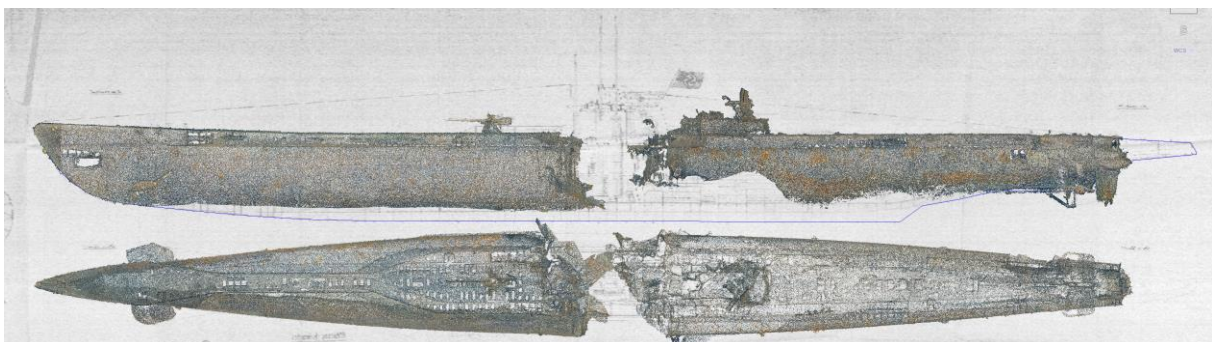
By superimposing the point cloud onto the design drawings, it was possible to make an estimation of how much of the submarine is buried. Figure 4-95 and Figure 4-96 display the starboard and port side view of the photogrammetry models on top of the design drawings. From the port side view, it was estimated that less than 2.5 m of the bow section is located below the seabed surface, when measuring the base of the point cloud to the keel of the drawing. Given that CPT 126 (Figure 4-8) indicates that the bedrock is approximately 2.5 m – 3 m below the surface, it is possible that the keel did not come in contact with the bedrock upon impact with the seabed. Consequently, the keel may not be as damaged as would be expected from making direct contact with the bedrock. This assumes that the top of bedrock does not become shallower directly under the bow section and that the overall impact with the softer seabed surface did not destroy the keel.

Figure 4-95 Starboard side view and top view

Figure 4-96 Port side view and top view

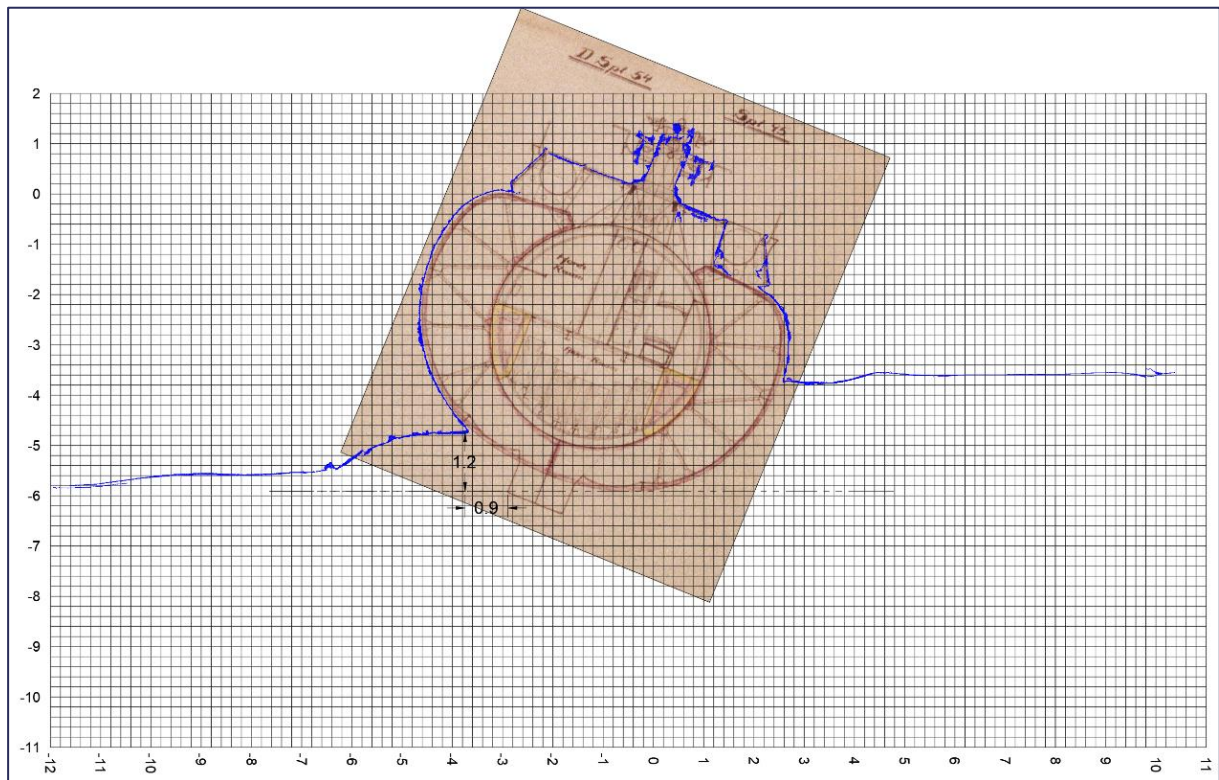
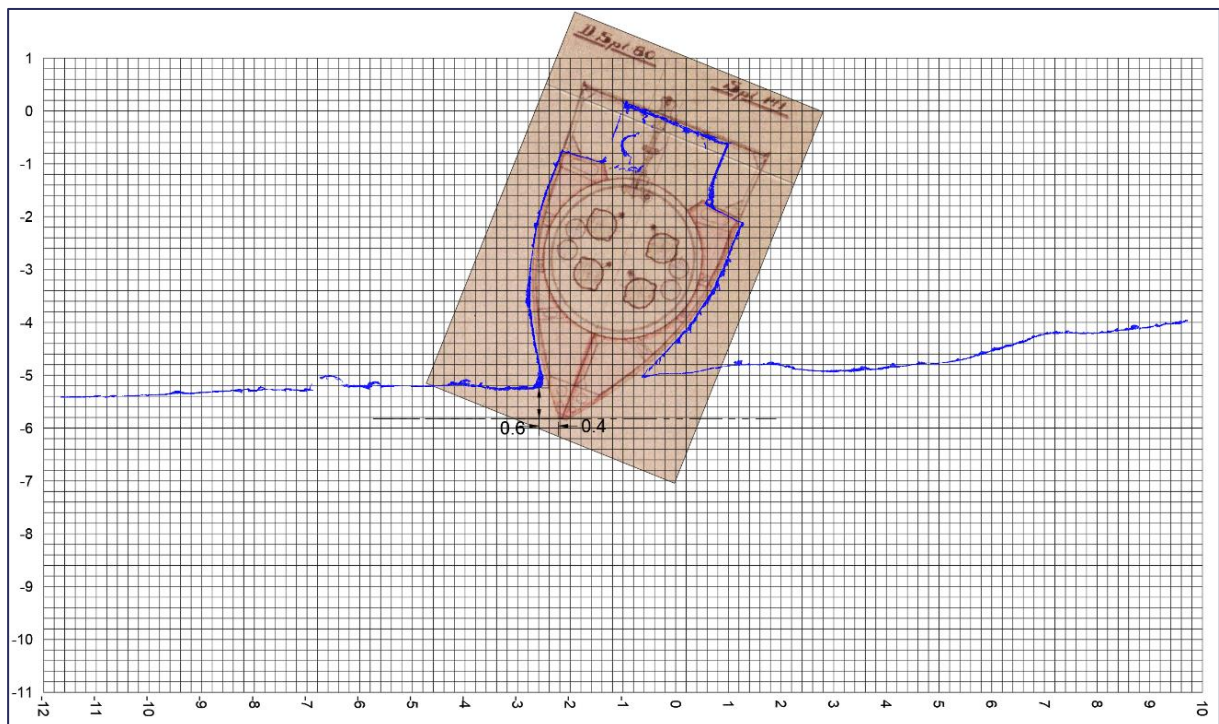
The cross profiles illustrate how the keel is positioned relative to the seabed, given that the keel is not deformed/crushed (Figure 4-100 and Figure 4-101). The actual condition of the keel is not known, however, CPT data close to frame 95 indicates that bedrock is found between 2.5 m – 3 m below surface. Based on the cross profiles, the keel may not be deep enough to have been destroyed during impact.

Figure 4-100 Deck frame 95. Axis represents metres

Figure 4-101 Deck frame 141. Axis represents metres

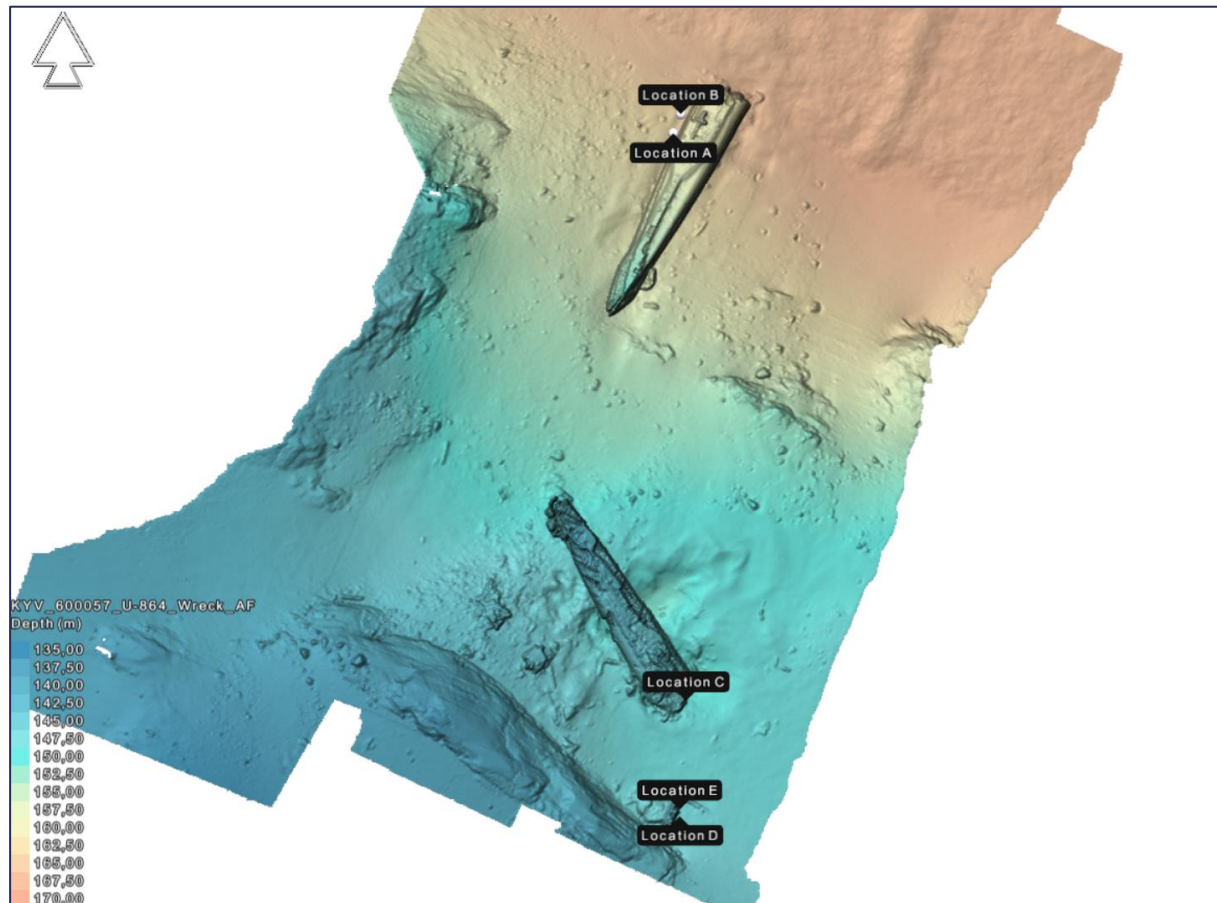
Figure 4-117 Overview of UT measurement locations

A total of five locations were investigated and at each location, two to three separate measurements were completed to ensure accuracy. The measurements at each location were taken in close proximity to each other. The five predetermined locations for the UT measurements are presented in Table 4-9 and an overview of their locations are presented in Figure 4-117. The estimation of the remaining material is based on the average thickness values from the 2005 survey. An overview of the 2005 thickness measurements is presented in Appendix G.

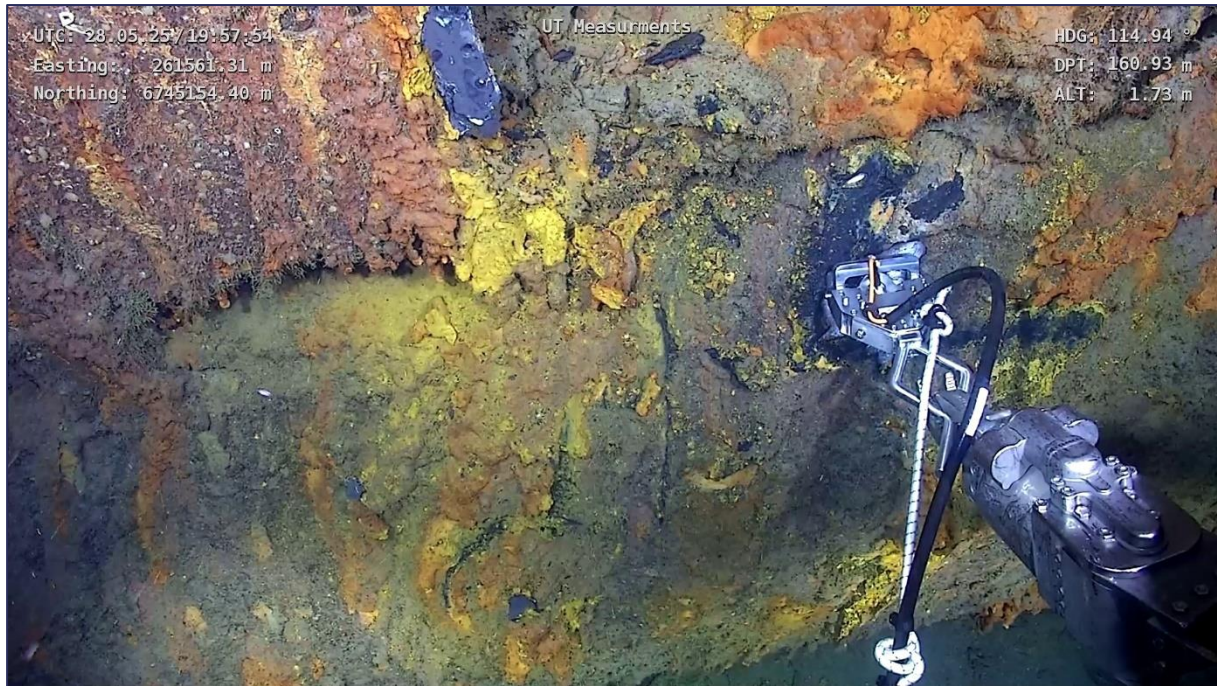
Figure 4-118 Ultrasonic measurement at location A

The measurements at location A were taken at the upper section of the submarine casing, approximately 10 m from the fracture point. The two readings indicate that the thickness of the casing has been reduced by 0.6 to 0.75 mm from the last reading (Table 4-10). Figure 4-118 displays the UT probe attached to the casing and Figure 4-119 displays the location in relation to the bow-section wreck.

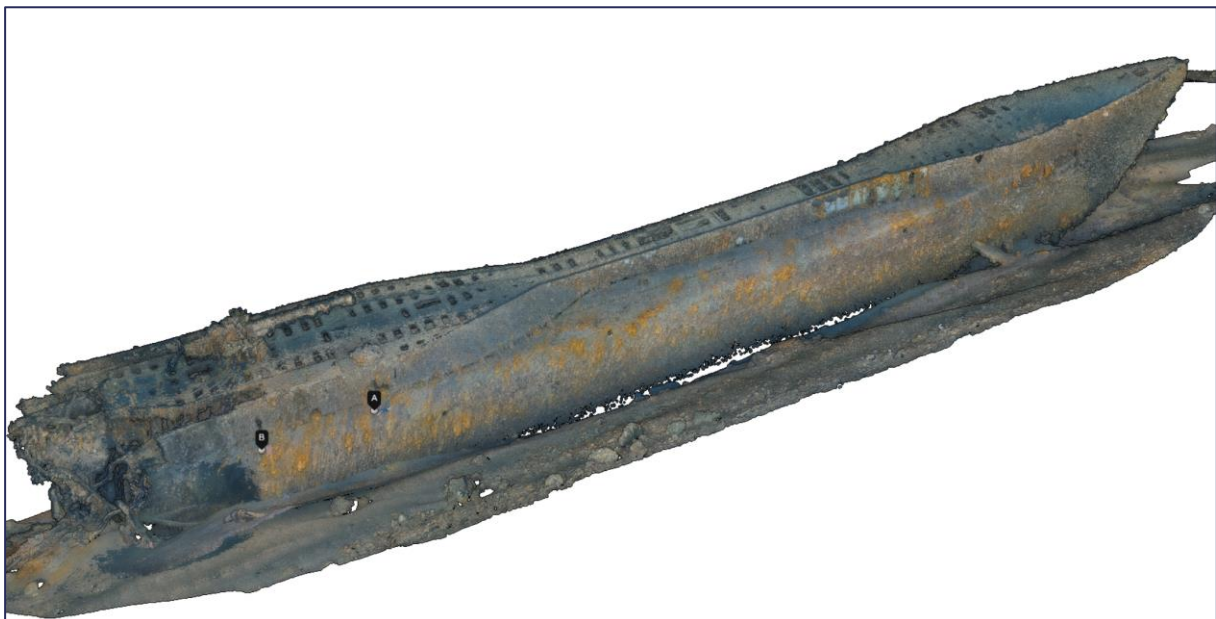
Figure 4-119 Location A and B alongside the bow section

The measurements at location B were taken at the upper section of the submarine casing, approximately 6 m from the fracture point, and 3 m away from location A (Figure 4-119). The two readings indicate that the thickness of the casing has been reduced by 0.6 to 0.85 mm from the last reading (Table 4-11). A photo of the measurement process, taken from location B, is presented in Figure 4-120.

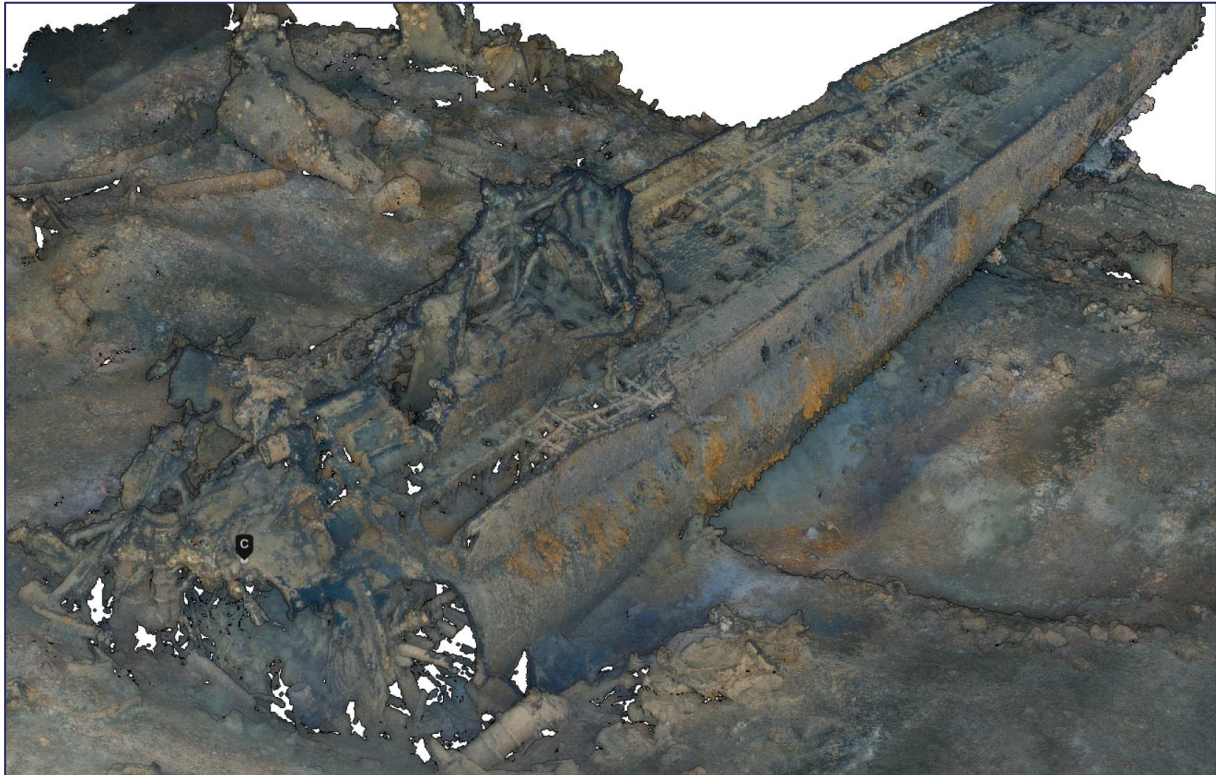
The measurements at location C were taken at an exposed section of the pressure hull on the port side of the fracture point (Figure 4-121). Three separate measurements were taken at location C, since the initial two measurements showed a difference of more than 1.5 mm. The third measurements confirmed the second reading, as they only showed a difference of 0.5 mm. Details of the readings are presented in Table 4-12 and a photo from the measurement is presented in Figure 4-122.

Figure 4-121 Location C at the fracture point of the stern

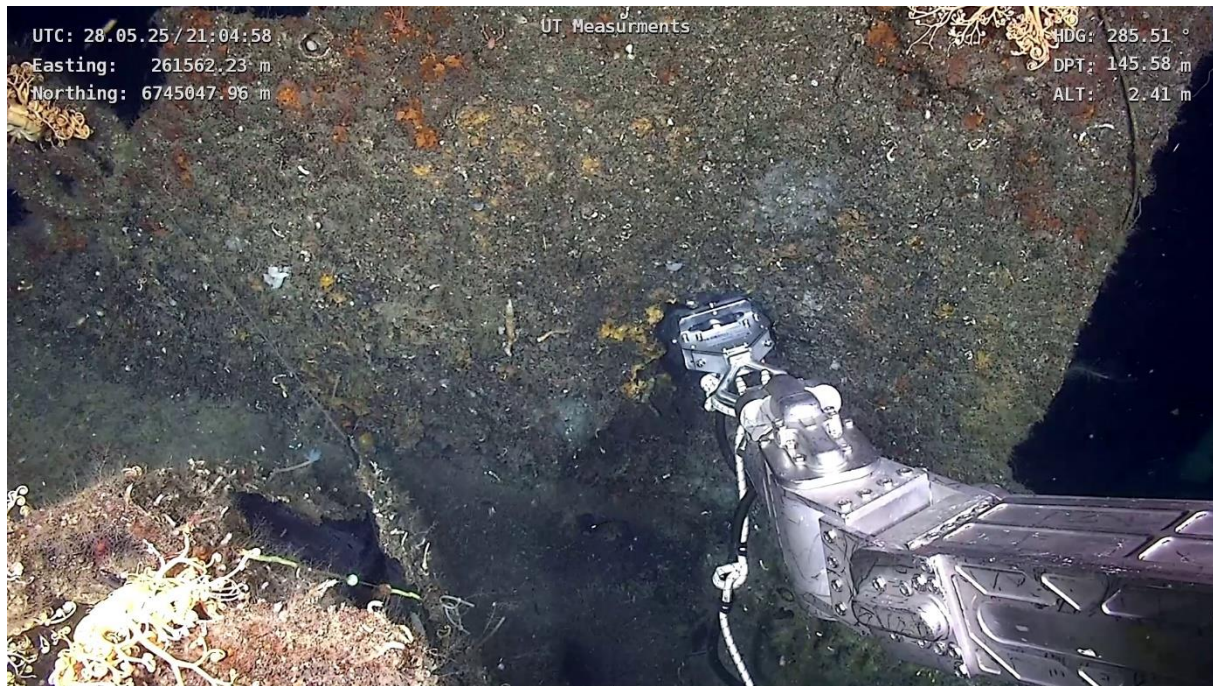
Figure 4-123 Ultrasonic measurement at location D

Measurements at location D were taken at the exposed pressure hull at the conning tower (Figure 4-123 and Figure 4-124). The two readings indicate that the thickness of the casing has been reduced by 0.4 to 0.5 mm from the last reading (Table 4-13).

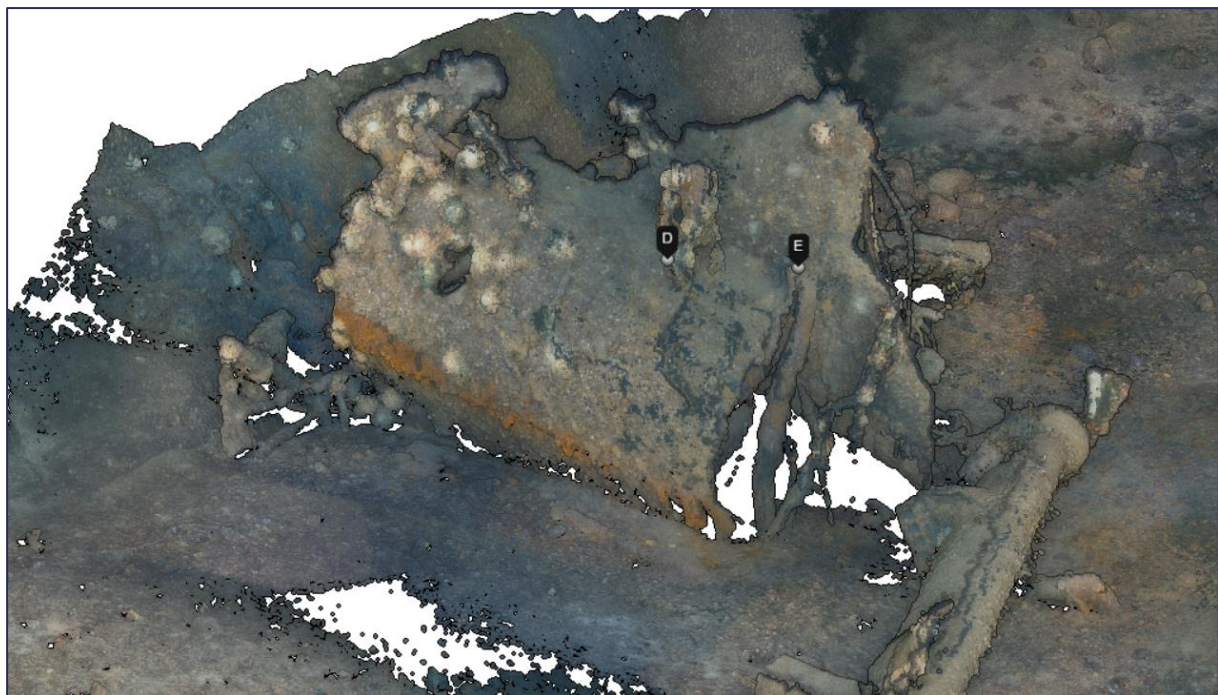
Figure 4-124 Location D and E at the conning tower

The measurements at location E were taken at the conning tower bunker tank (Figure 4-124 and Figure 4-125). The two readings indicate that the thickness of the casing has been reduced by 1.16 to 1.21 mm from the last reading (Table 4-14).

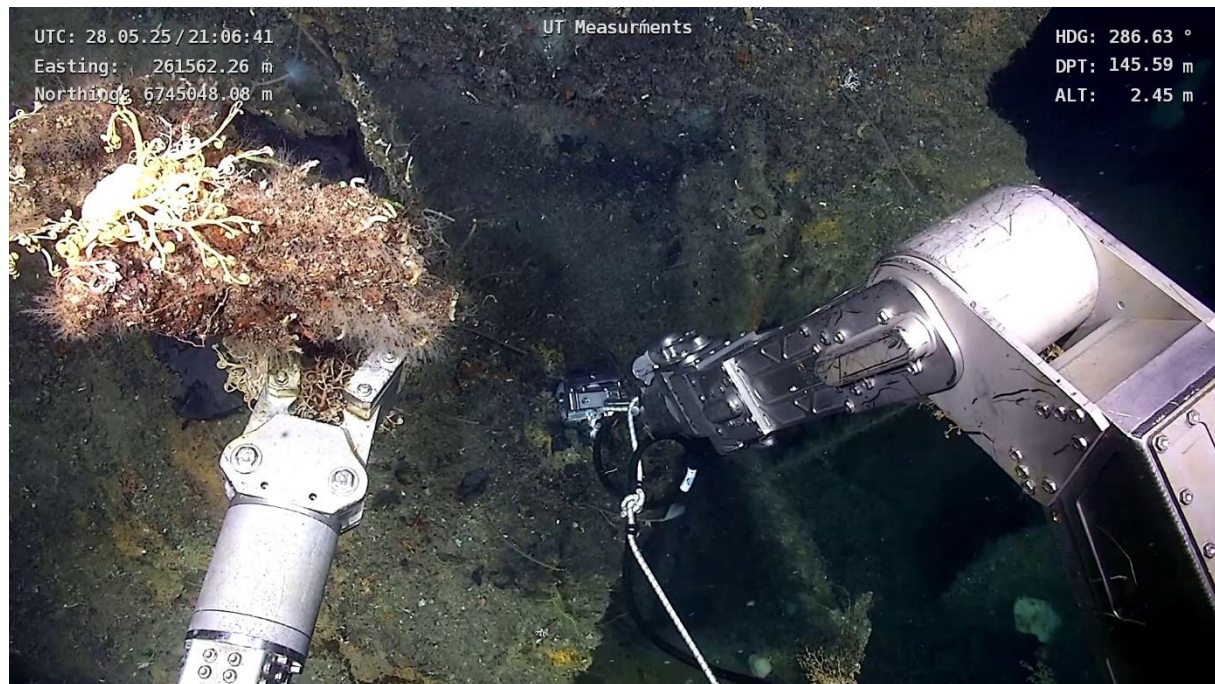
Figure 4-125 Ultrasonic measurement at location E

The overall results from the ultrasonic measurement probe show that the thickness of the wreck has been reduced between 19 % and 3 % from the previous readings. The reduction in material on the two large wreck pieces are relatively similar, measuring an average of 84 % reduction in material compared to the previous measurement. The thickness measurements indicate that the pressure hull is thinning compared to the previous survey. It should be noted that the measurements from 2005 show a bigger difference, between the two independent measurements, than from the current survey. The larger difference between the independent measurements at each location does question the validity of the previous results. Accurately determining how much the thickness has been reduced is therefore difficult.

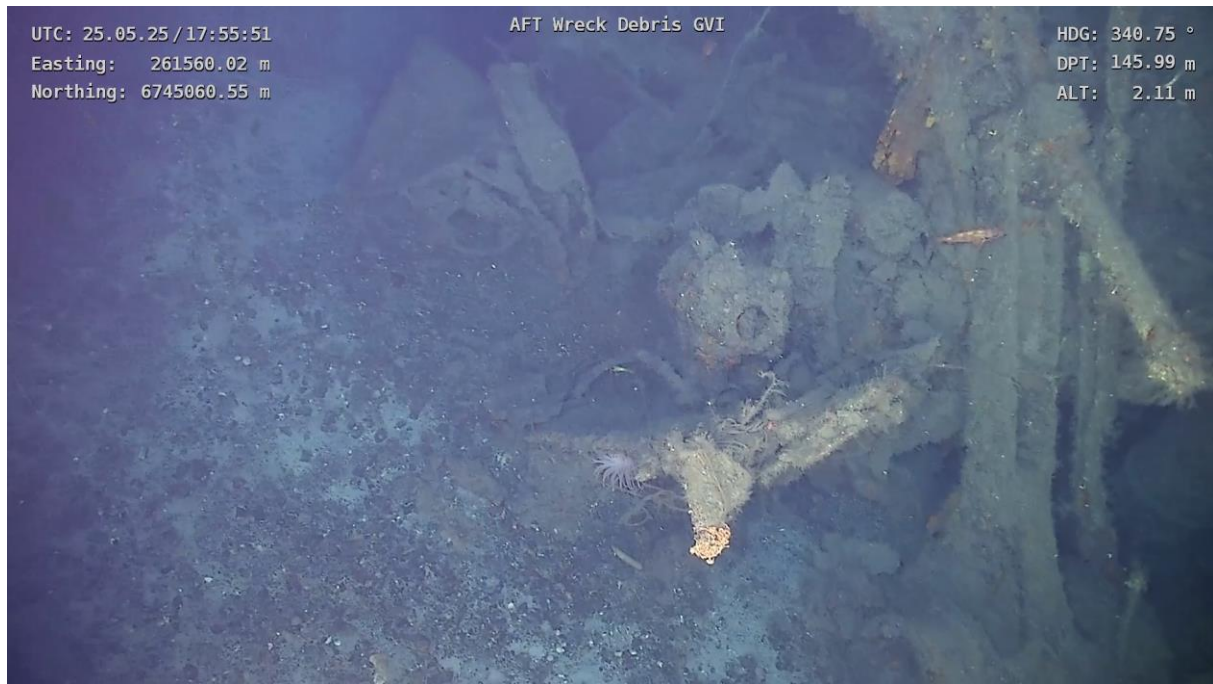
Prior to the survey, concerns regarding the surficial sediment conditions and potential contamination due to suspension were raised. During visual inspection, the surficial sediments close to the wreck were found to consist of coarser sediments, such as sand (Figure 5-1 and Figure 5-2). This was also supported by core samples from 2006 (Reference 3), which showed a thin upper layer of sand followed by a layer of soft clay. Flying over the surficial sediments did not result in significant suspended material, limiting any potential contamination of the ROV and the sensors. The coarser seabed can also be seen in the 3D model from the photogrammetry (Figure 5-3 and Figure 5-4).

Figure 5-2 Image example from the stern section, showing coarser seabed than expected

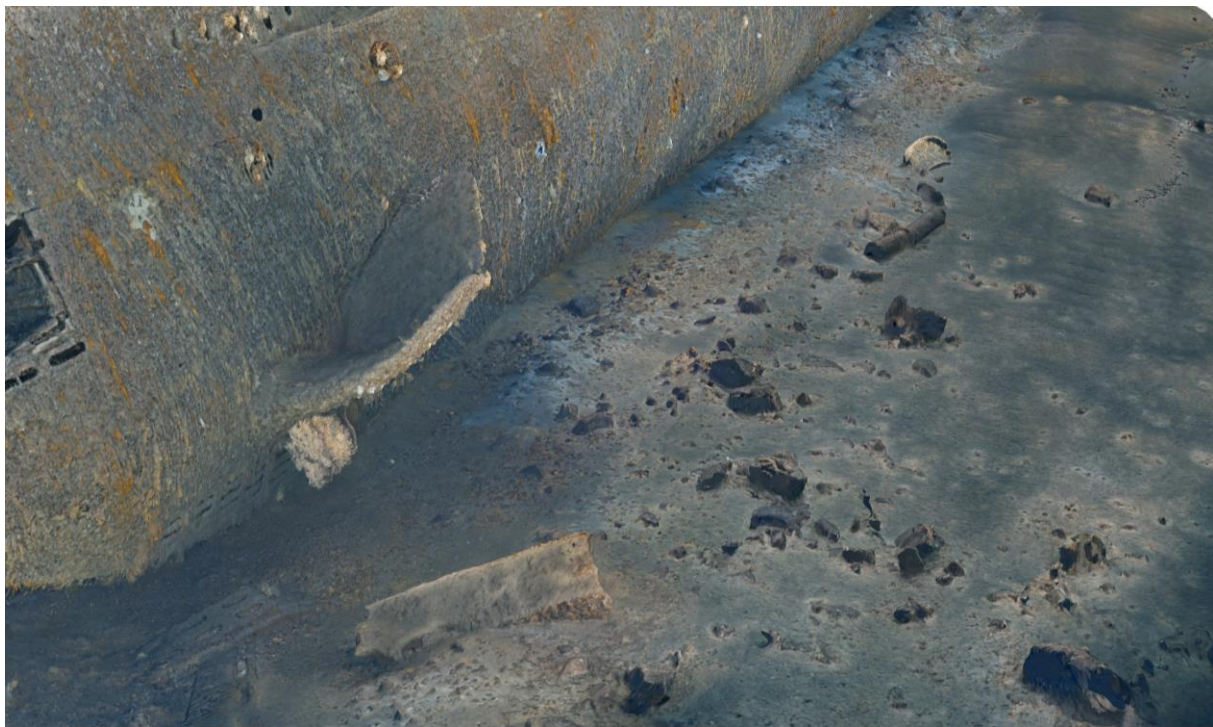
Figure 5-3 Photogrammetry data example, along the eastern side of the bow section, showing coarse sediments. The lack of submersion of debris and boulders support a coarser seabed than initially believed
