MARSTRAND - KYSTVERKET - U-864 2024 KONSULENTTJENESTER

# Assessment of corrosion of mercury canisters in the keel of U864

Report no.: 2026-0669, Rev. 0

Date: 2026-05-19

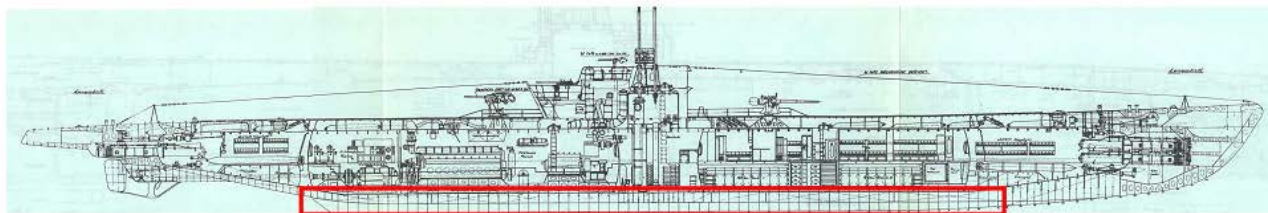
**Figure 1. IX D2 submarine type. The area marked in red shows the keel, where the mercury canisters were stored /3/.**

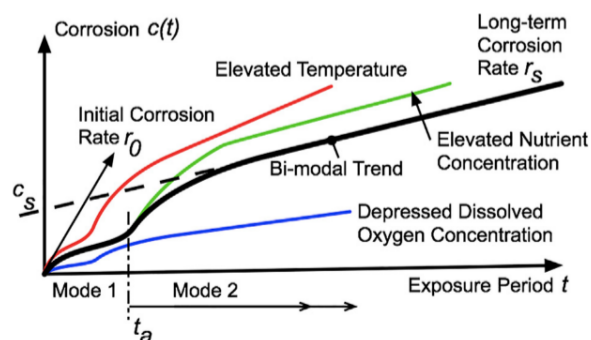
For buried structures, studies have shown that corrosion evolve over time following 2 modes; transitioning from an initial oxygen-controlled mode towards a diffusion-limited and anaerobic mode, in which nutrient transport to the steel surface is corrosion rate-controlling /6/. Figure 4 shows a typical representation of the corrosion evolution over exposure period for buried steel. Considering the information given that the canisters are located 2-4 m deep, it is assumed that no oxygen is available.

**Figure 4. Schematic bimodal representation of the development of corrosion loss  $c(t)$  as a function of increased period of exposure ( $t$ ) [6].**
