# Final Report

## Kystverket - U-864 - Wreck Campaign 2

21 August 2026

Revision 2

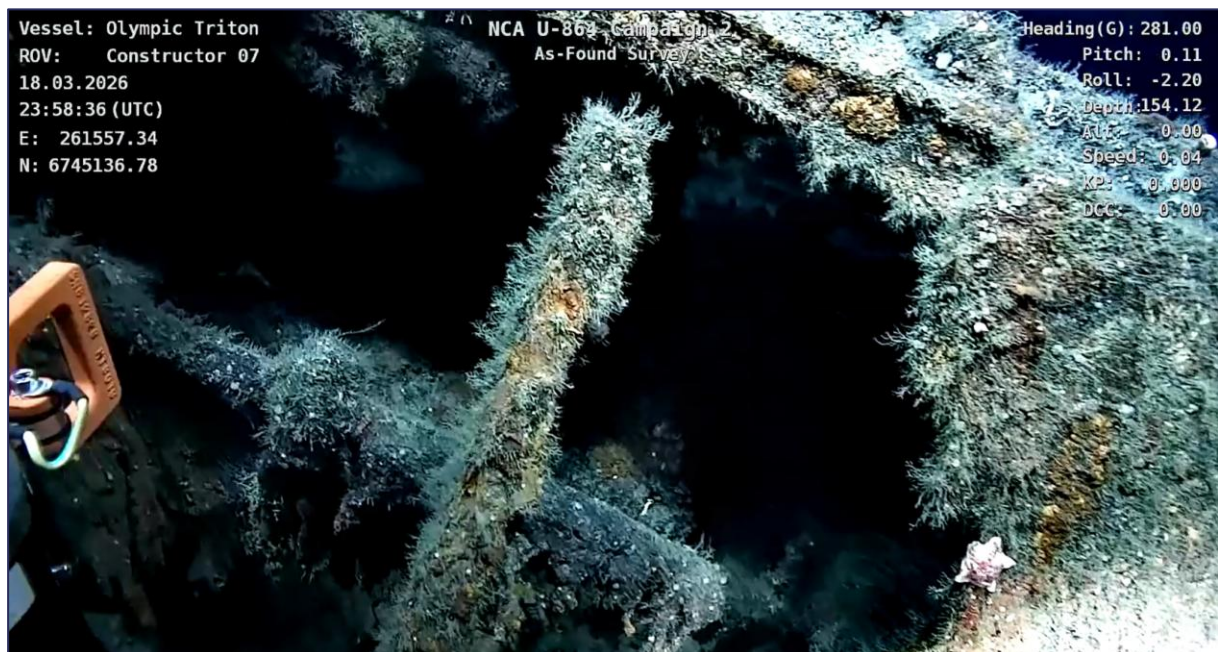
Figure 3-1 Fix taken on frame # 138 (fix position 261557.2 mE, 6745136.7 mN)

Location fixes were taken on frame # 138 Upper position and # 136 Upper position for TP-010.

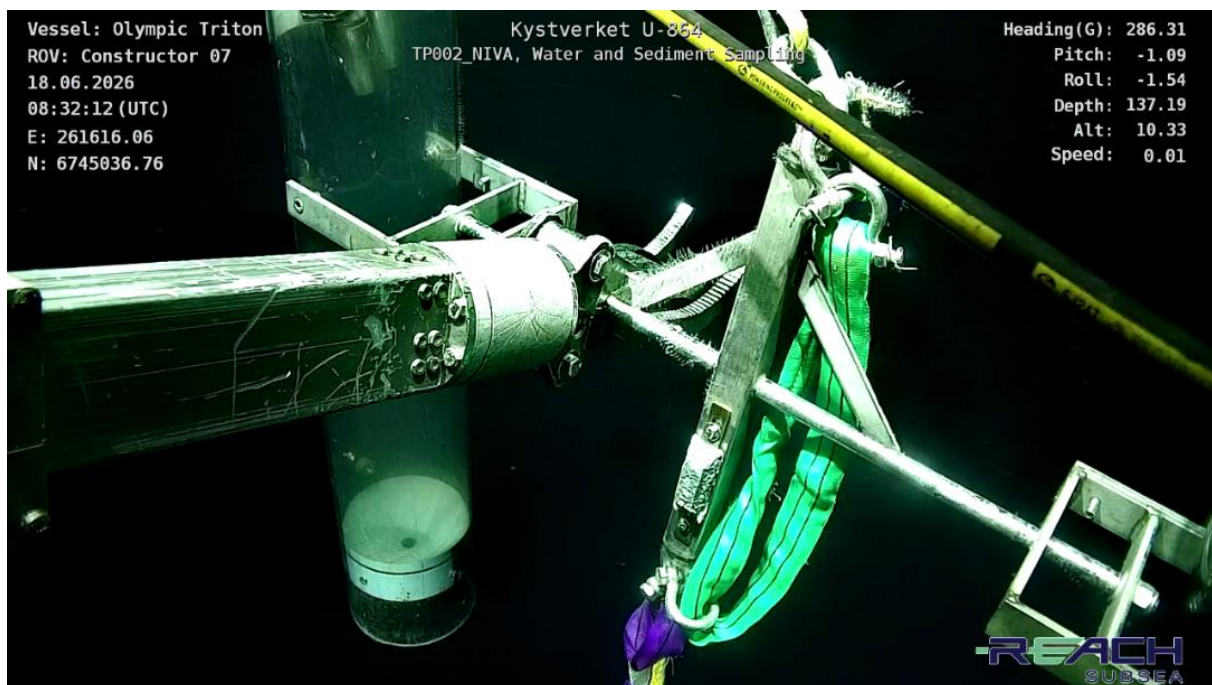
Figure 3-5 Cleaning sediment traps (Tp-002)

Upon arrival on site in June, a general visual inspection was performed. On NIVA request, the sediment traps that had been on seabed since previous campaign in March 2026 were emptied of their contents, the contents were not analysed. DGT samplers were then attached.

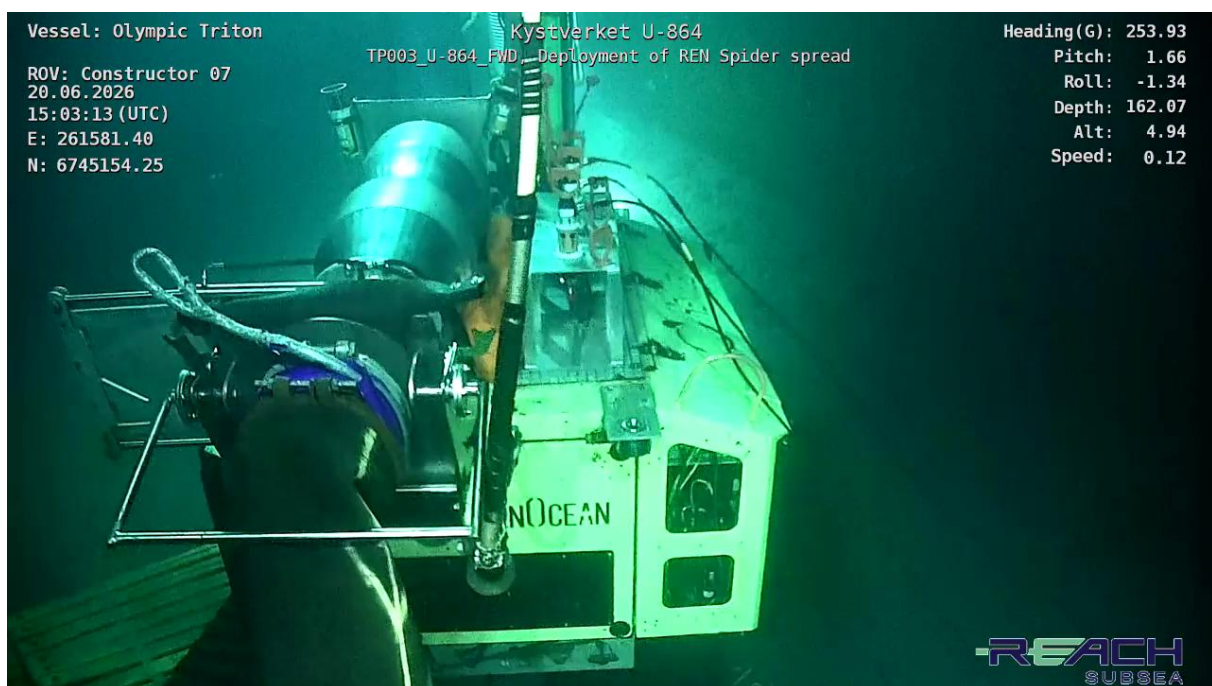
Figure 3-14 RenOcean Spider overview

Based on the experiences on site, the soil was more solid than what was predicted in the stability assessment made by Sweco. There were lots of rocks of various sizes in the area to be dredged, some large enough to block the dredge pipe. Apart from the rocks, the soil appeared to have uniform properties throughout the excavation area with regards to soil density, strength and layering. Due to the soil being solid, the local slope remained stable for the duration of the operations, with no degradation of the pit wall integrity.

With the soil being solid, the dredging operations progressed more slowly than estimated. For the removal of approx. 45m<sup>3</sup> of soil, a total of approx. 24 hours actual dredging was performed. The immediate factors affecting dredging speed was the soil composition and size and quantity of rocks in the area. Using a strainer on the dredge nozzle could have reduced the time spent dredging or unblocking the suction pipe, but the rocks would still need to be removed from the pit for the ROV to have a stable position for obtaining access to the keel section.

In the earliest phase of the project, no strainer was fitted to the suction nozzle. However, as it became apparent that the dredge pit was littered with large rocks, the Spider was recovered to deck and a strainer was fitted.

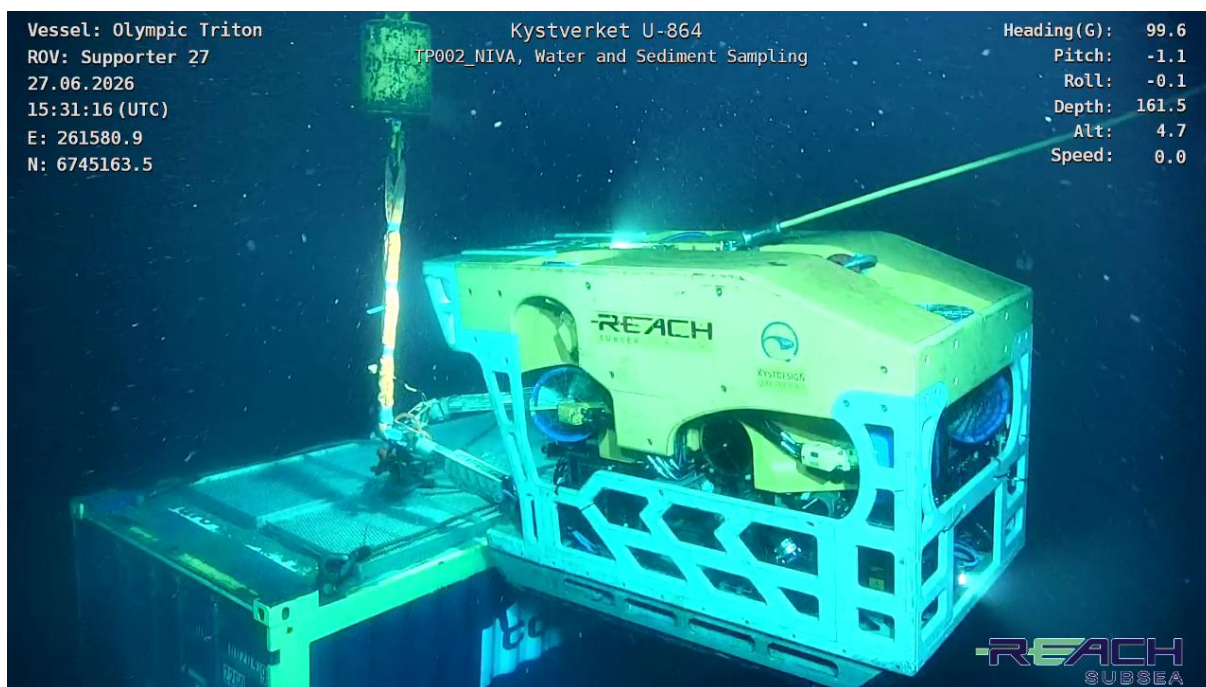
Figure 3-17 Constructor hooking up crane on dredging container

Images of the RenOcean spider are shown in Figure 3-14 through Figure 3-16. Note that a dredging container was utilised to hold the dredged sediment (Figure 3-17). While the intention of the dredging container was sound, it turned out to be of limited use during actual operations in June. Filters on the dredging container became clogged and reduced the flow of the dredger to the extent that the dredger did not work while the container was connected. The decision was made to disconnect the dredge container and to have an open exhaust pipe. A mitigating measure in this regard was to conduct more active turbidity measurements to measure the mercury levels in the area during dredging operations. Mud mats were installed on the seabed on 20 March 2026 in preparation for landing of the dredge container. These were recovered at the end of the campaign.

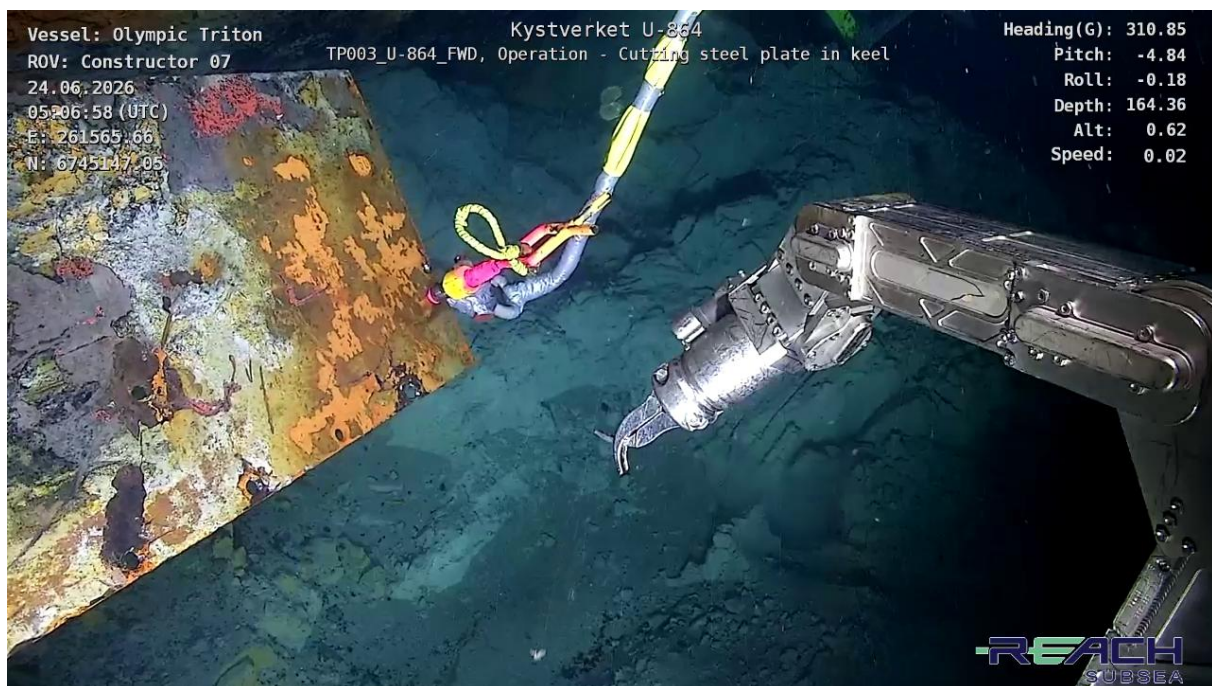
Figure 3-19 Removal of keel plate for access to compartments

Access to the keel was gained at pressure hull frames #60-#66 (#103-#112), and the keel was subsequently opened. Taskplan REACH-600096-TP-003 described that access to keel compartments was to be obtained by cutting an opening in the keel plate, utilising the Spider Belly Basket with grinder. When the dredging operations had provided sufficient access to the keel, it was discovered that a larger keel plate cover could be removed by prying loose the plate from the original fasteners. MOC-017 was prepared to allow for an alternative method of obtaining access to the keel compartments. The plate was pried loose by using the ROV manipulator and a modified crowbar. Once the plate was loose from the fasteners, attempts were made to drag the plate away from the keel section. This turned out to be too difficult for the ROV, due to weight of the plate, as well as the ROV not having sufficient grip on the plate itself. To increase the grip on the plate, the ROV pilots on board modified a plate clamp to be operable by the ROV. This plate clamp was then fastened to the keel plate for more attempts at removing the plate by the ROV. Finally, the clamp was connected to the boom of the Spider by a round sling. This gave the required leverage to remove the plate. Once the plate was free from the keel section, it was re-located to the nearby rock dump for later recovery to deck.

During the process to remove the plate some debris was observed to fall out from the keel section. For the most part the debris consisted of surface corrosion, soil remnants on the steel plate, broken glass and what turned out to be the charred remains of wood. The falling debris caused the vision to deteriorate, requiring frequent stops in the removal process to wait for visibility to operate. Due to the roll angle of the wreck, it is unlikely that liquid mercury was released while removing the keel plate. However unlikely, it is still a possibility that droplets of liquid mercury was released along with the other debris.

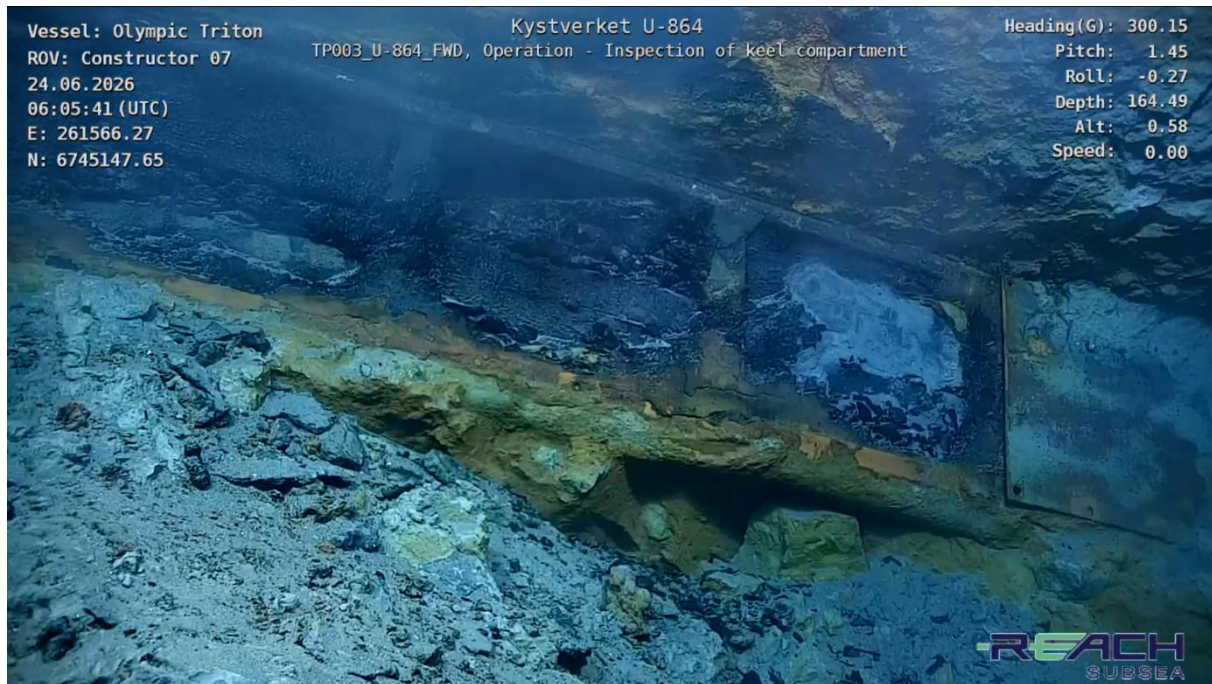
Figure 3-20 Keel compartments after removal of keel plate

The condition of the compartment boundaries appeared to be good and solid, which was also reflected in the keel plate that was recovered to deck. Remnants of the mercury canisters and packing materials had affected the surfaces of the boundaries, rendering a qualified assessment of the boundaries difficult.

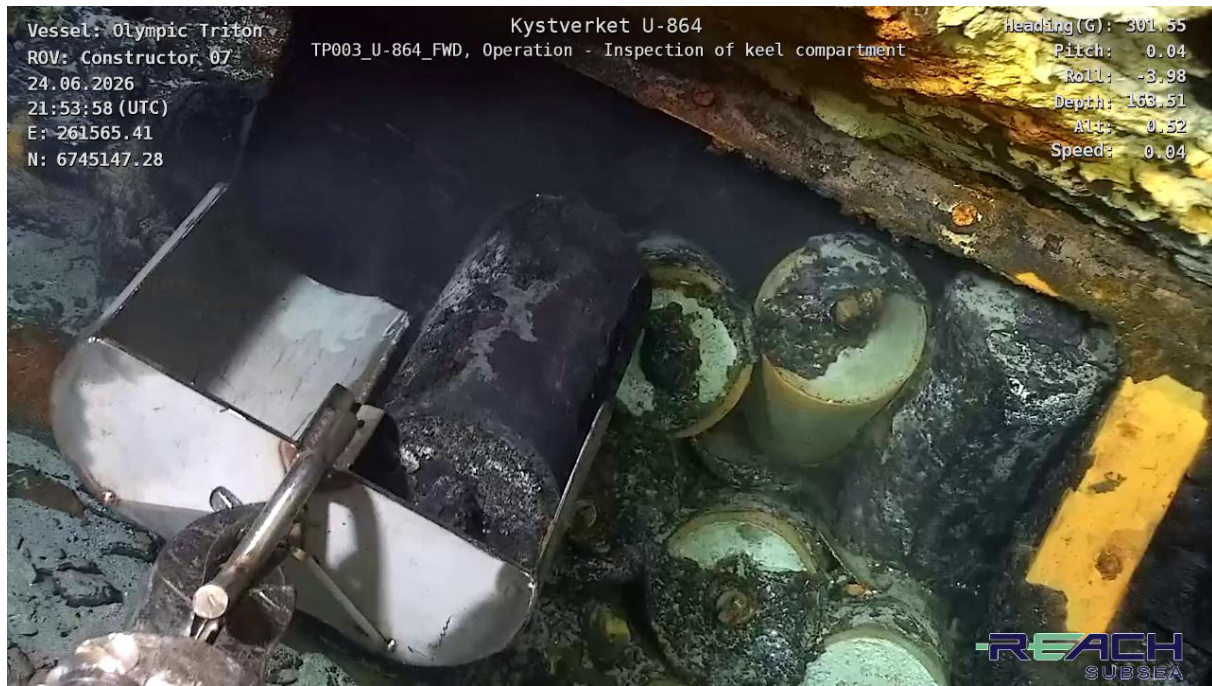
Figure 3-22 Recovery of mercury canister from keel compartment frames #65-#66 (#110-#112)

On examination further aft in the keel section, at frame #65, mercury canisters were found.

Total 22 mercury canisters were recovered to the mercury recovery basket.

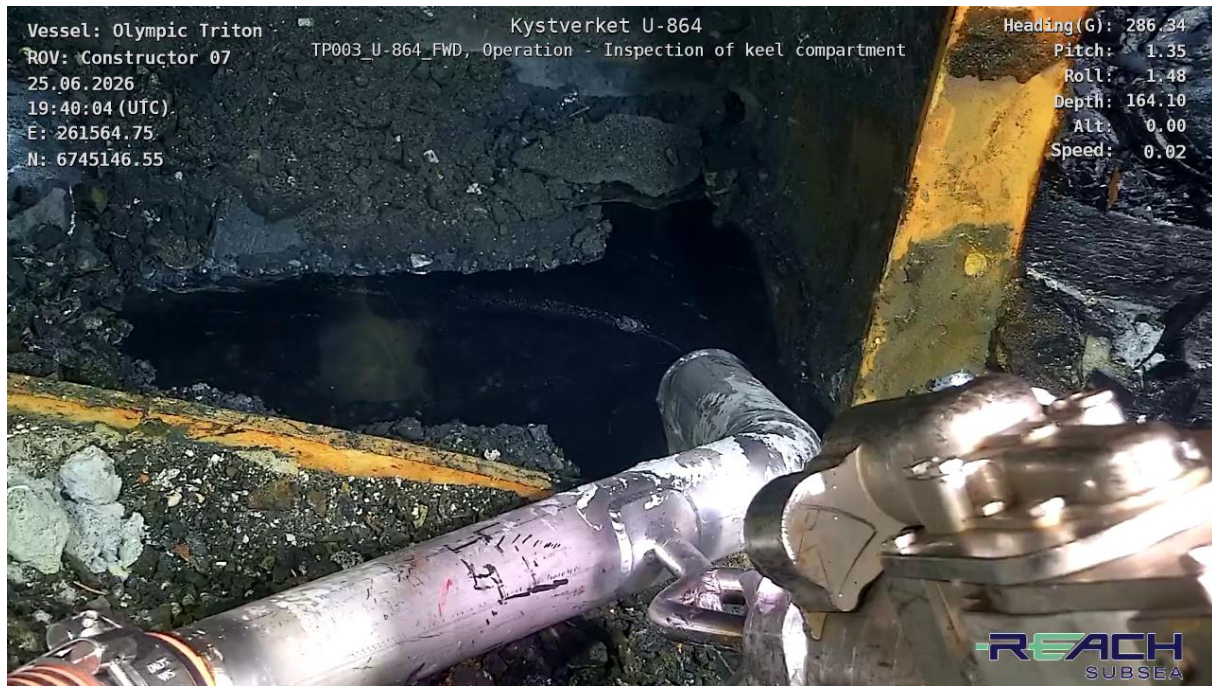
Figure 3-26 Recovery of liquid mercury from keel compartment

Liquid mercury from the keel was recovered using the Strike Subsea suction tool, as shown in Figure 3-26 through Figure 3-29.

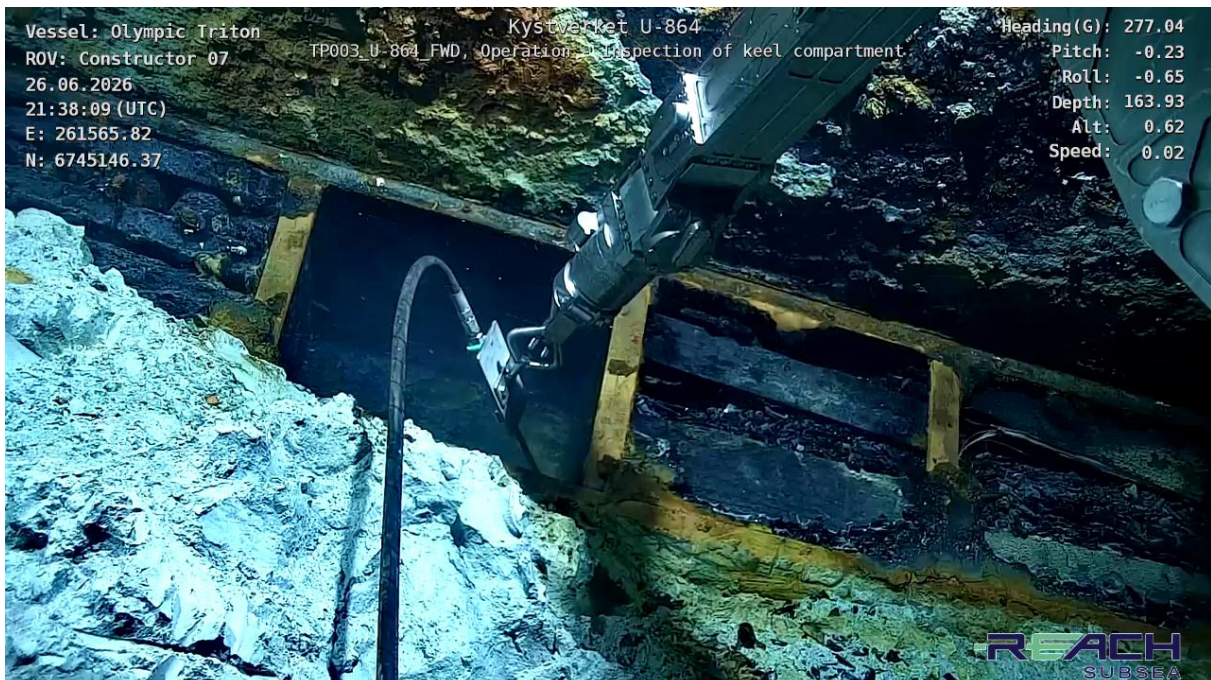
Figure 3-28 Strike Subsea suction tool draining liquid mercury from the storage compartment

For recovery of liquid mercury, cyclone dredger was intended to be used. The Supporter ROV powered the cyclone, while the Constructor ROV directed the suction nozzle towards the liquid mercury. It was observed that cyclone was efficient with regards to suction of debris, but not suitable for suction of mercury. Due to lack of observation ports in the cyclone holding tank, it was not possible to know how much mercury or debris was in the tank.

After recovery and delivery of the mercury containers to Franzefoss, it was discovered that the cyclone holding tank only contained seawater. This was due to the suction pipe being clogged by rocks and sand.

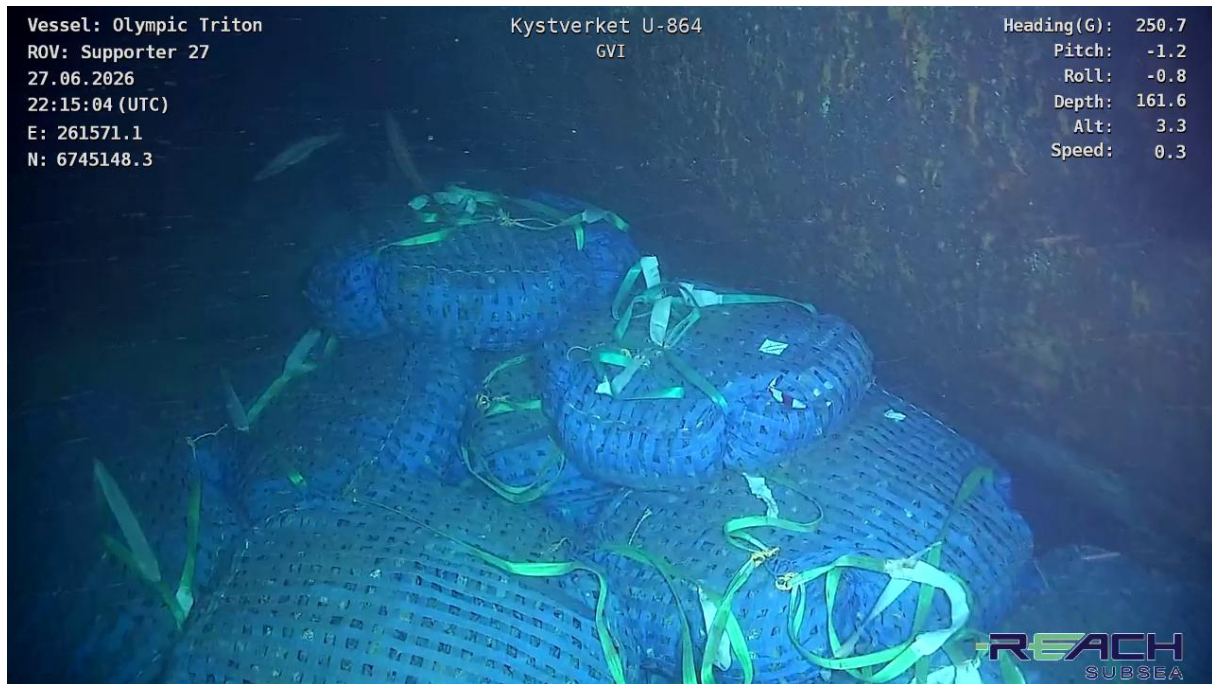
Figure 3-32 Rock bags installed in dredged area towards FWD wreck

Once mercury recovery operation had been concluded, from the 25 June 2026, filter units were installed in the dredged area (Figure 3-31) to stabilise the area. A total of 43 filter units were deployed to the seabed, and these were comprised of 4T and 2T units. There was a surplus of units lowered to the seabed and due to the mercury contamination hazard, they could not be recovered back to deck. As a result, these were wet stored to the north of the wreck. The associated wet stored units have been marked accordingly in the GIS deliverable.

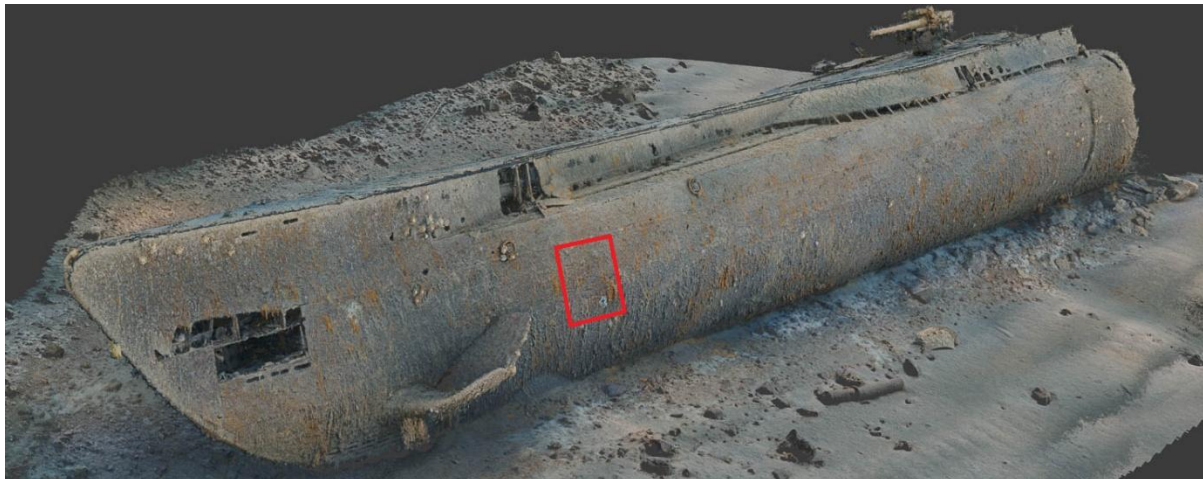
Figure 3-35 Approximate location of cutting for FMD works

In order to verify whether the fore torpedo room was water filled or not, FMD was attempted between 19 and 20 March 2026. The scope involved creating an access opening between frames #136-#138 (frames #76-#78 on pressure hull), cleaning the exposed structure and carrying out FMD measurements. Cutting was performed on 20 March 2026, the results of which are shown in Figure 3-36. Note that this area of hull cutting has also been marked in the GIS deliverable.

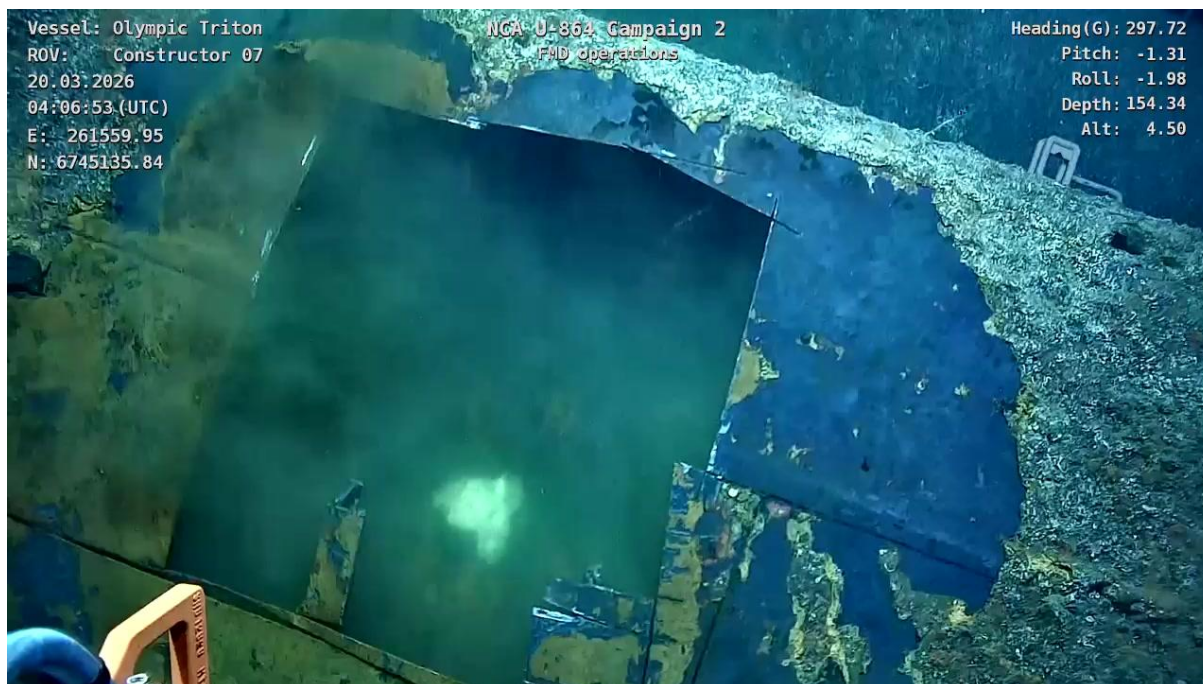
Figure 3-36 Post-cutting access of outer hull between frames #136-#138, allowing for FMD works

The operation was not successful due to the shape of the space to be monitored. The equipment needed a opposite wall or plate surface that was roughly perpendicular to the sensor beam and parallel to the surface where the sensor was mounted. The space was trapezoidal in shape resulting in angled surfaces causing misleading returns.

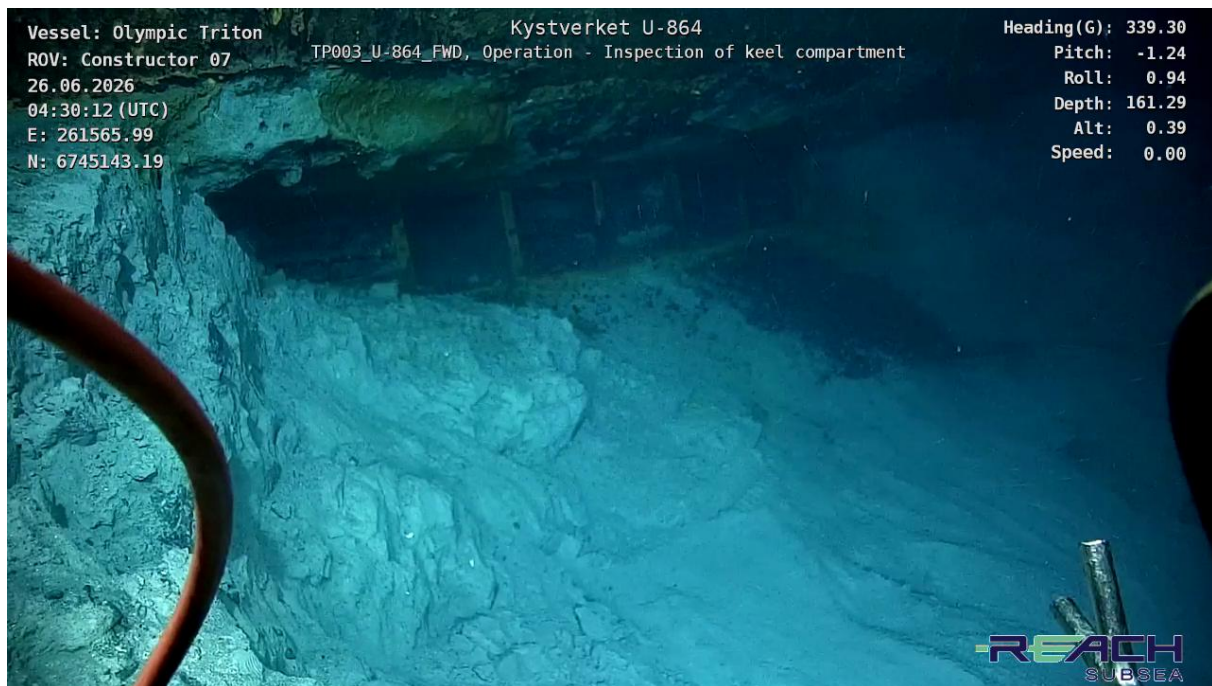
Figure 3-38 The keel plate uncovered 6 compartments

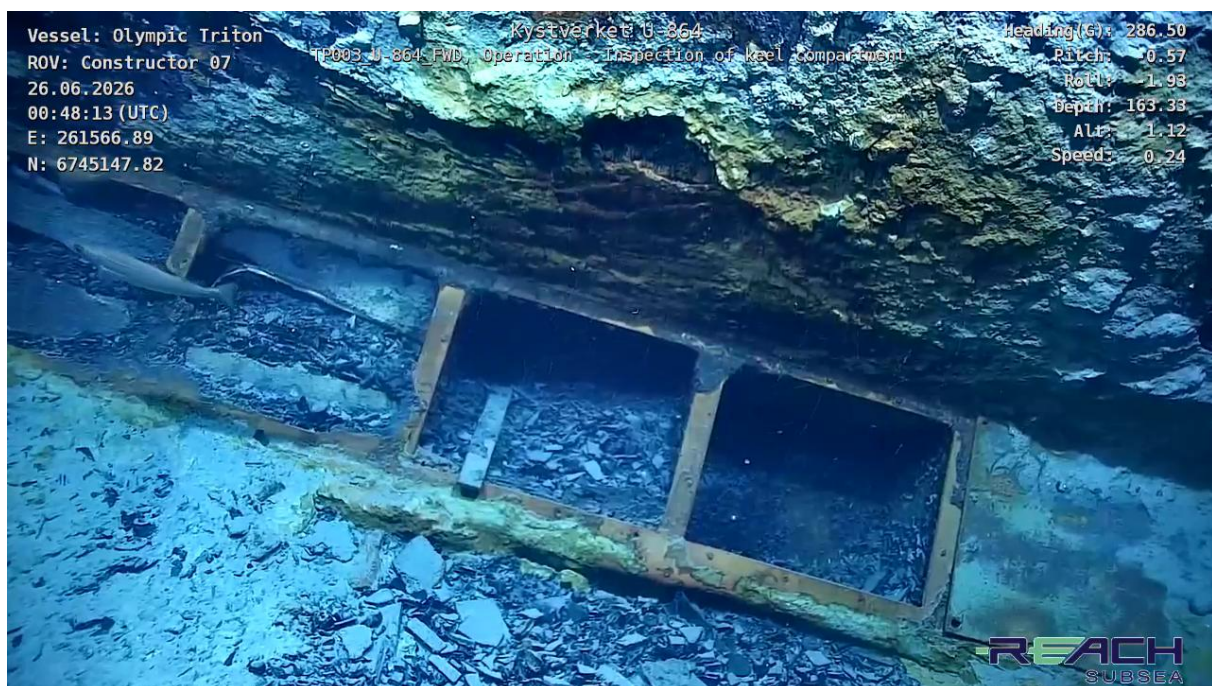
On inspection of the first keel compartment at frame #60, the content seemed to be broken glass, coal and wood. Samples were taken for further study by client on shore.

Figure 3-39 General visual inspection of the accessible compartments. Keel frame #60 to the right

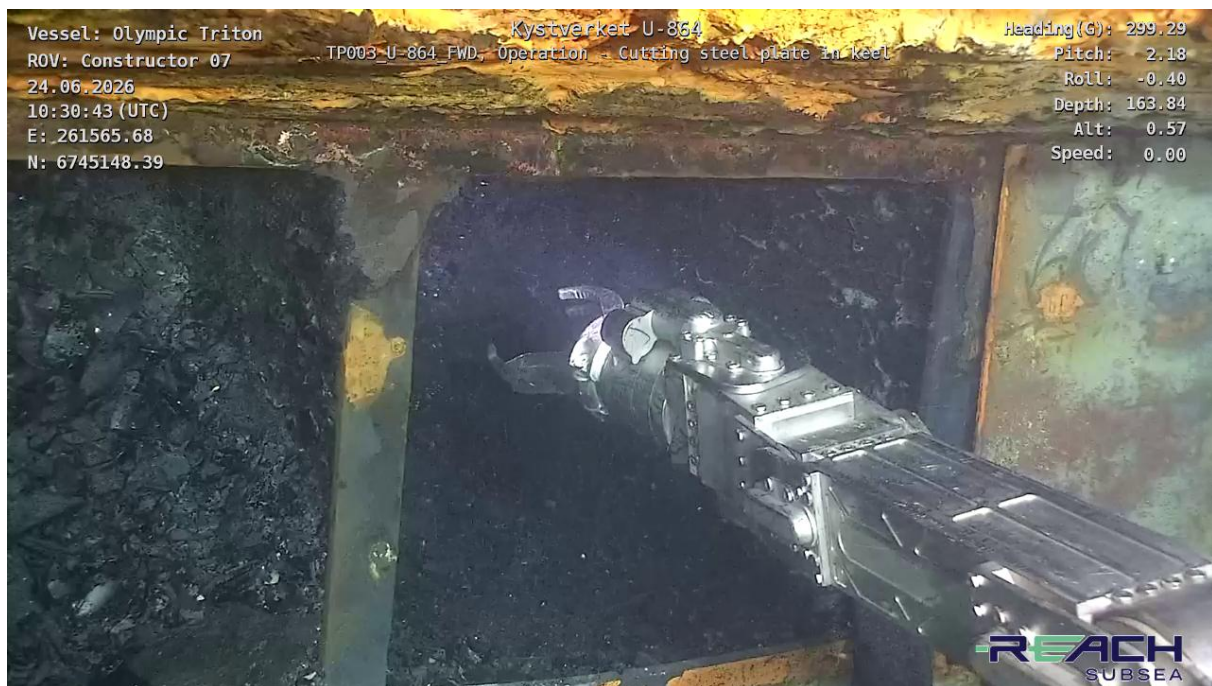
Figure 3-41 Inspection of first keel compartment #60-#61 (#103-#104) area

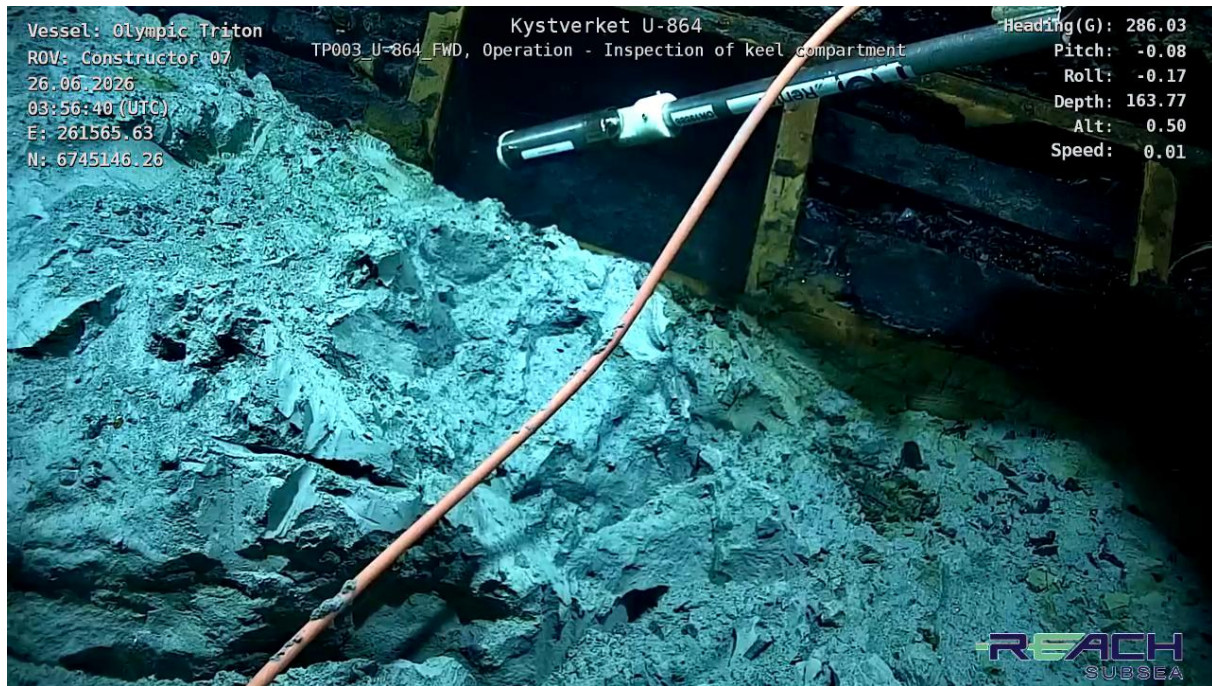
Figure 3-44 Camera stick used to inspect inside the keel compartment

Inspection of keel compartment 5 at frames #64-#65 showed no apparent openings or breaches between the compartments. The compartments appeared to function as separate volumes; however, it cannot be ruled out that there are openings between them. Efforts were made to clean the inspected compartment of all debris; however enough debris remained to potentially cover the lowest parts of the compartment where any openings possibly would exist.

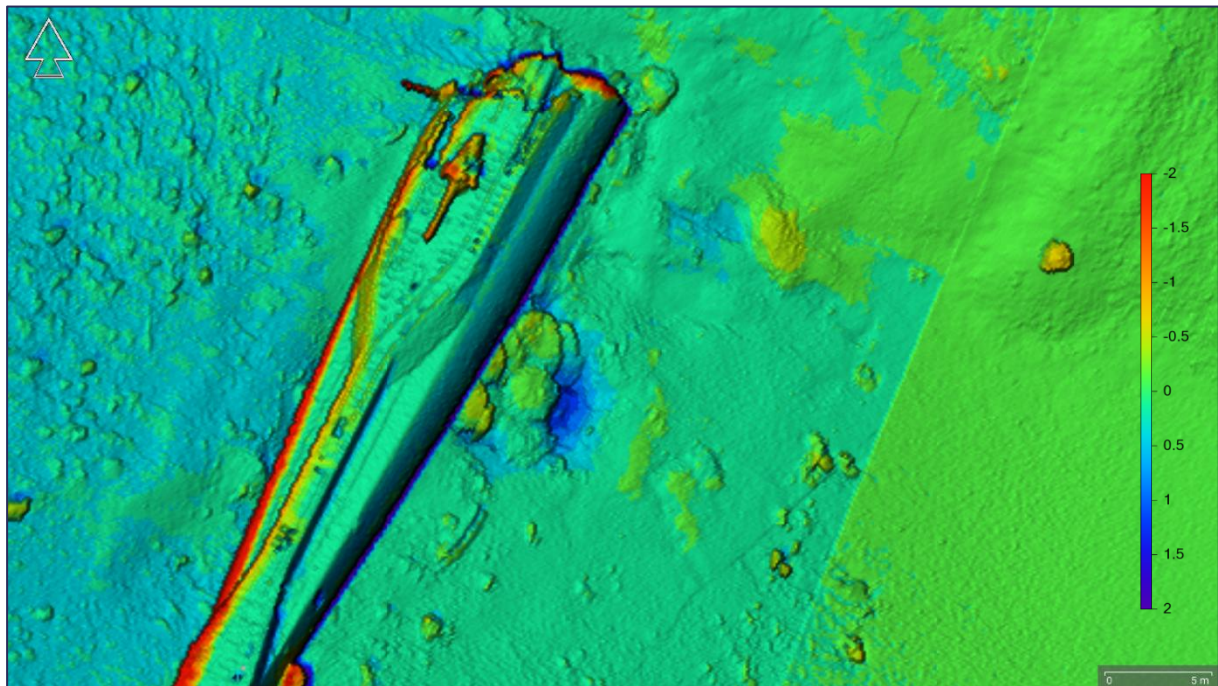
Figure 3-62 Dredged area after installation of rock bags, with difference in depth compared ref DTMAfter the as-left MBES survey, a GVI was performed on 27 June 2026 with the supporter ROV as a final task before leaving the field. No specific observations were made during this GVI. An image of the dredged keel area filled with filter units at the interface with the hull is shown in Figure 3-62.

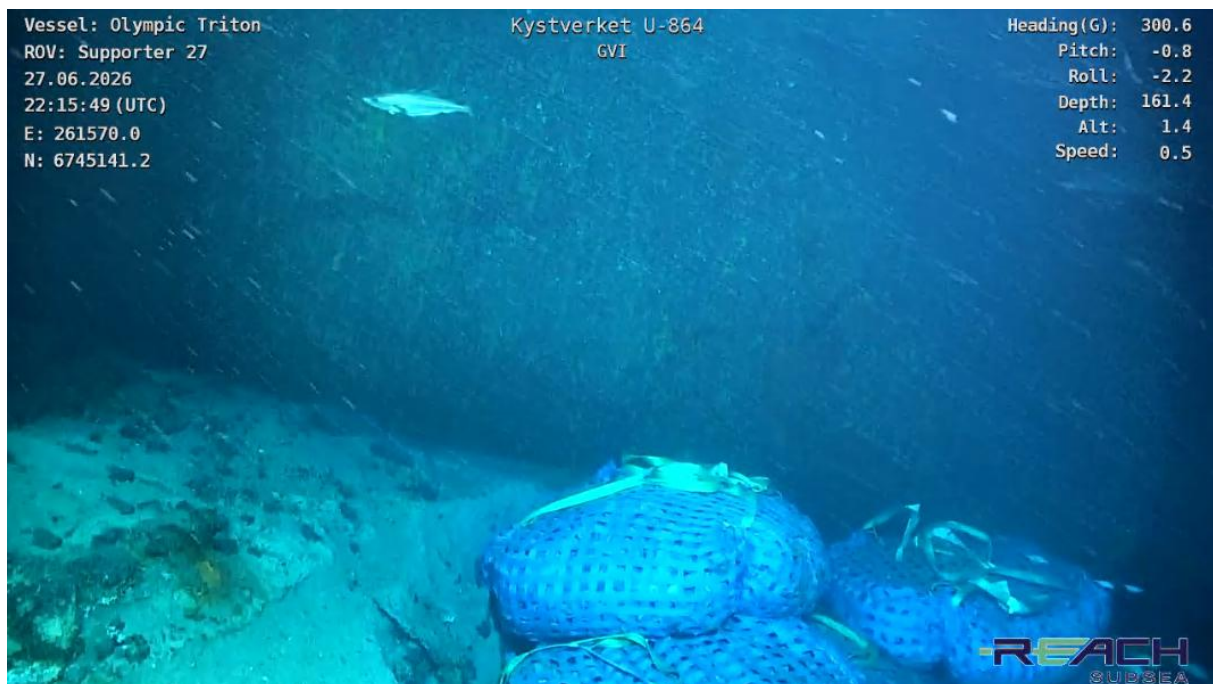
Figure 3-63 GVI image of filter units adjacent to wreck
